Accident Report
Serious Harm Injury
Riptide

1 December 2005

REPORT NO.: 96 489

VESSEL NAME: *RIPTIDE*

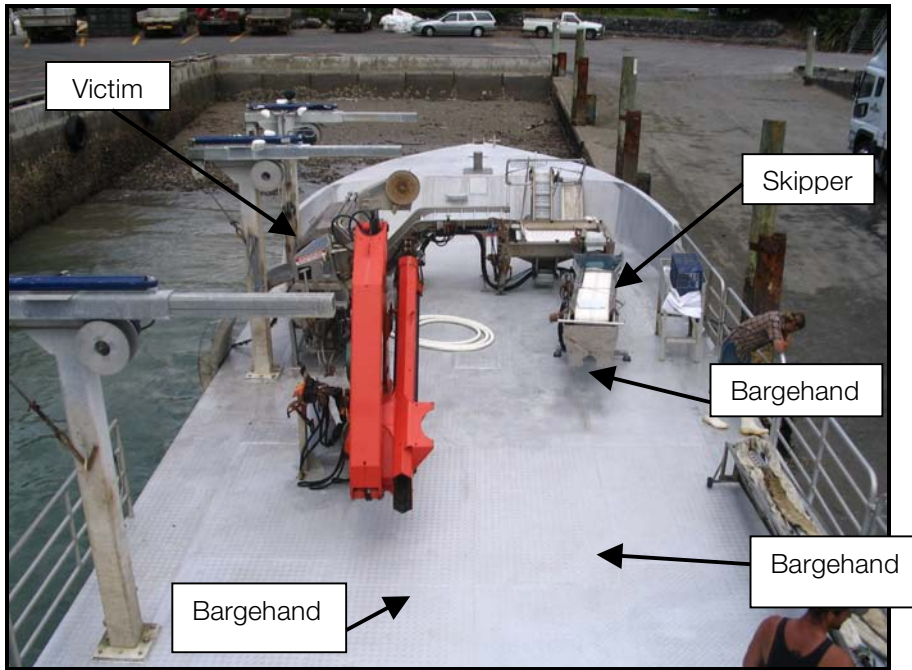
Shortly after arriving at the beds, the crew commenced harvesting operations on the foredeck of the vessel (See *Photograph 1*). The injured bargehand (Crewmember 1) was engaged in cutting the growing lines on the port side of the vessel, with the Skipper grading mussels on the starboard side table. One bargehand was changing bags and the other two bargehands were sewing and stacking the bags of mussels at the after end of the foredeck.

Photograph 1
Approximate location of crewmembers at the time of the accident

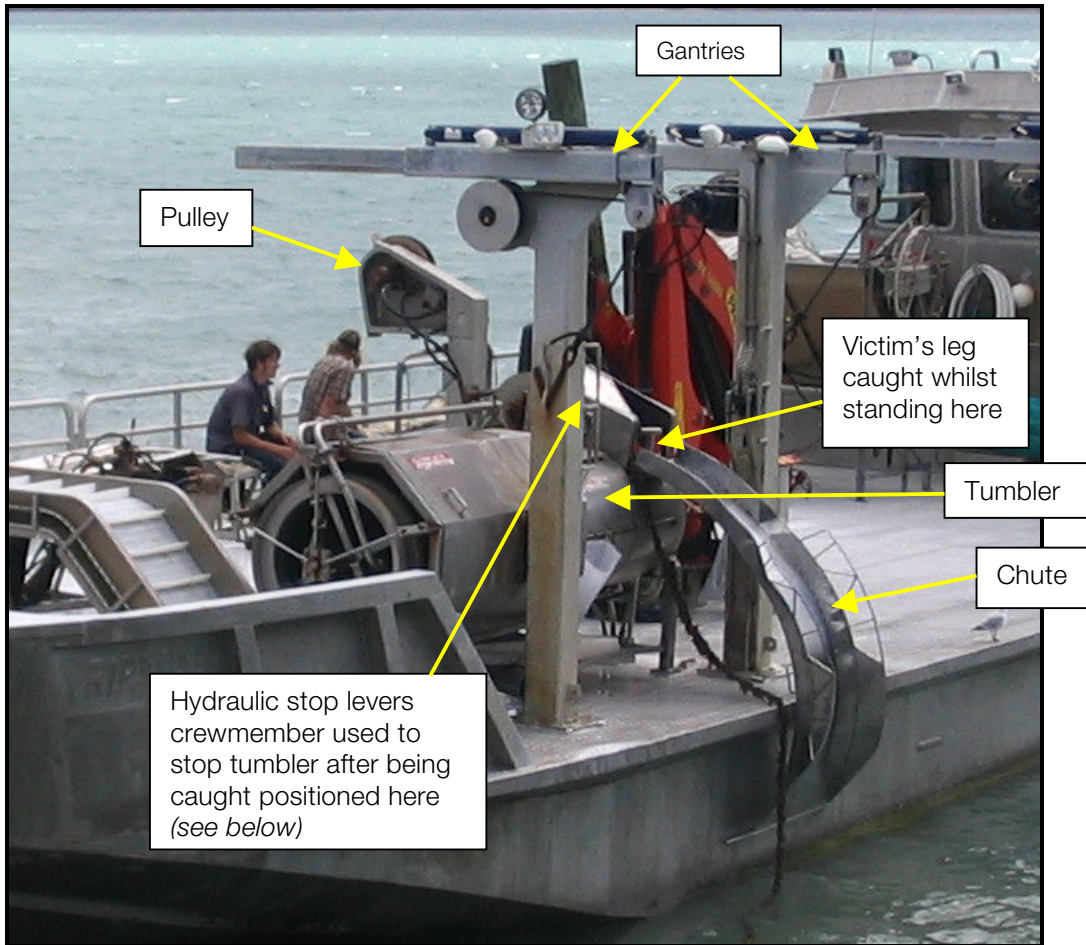
Photograph 2
Overview of Tumbler

There were three warning signs stating "Danger Moving Machinery" displayed on the casing of the tumbler, however two of these were badly worn, only one being prominent.

3. It is recommended that the owner of **Riptide** critically reviews the guarding arrangements at the entrance to the tumbler. *In commenting on the draft report, the Owner confirmed that this recommendation has been implemented.*

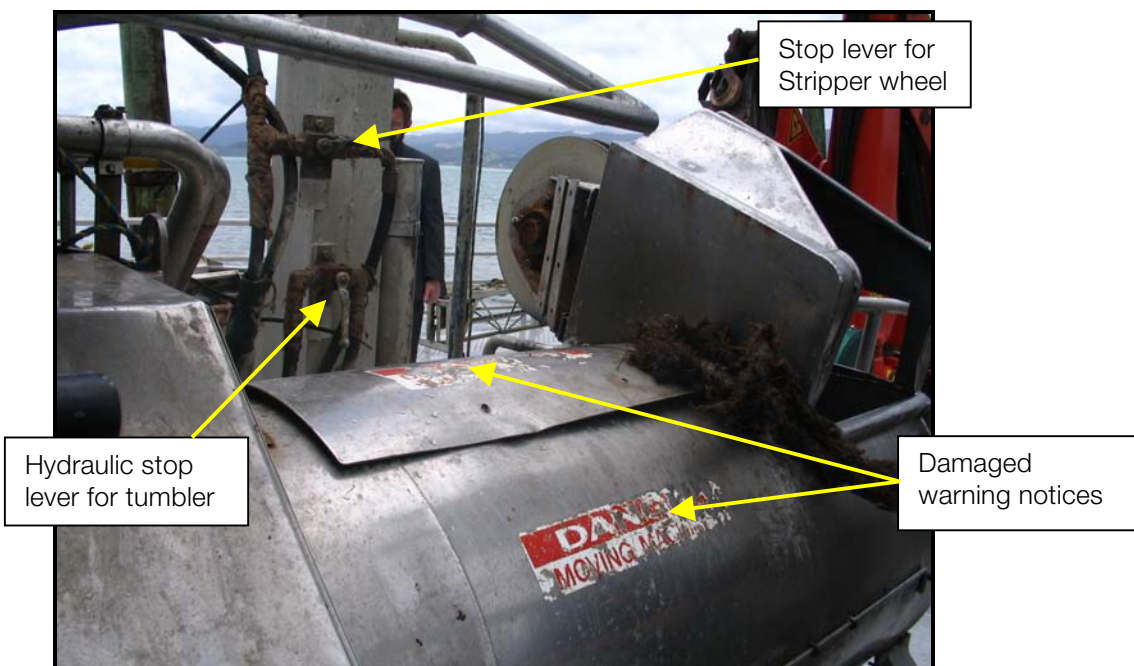
Whilst he was standing on top of the tumbler casing, a turning tine within the tumbler managed to catch on Crewmember 1's leggings, or his steel capped gum boots, and his right leg was dragged into the tumbler. As soon as Crewmember 1 realised what was happening, he shouted for help and managed to reach to the hydraulics controls and turn off the tumbler hydraulics which stopped the tumbler turning within approximately half a turn.

Photograph 3
Close up of Tumbler

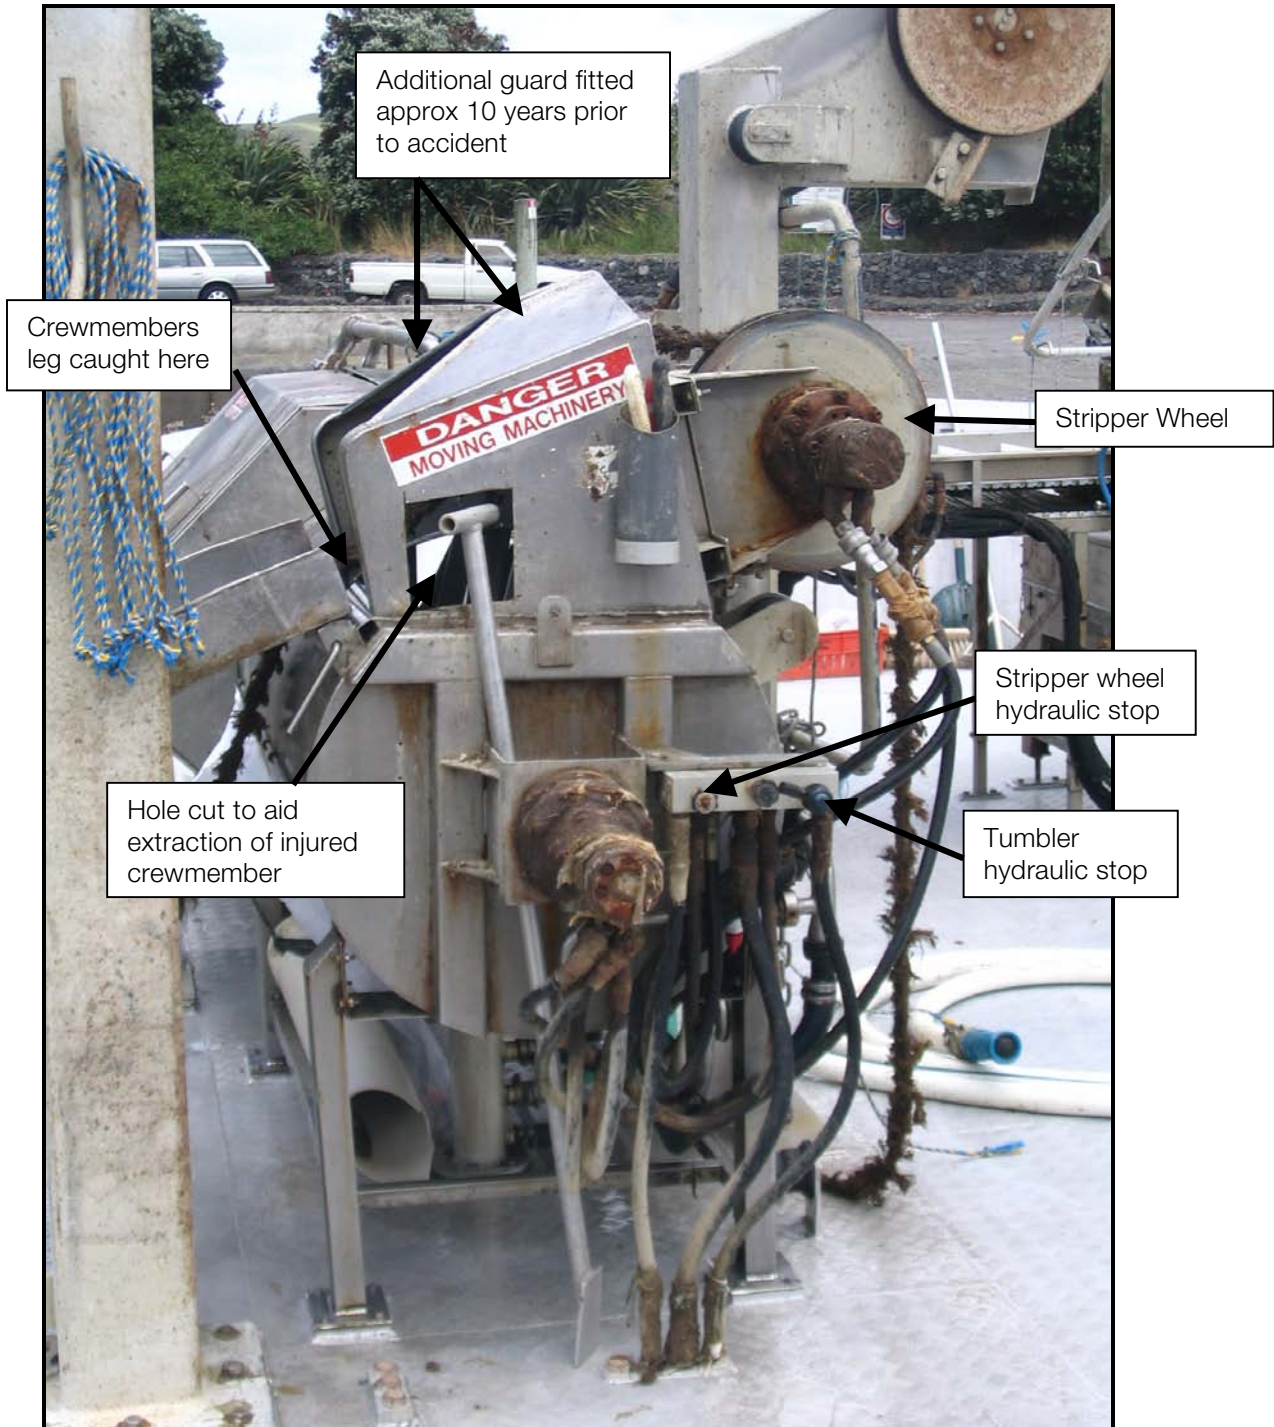
Photograph 4
View of Tumbler from aft

Approximately ten years ago, the guard at the entrance of the tumbler was modified to provide more protection for crew.

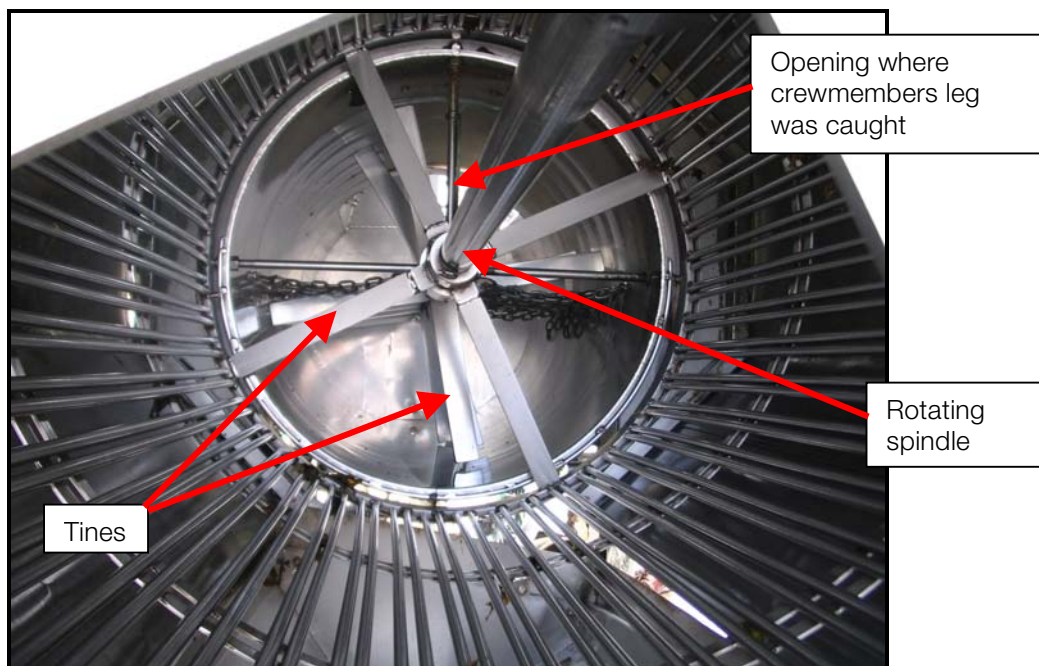
Within the tumbler, stainless steel tines turn anti clockwise at a speed of 22 rpm. There are nine sets of tines welded to a central spindle which is mounted horizontally. Each set consists of two tines that are welded 180mm apart on the spindle. The tumbler is hydraulically powered.

Photograph 5
 Inside of Tumbler looking from forward end
