Incident Report  
Close Quarters Situation  
*Washington & Rose Croix*  
1 September 2005  
Class C

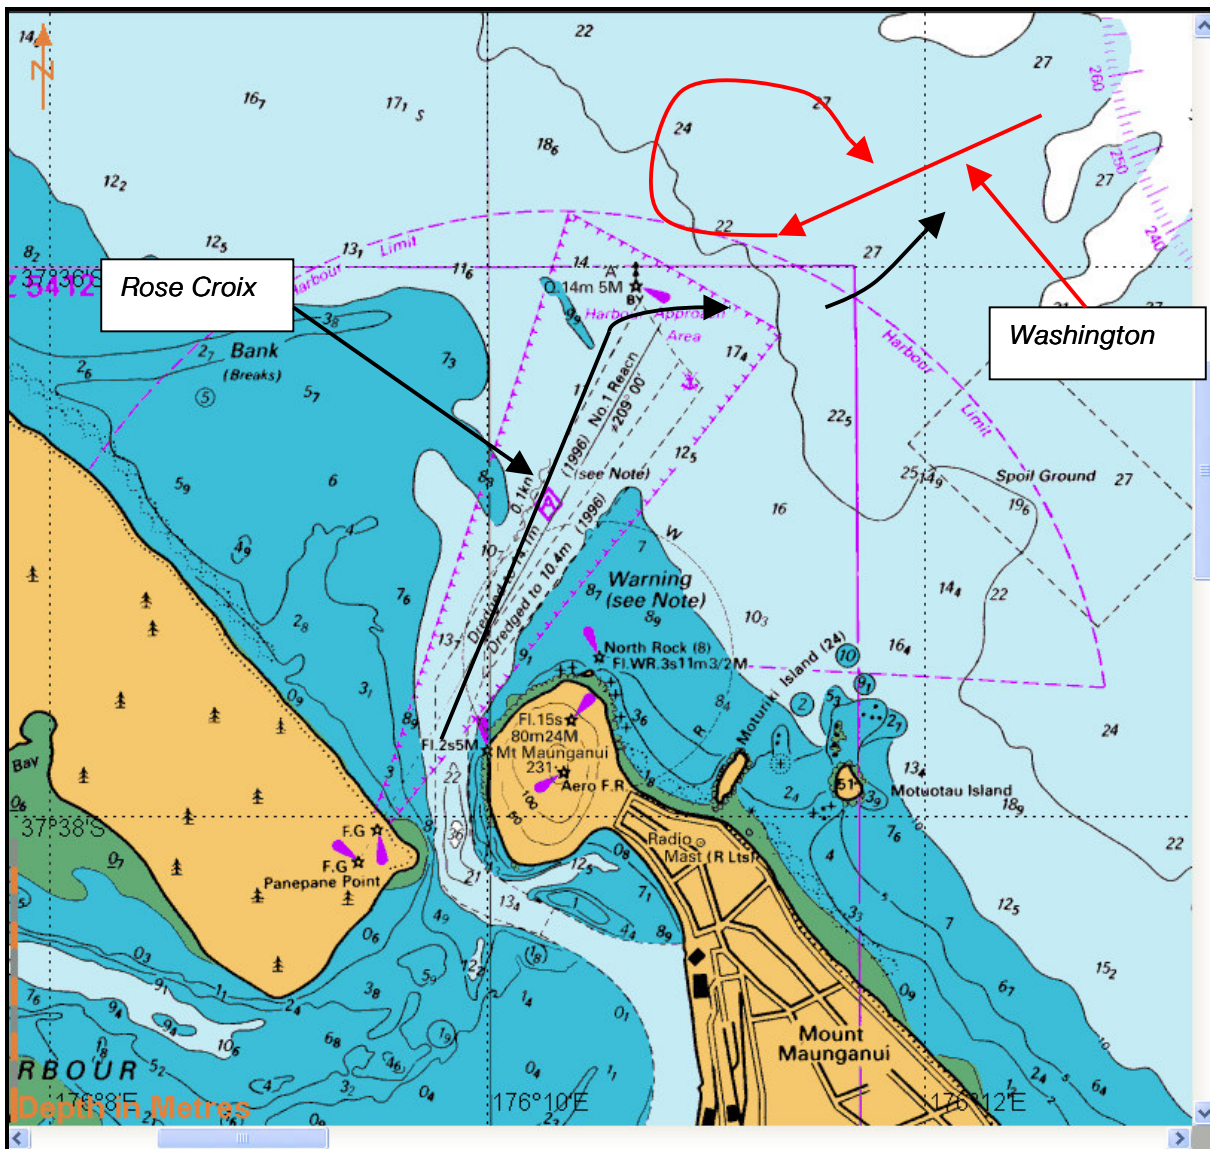
Figure 1  
Chart NZ5413 – Approaches to Tauranga

At 0905 hours, **Rose Croix** was seen crossing from **Washington's** port side on a steady bearing.

**Washington** was about to enter the Port Approach Area when **Rose Croix** was seen in the main channel, heading approximately 029°(T). Since **Washington** was required to keep its course and speed, and therefore unable to turn to port to enter the channel, **Rose Croix** was impeding its way, which was contrary to the requirement of **Maritime Rule 22.9(b)**.

While proceeding along the course of the fairway, **Rose Croix** did not keep as near to the outer limit of the fairway which lay on its starboard side as was safe and practicable, as required by **Maritime Rule 22.9(a)**.
