Accident Report

Flooding

San Rakino

REPORT NO.: 05 3855

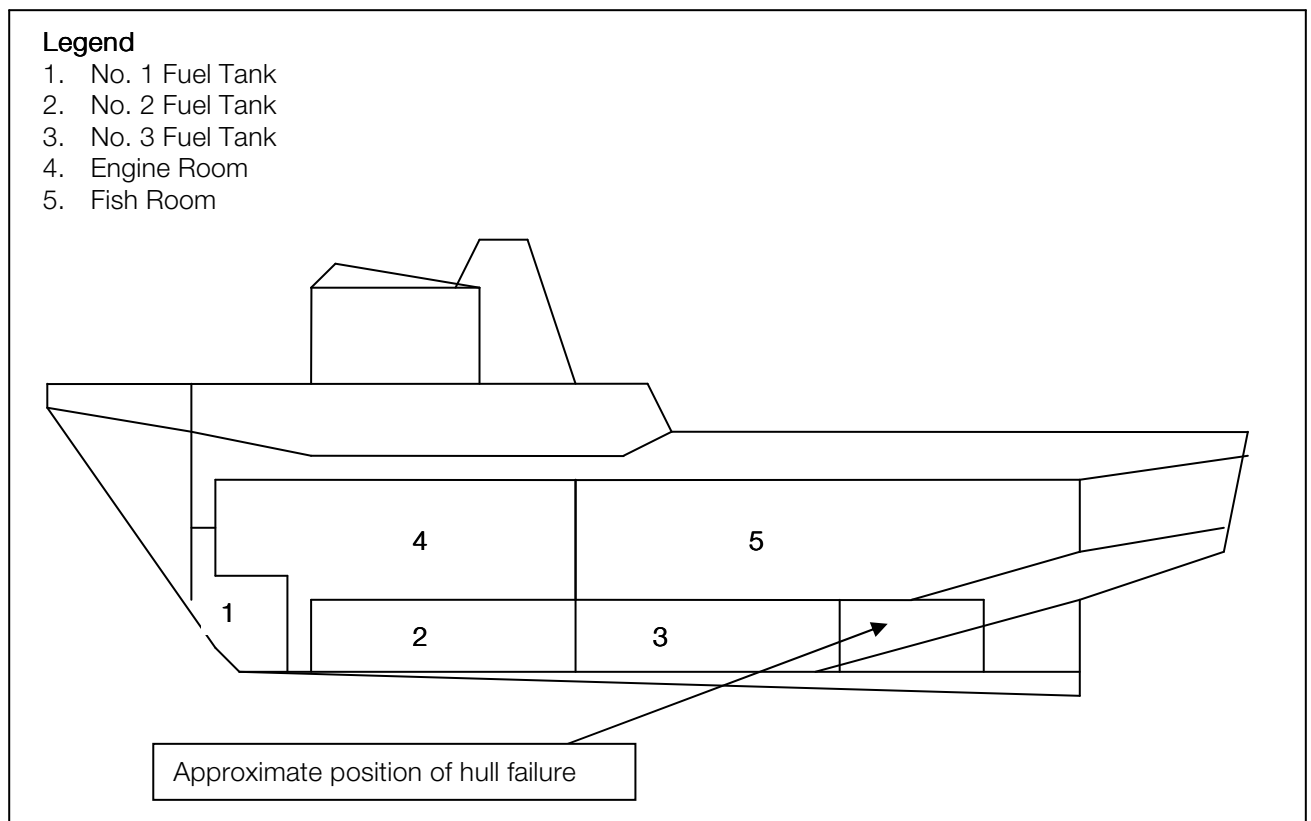
Figure 1
San Rakino Vessel Profile

At 0700 hours, divers and the Fleet Manager arrived on board. Divers subsequently reported a hole in the hull plating on the port side close to the keel plate. A plywood patch and rubber seal, measuring approximately one metre square, was placed over the hole and attached with self tapping screws (See *Figure 1 – Vessel Profile & Photograph 8*).

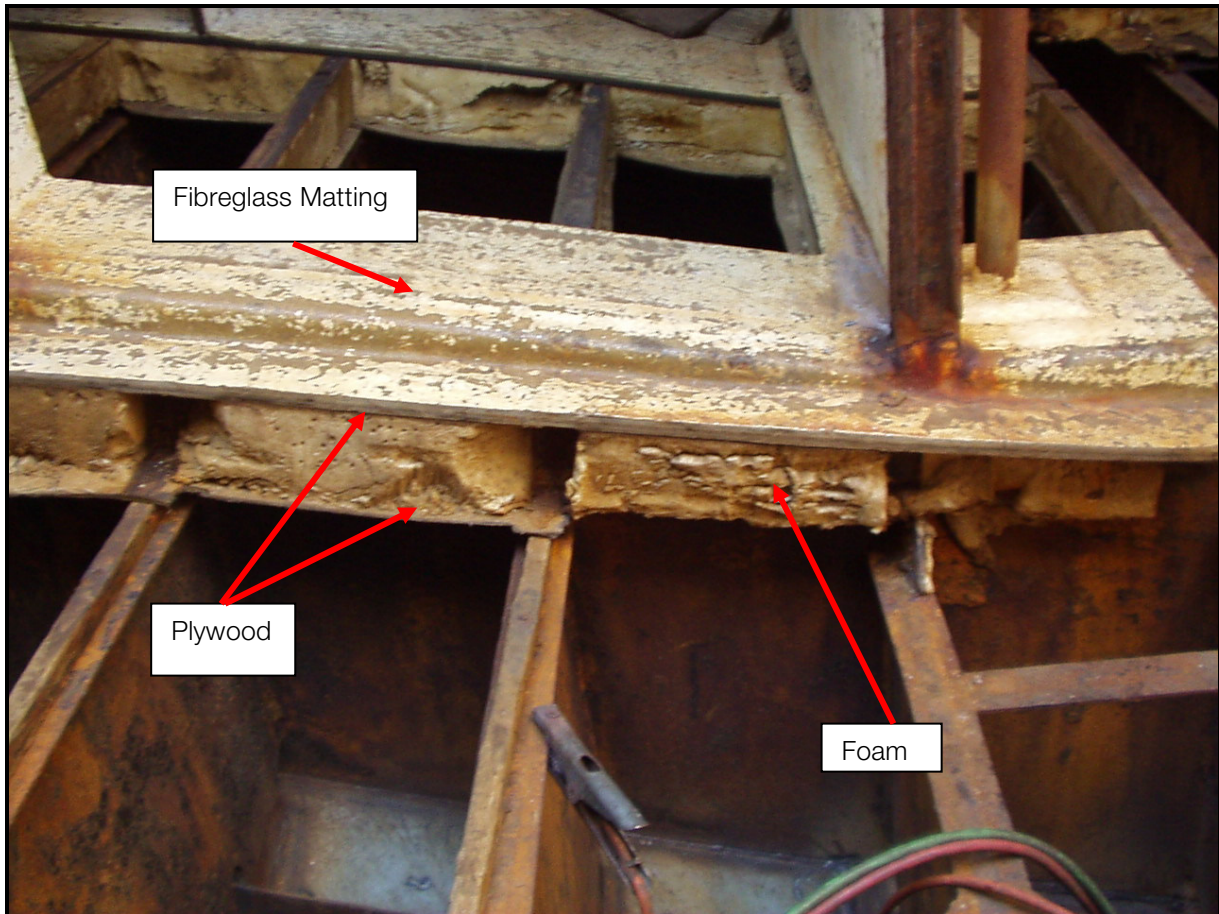
Photograph 4
Showing cut away section of fish room floor

San Rakino's fish hold is lined with foam insulation material. The floor section is made up of a 'sandwich' consisting of 2.54 cm and 0.63 cm plywood at the top and bottom respectively, which are separated by 17 cm of foam. The sandwich rests on bottom longitudinals and transverse void frames. A fibreglass matting lies on top of the top layer of plywood (See *Photograph 4 - Showing cut away section of fish room floor*).

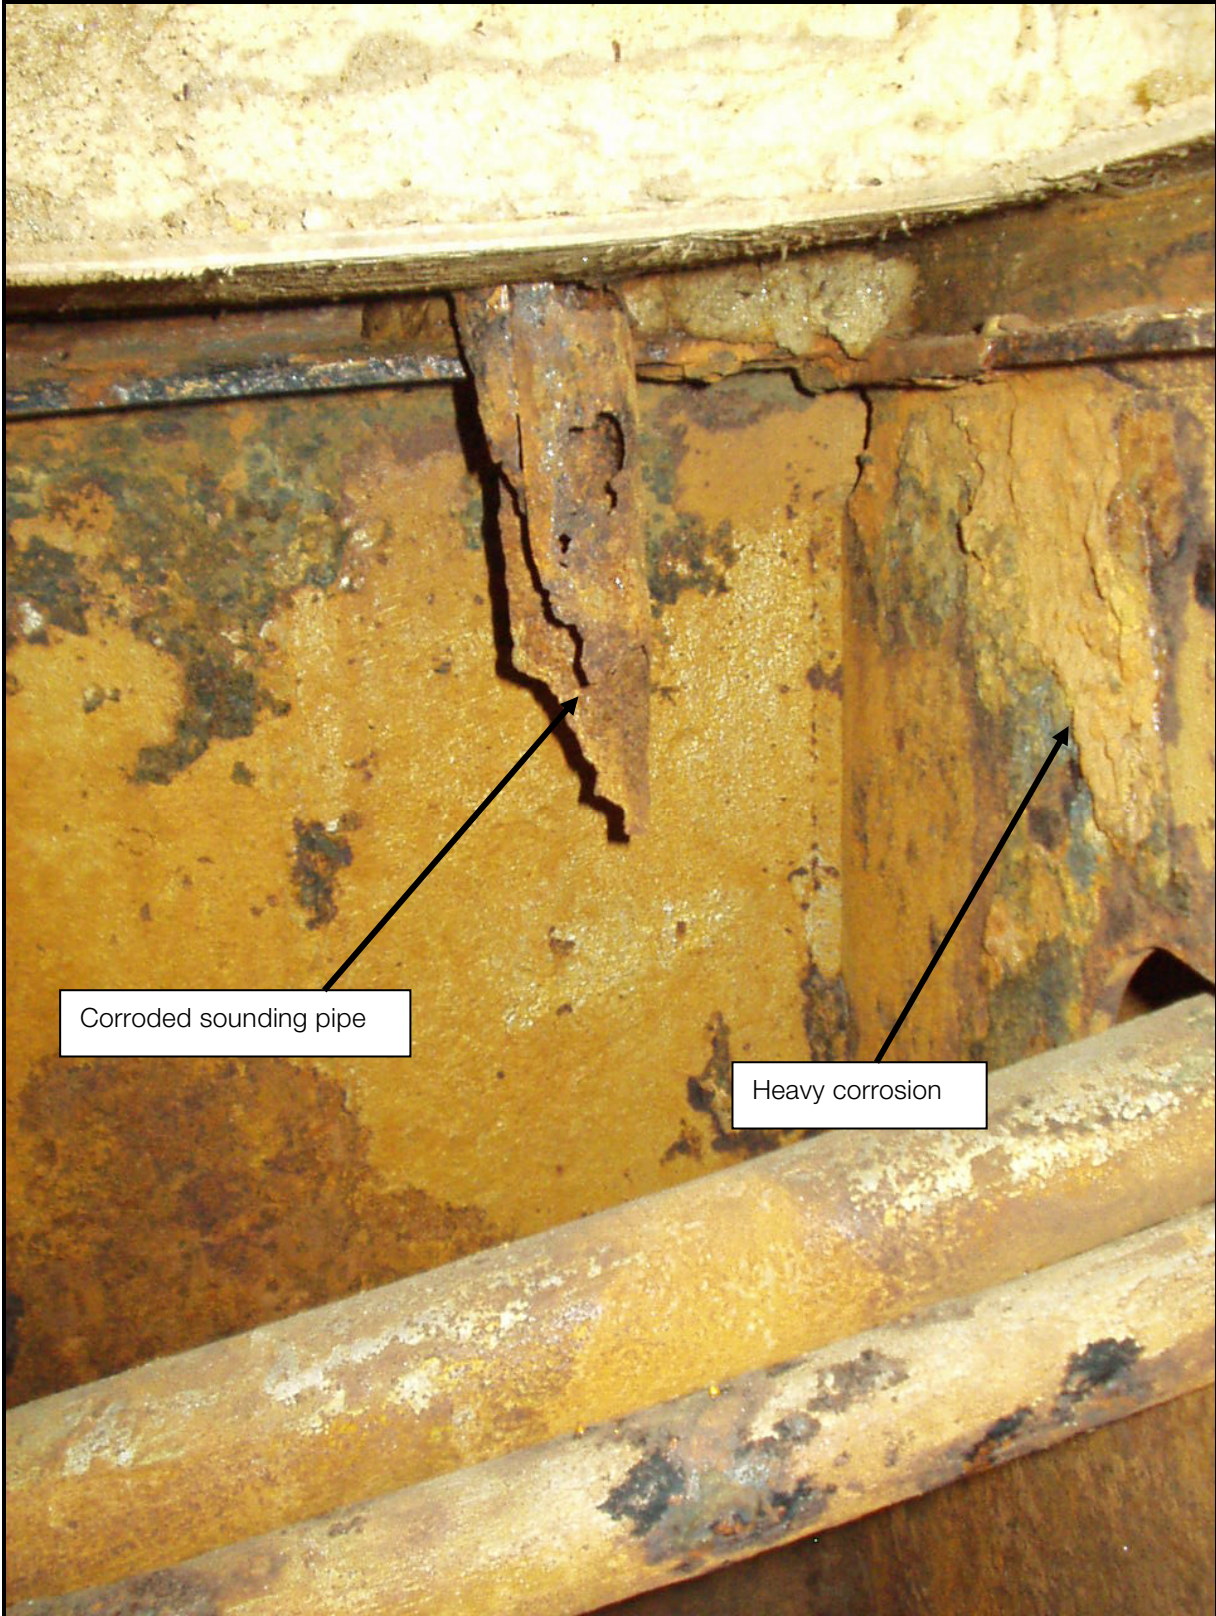
Photograph 5

The galvanised sounding pipe in the void space in which the hull plating failed, had completely corroded away due to galvanic corrosion (See *Photograph 5*). This pipe and another leading to another void space on the starboard side of the fish room was installed after **San Manukau** capsized. There was no evidence of a striker plate being fitted against the hull under the sounding pipes although the section of hull that failed was not directly beneath the pipe aperture. In all other void spaces that were inspected, heavy rusting was found on the transverse and longitudinal frames (See *Photograph 5*).

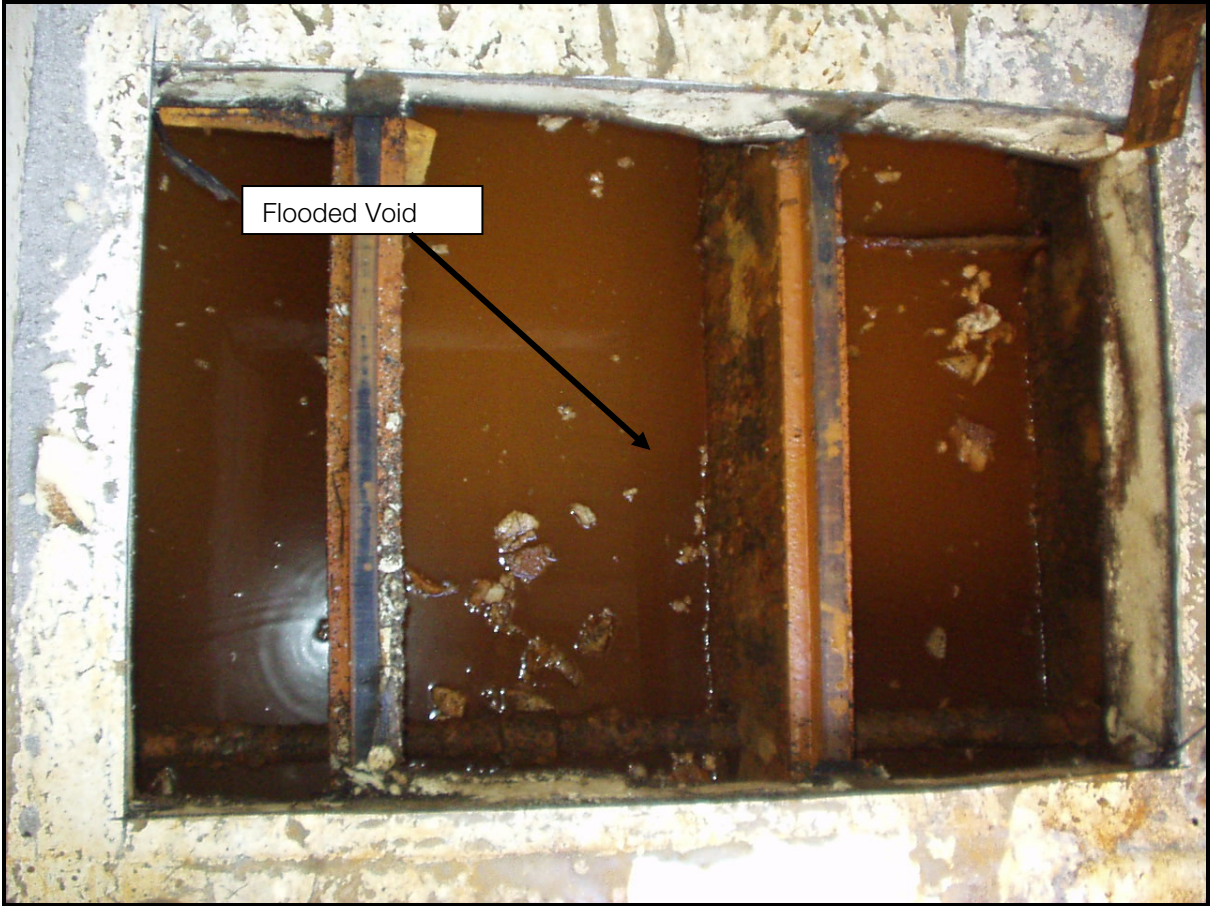
Photograph 6

The void space on the starboard side of the fish room, adjacent to the section of hull plating that failed, was full of rust coloured water. When sounded, it was found to have thick rust sediment measuring approximately 200 mm in depth in the lowest point of the void. Analysis of water from the flooded void established it was at least 90% seawater and had an acidic level of 5.71 pH. This made it highly corrosive (See *Photograph 6*).

The high acidic pH level found in the flooded starboard void space was highly corrosive. This suggests that despite the Operations Manager's statements that the void spaces were religiously checked by shore staff the void space had been flooded for a considerable period. Heavy corrosion was found in this and other void spaces including the void space in which the hull plating failed.

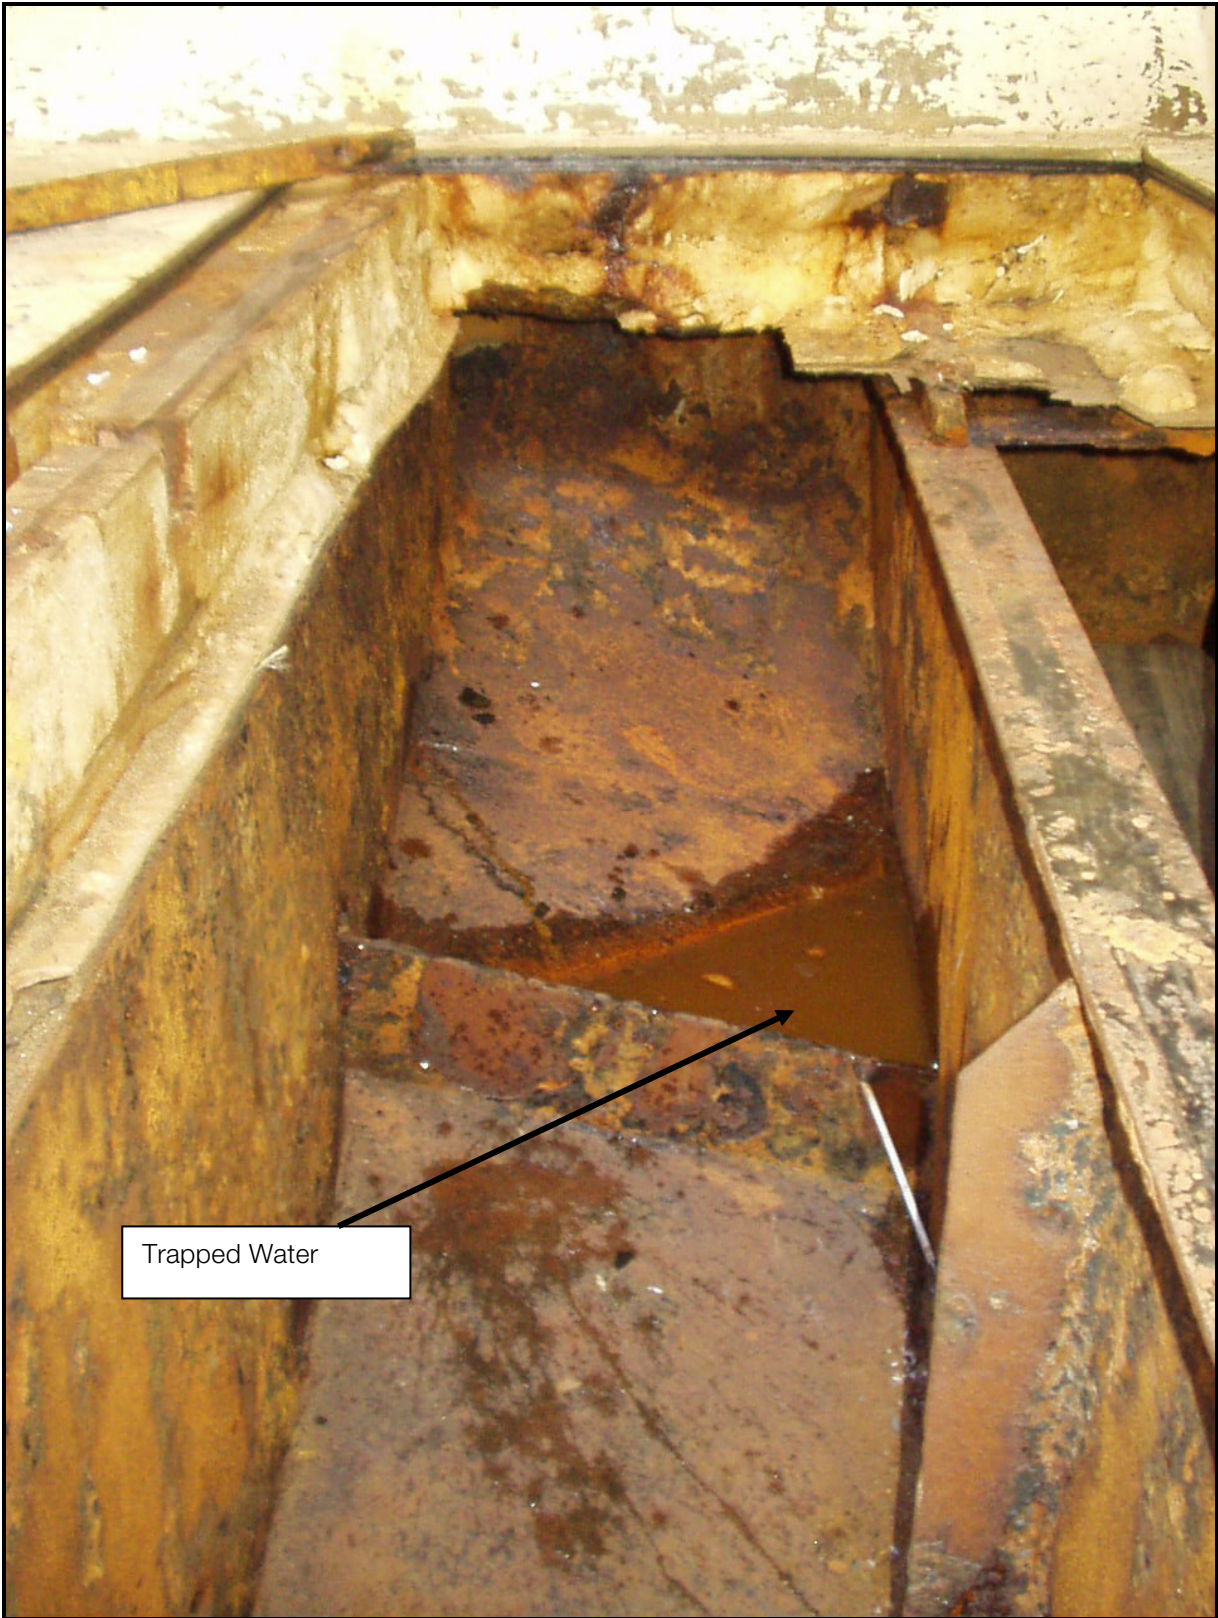
Photograph 7

In the void space in which the hull plating failed, loose coat rusting was evident. A steel fore and aft stringer located higher up on the hull did not have a limber hole to allow water to drain clear (See *Photograph 7*).
