Accident Report

San Rochelle

Fire & Sinking, 95.1 miles
Northwest of Cape Reinga
on 27 October 2004

REPORT NO.: 04 3590

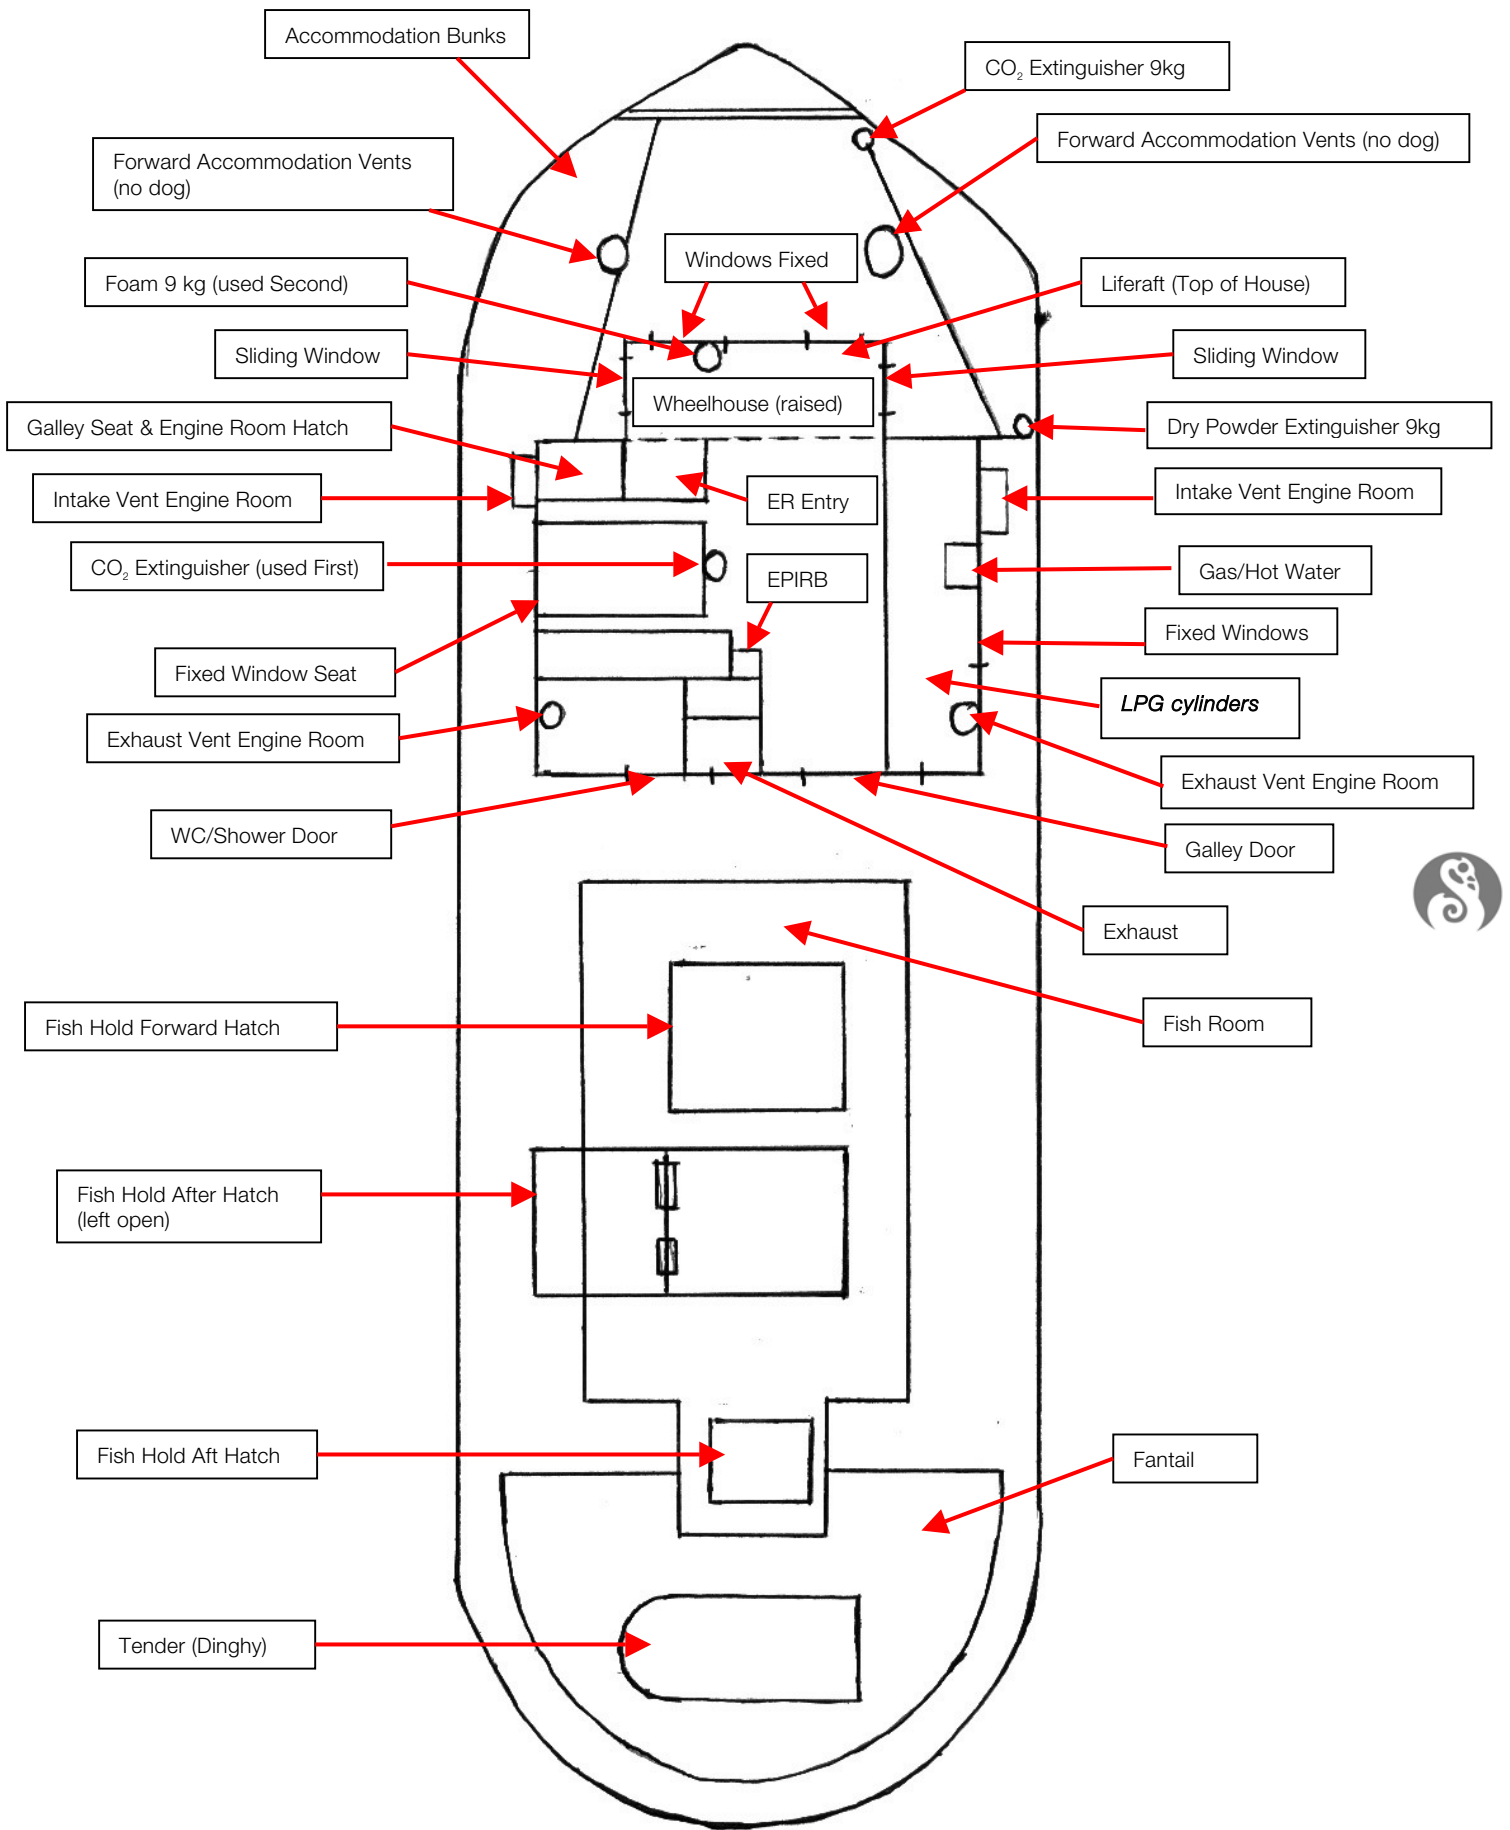
Figure 3 – *San Rochelle* Saloon/Deck General Arrangement Plan

The crew stated that when first observed, the smoke was light grey in colour and was in the vicinity of the exhaust stack abaft of the wheelhouse. The Skipper stated the flames were licking around the hatch coaming to the engine room from the port side of the deckhead when he first opened the hatch. He was unable to see the source of the fire or enter the engine room due to the smoke and heat. As a result he was unable to direct fire extinguishers at the source of the fire. For this reason he elected not to use the remaining fire extinguishers and instead opted to fight the fire by cutting off the oxygen supply in accordance with his fire fighting training. He was aware that opening the hatch a third time would allow oxygen to the fire but he stated he had to know the situation in the engine room to determine if it was necessary to abandon ship. The vessel had a deck pump on board that could have been used to fight the fire. However, it was operated off the main engine and when this failed the pump was rendered inoperable (See *Figure 3 – General Arrangement Diagram for Saloon & Deck*).

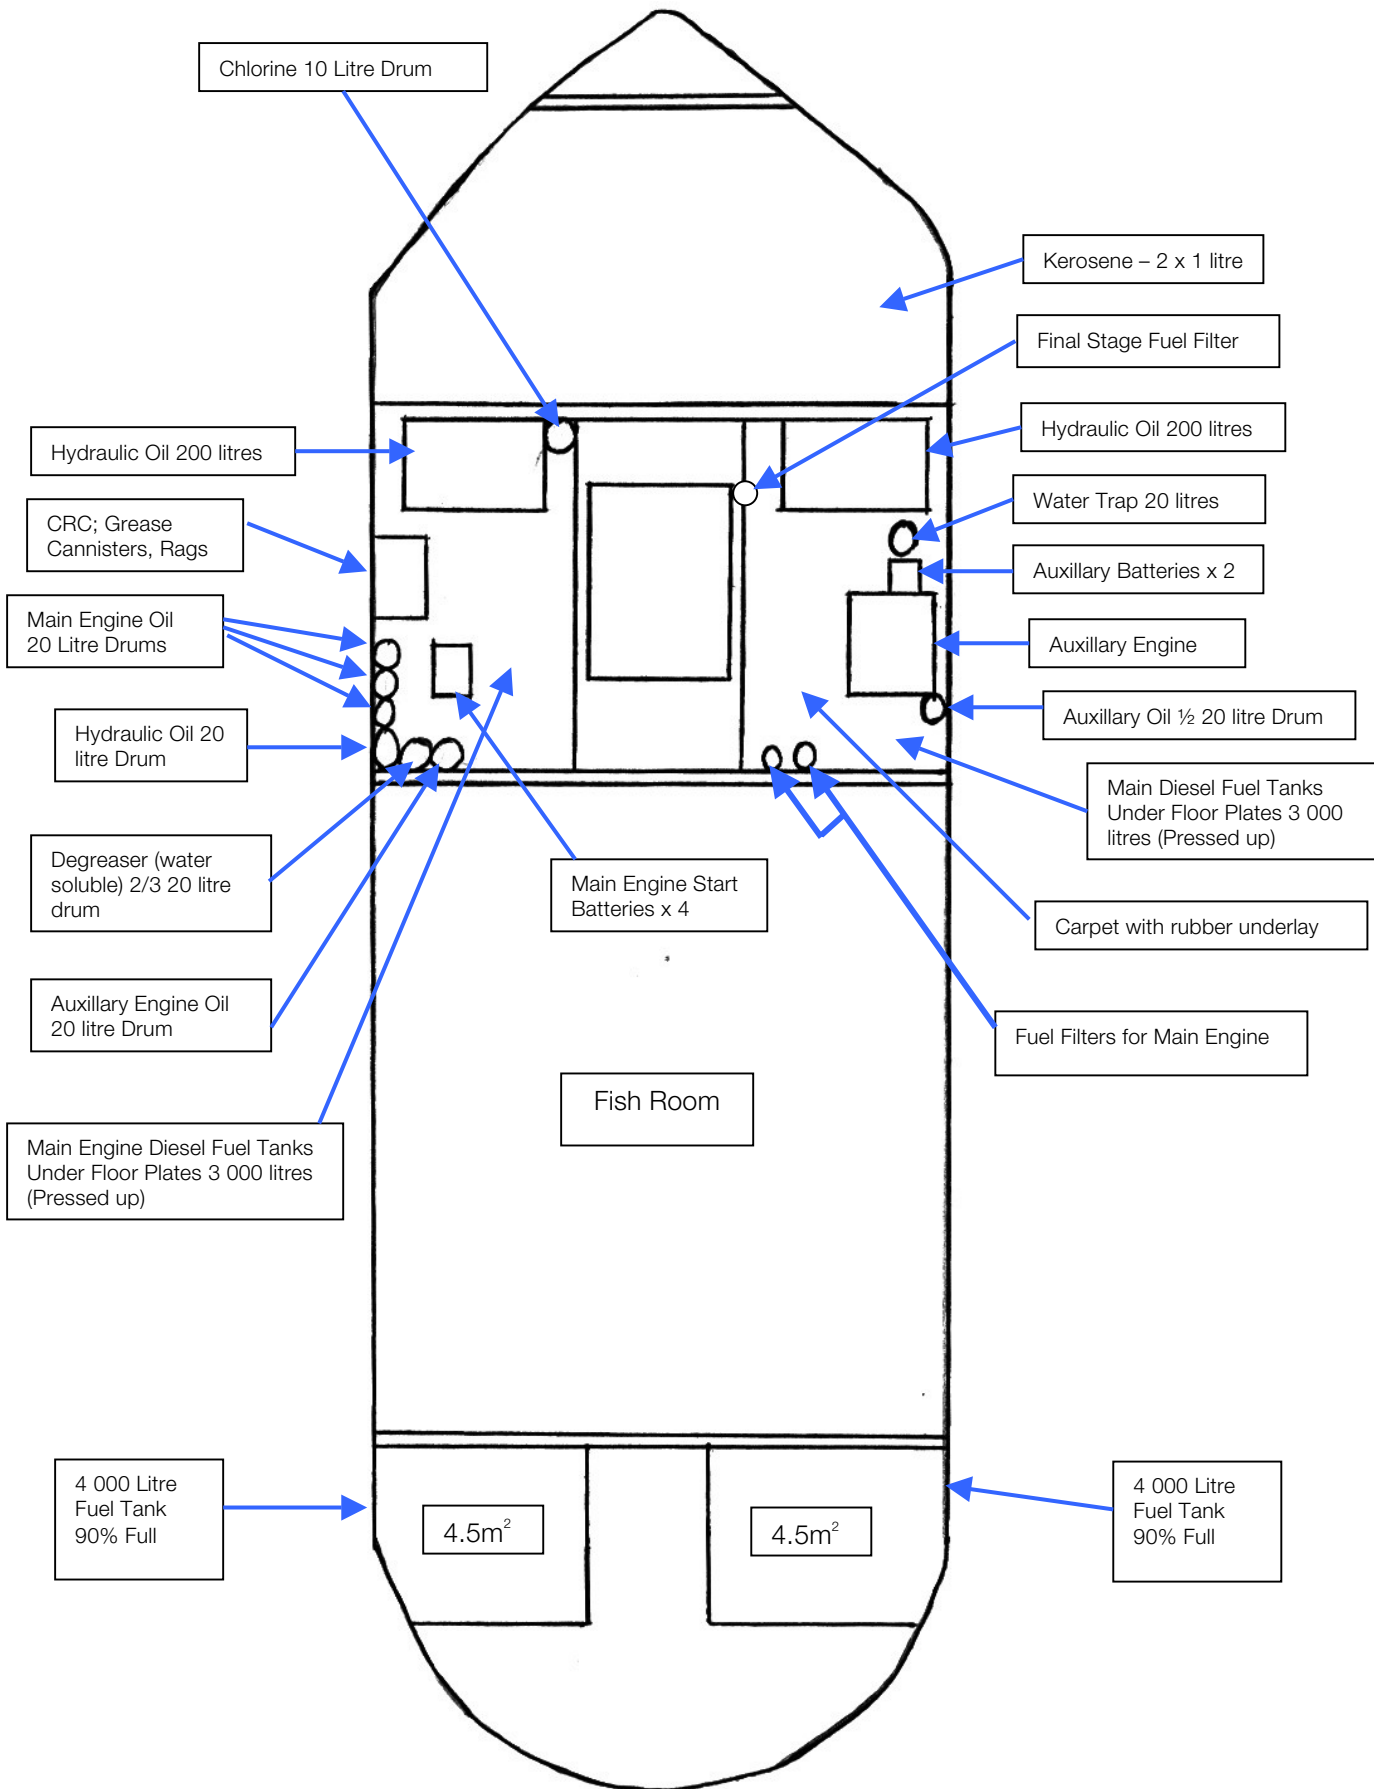
Figure 6 – *San Rochelle* Engine Room General Arrangement Plan

San Rochelle had suffered a minor fire under the previous owner. On that occasion, brackets holding the main engine exhaust at the deckhead of the engine room had broken causing contact at the deck head. Creosote had then ignited.

The Master stated that *San Rochelle* had a rebuilt main engine installed approximately 18 months prior to the accident. Prior to departure on 24 October, he was aware of a crack in the section of bellows between the manifold and main engine exhaust system. This was an ongoing problem due to misalignment of the exhaust pipe with a resultant small amount of exhaust gasses leaking into the engine room. He had made arrangements for repairs on return.

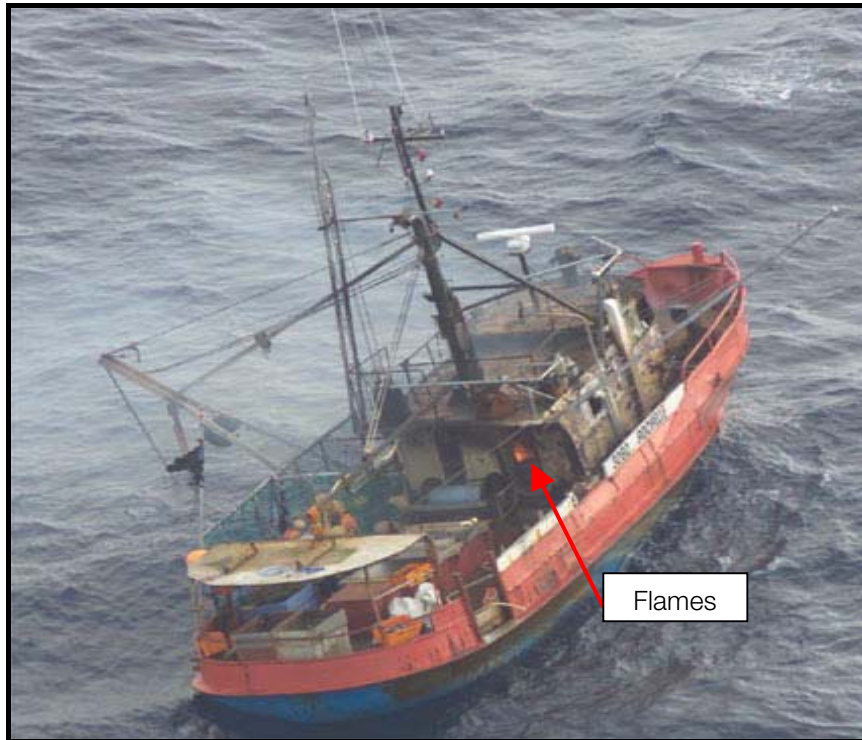
Figure 8 – RNZAF Photograph of Vessel

The last photographs of *San Rochelle* were taken approximately five hours after the height of the fire. They show substantial fire damage to the wheelhouse with smoke emitting from the forward vents. There is no visible damage from the fish hold aft. This suggests the aft engine room bulkhead may have prevented the fire from spreading. In addition there was no obvious list or trim indicating the vessel had taken little or no water at that time. From the photograph in Figure 8, it would appear the fire had largely burnt out at the time it was taken. Smoke can clearly be seen coming from the wheelhouse and forward

sections of the vessel. The companionway door was constructed of wood and had burned through when photographed. What appear to be flames are visible through the companionway entrance. The photograph below shows the vessel still riding high in the water (See Figure 8 - Photograph of Vessel).

The photographs taken by the RNZAF Orion establish that the aft fish hatch cover was left open and that the saloon entrance door had burnt away. Once the door burned through this would have fed oxygen to the fire. Equally, once the saloon windows exploded from the heat this too would have fed oxygen to the fire.

2. The failure to ensure the aft fish hold hatch on the weather deck had been closed properly before abandoning the vessel could have been avoided by the application of good seamanship and a general awareness of the risks such an opening provided. In this regard, it is recommended that copies of this report be forwarded to Fish SAFE for their attention and that a copy of the report be forwarded to Seafood NZ and Professional Skipper magazines.
