Accident Report  
*San Tongariro*  
Grounding at French Pass  
on 11 August 2004

REPORT NO.: 04 3528  
VESSEL NAME: *SAN TONGARIRO*

Date of Casualty: 11 August 2004  
Time of Casualty: 0315 hours New Zealand Standard Time (NZST)  
Casualty Type: Grounding  
Casualty Location: French Pass  
Weather Forecast Area: Stephens  
Investigator: Domic Venz

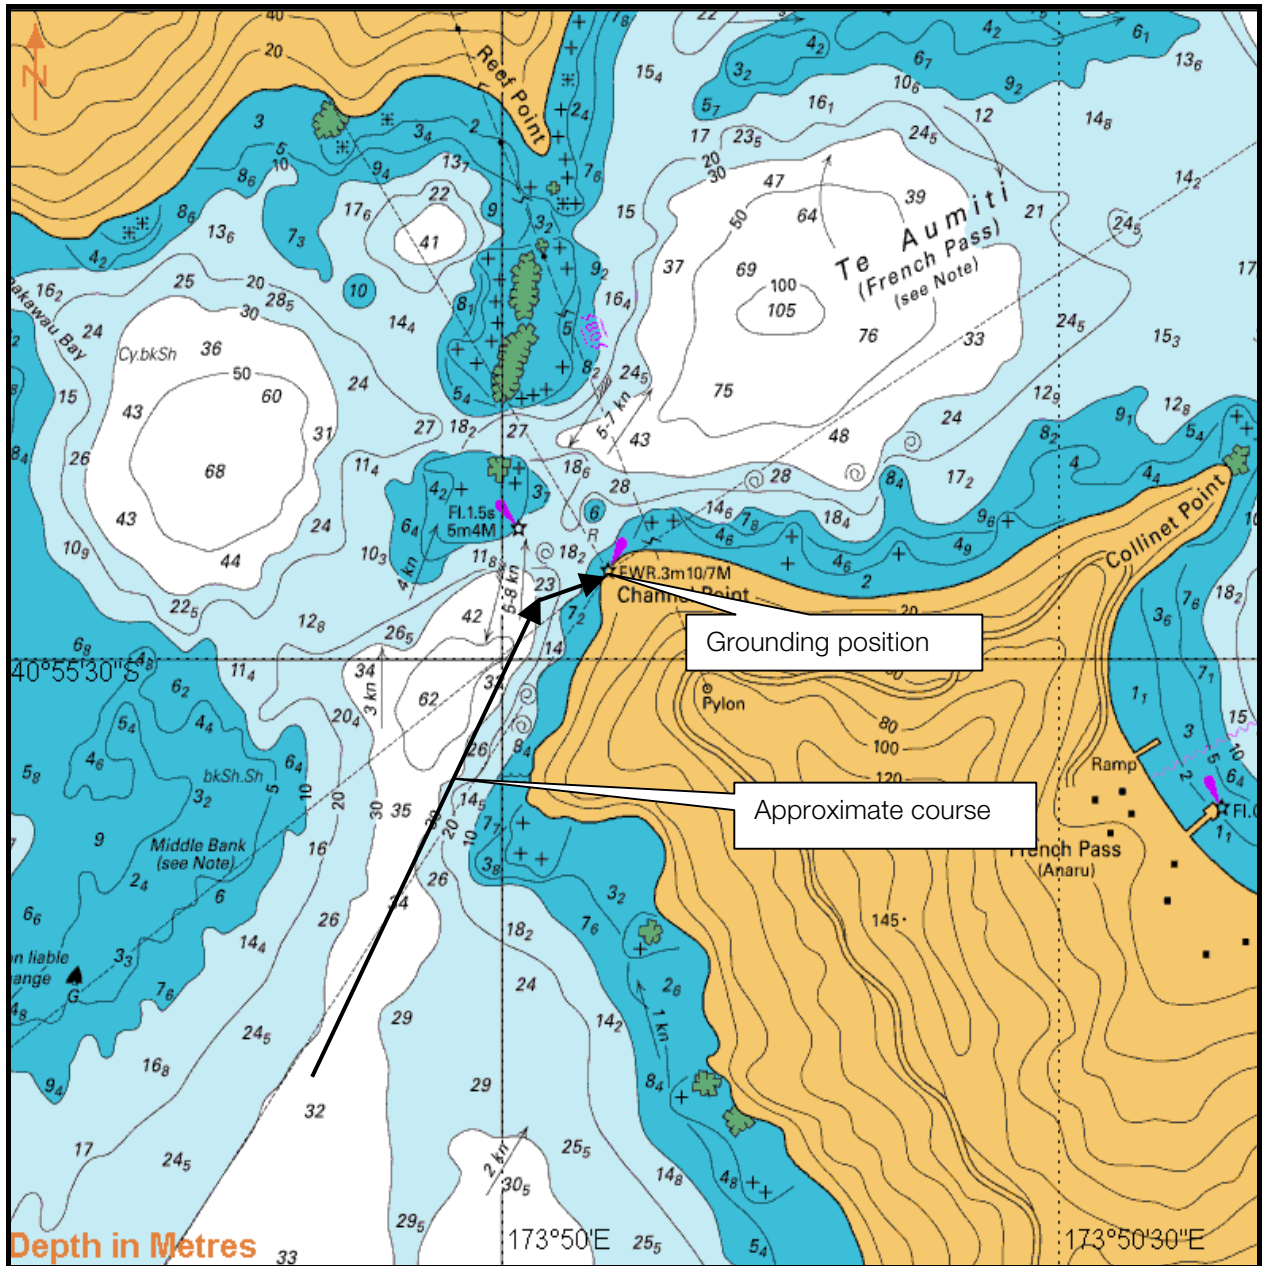
# Appendix 1

- 1.13 At 0315 hours, **San Tongariro** grounded by the bow, about 12 to 15 metres immediately south of the Channel Point light (*See Appendix 1 - Grounding Position*).
