Accident Report

Grounding

Sanga Na Langa

REPORT NO.: 06 4041

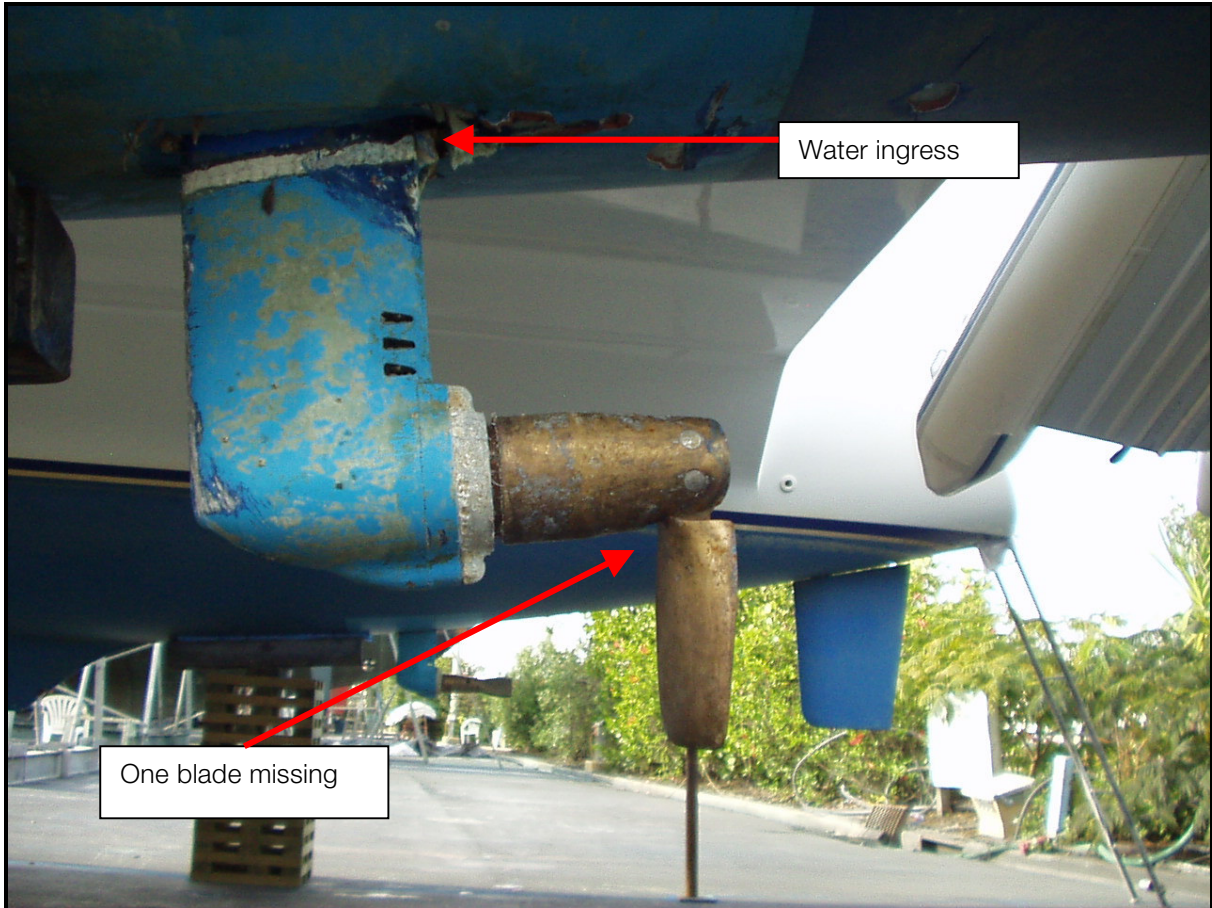
Photograph 1

Fortunately the pumps were able to control ingress and the vessel was beached in Man O War Bay on Waiheke Island using the port motor. Low tide revealed extensive port hull damage and a missing port propeller blade.

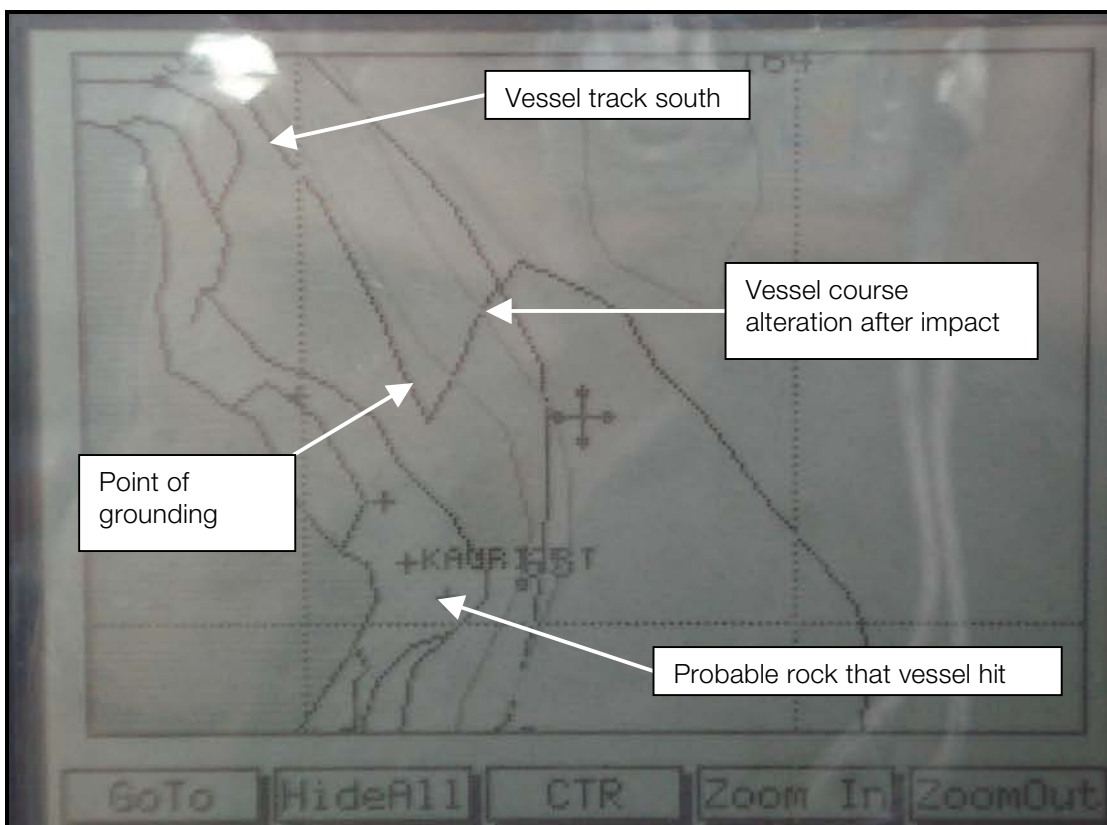
GPS data can often give incorrect data for a variety of reasons. The manufacturers agent checked the model and determined there was no cross track error. The position of the rocks as displayed on the screen correlated with their position in NZ Chart 5324 which suggests the electronic chart was reasonably accurate. Often when “GPS assisted groundings” take place the fault lies with the accuracy of the electronic chart however the reasons can be varied and complex. It is not uncommon for display screens that have been monitoring a vessel's position whilst stationary, for example whilst berthed overnight, to show positions a considerable distance from the vessel's position.

Figure 1
GPS Screen as Observed by the Skipper

GPS derived positions are a useful tool in determining a vessels position but should be used in conjunction with all other means of position fixing at the navigators disposal. The temptation to push a button to obtain such data and not utilize more labour intensive, traditional methods of position fixing is, to put it bluntly, bad seamanship that puts vessels and their crew at risk.
