Accident Report

Santa Regina

Navigational Error South of
Pencarrow Head, Wellington on
14 April 2005

REPORT NO.: 05 3730
SANTA REGINA – NAVIGATIONAL ERROR

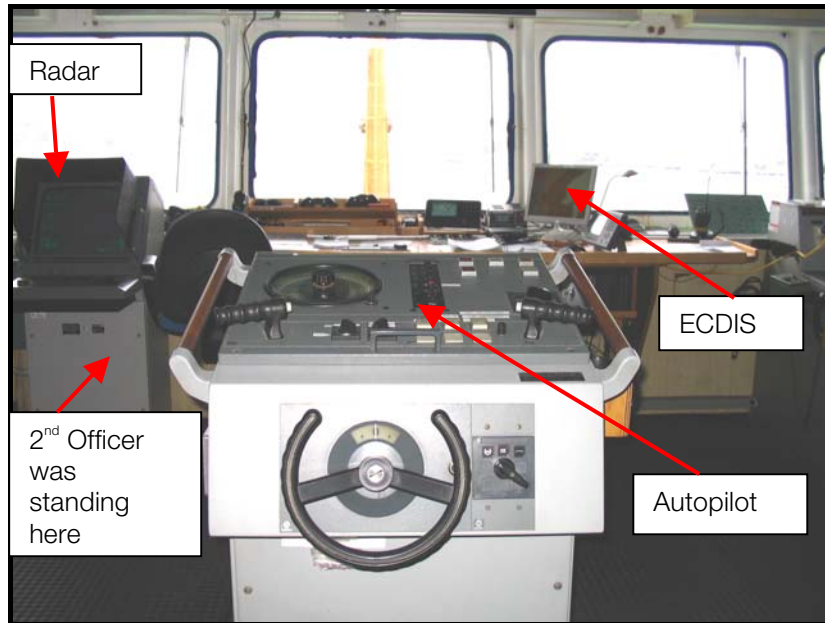
At approximately 1030 hours, the Cadet and the 2nd Officer became engaged in a conversation regarding the magnetic compass. They were standing at the front of the wheelhouse. The 2nd Officer was standing immediately to port of the steering consol and looking forward. From where the 2nd Officer was standing, it was possible for him to see both the Electronic Chart Display & Information System (ECDIS) and radar. This conversation distracted the 2nd Officer and caused him to forget to alter course at the charted position in order to bring the vessel round onto a heading of 016°(T) and thus onto the approach leads into Wellington Harbour.

Photograph 1
View of wheelhouse from centreline looking forward

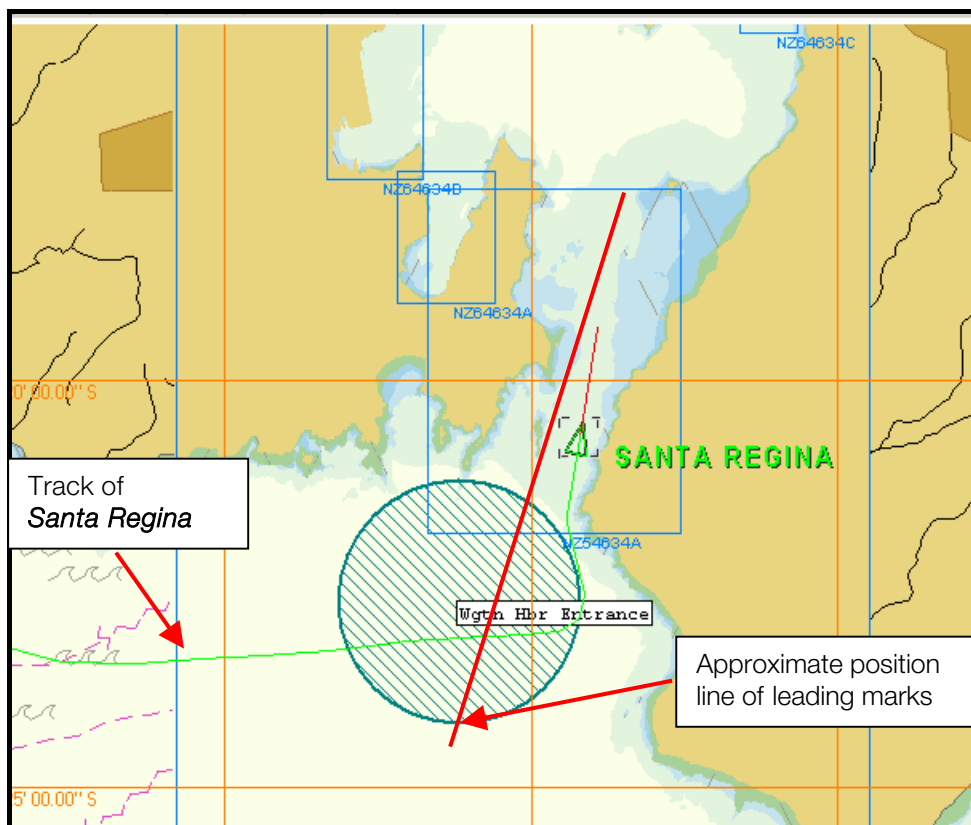
Diagram 1
Chartlet obtained from Maritime Operations Centre (MOC), showing AIS (Automatic Identification System) track of *Santa Regina*

At the completion of its turn to port, the vessel was approximately 6.5 cables to starboard of the leads and just over half a mile off the coast.

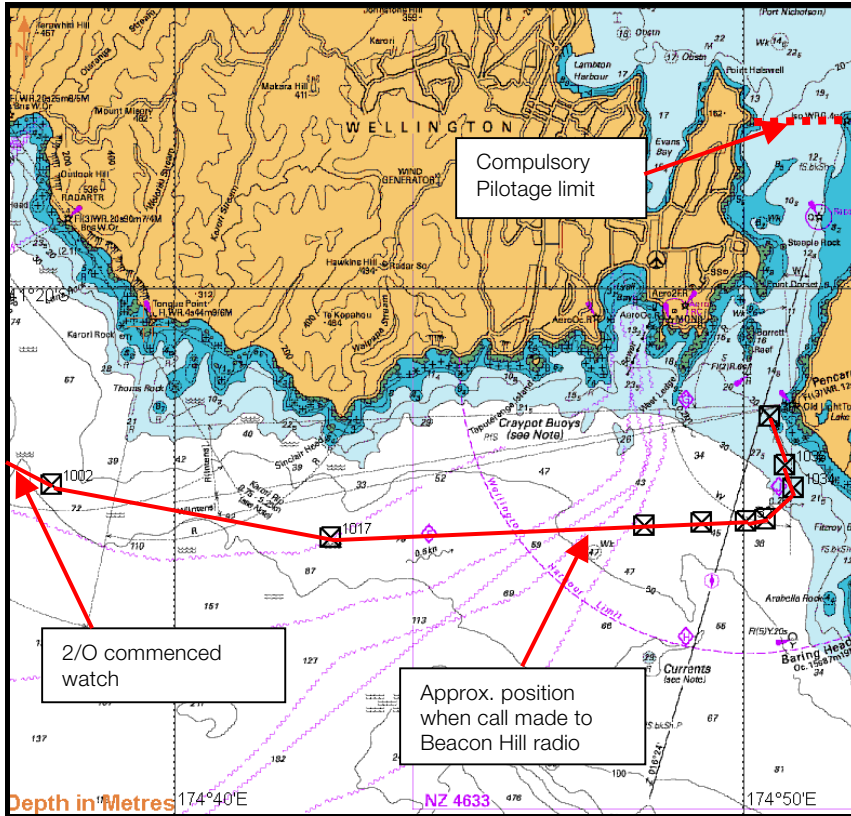
Diagram 2
Extract of Chart NZ4633

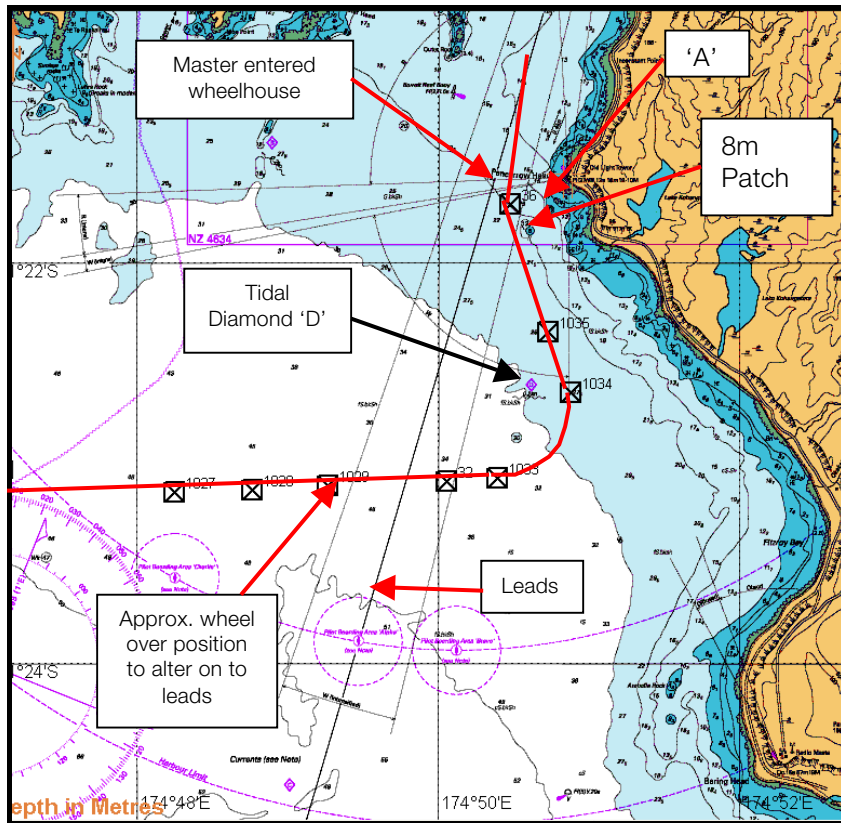
Diagram 3
Extract of Chart NZ4633

The vessel's maximum draft at the time of the incident was 6.02 metres. At approximately 1036 hours, the vessel came within 50 metres of passing over a rock with a charted depth of 8 metres. With 1.5 metres height of tide, the depth of water over the rock at the time of the incident would have been 9.5 metres giving a maximum clearance of 3.5 metres.

The closest that ***Santa Regina*** got to shallow water was when the vessel had shallow water and rocks approximately 1.8 cables or about 330 metres on its starboard side when in a position to the South West of Pencarrow Head. (See *Diagram 3 - Position 'A' of chartlet*)
