Accident Report

Crane Failure

Sea Angel

SEA ANGEL - CRANE FAILURE

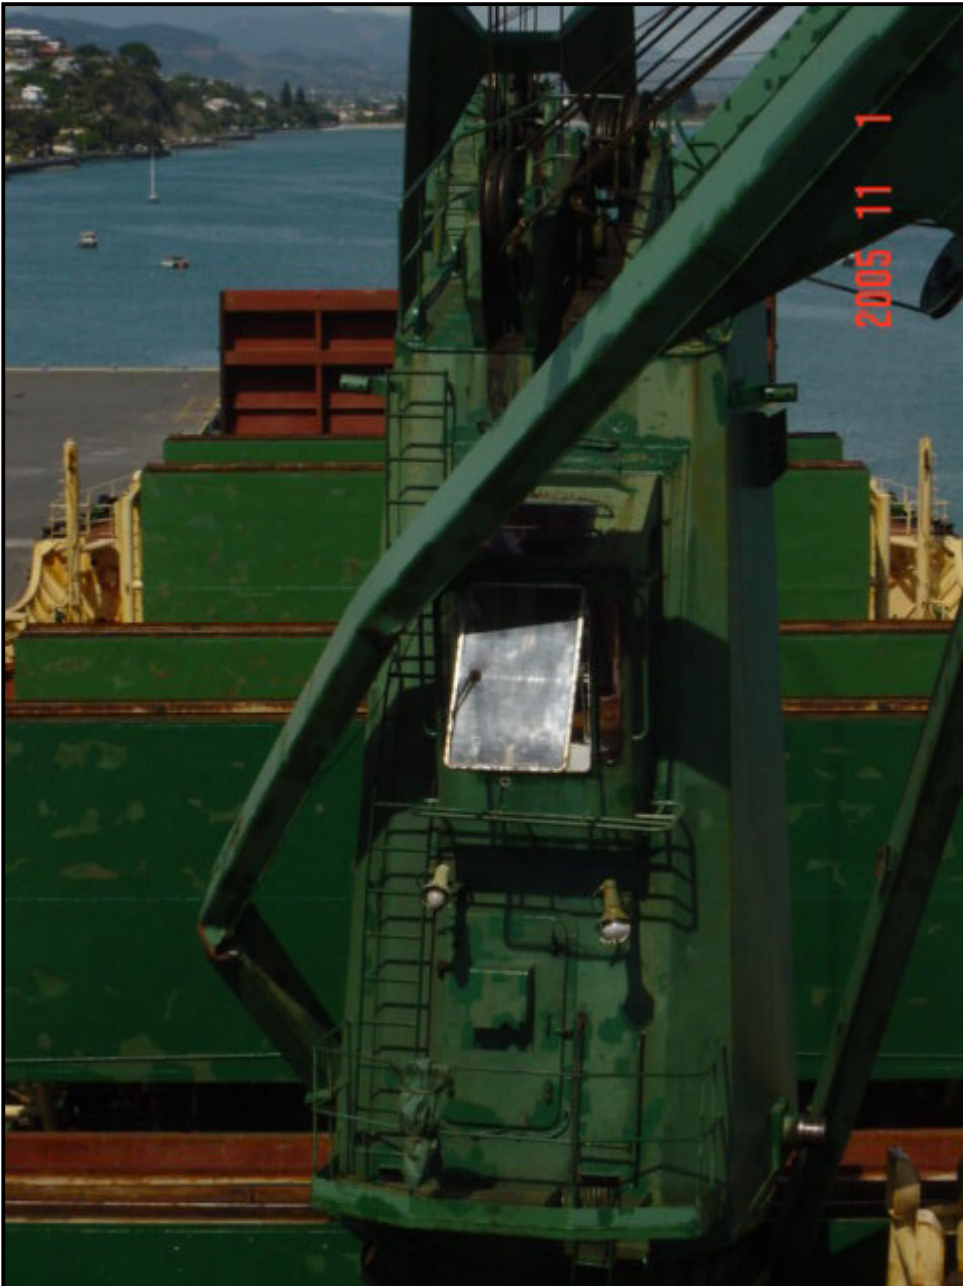
Photograph 2
Photo showing damaged No. 3 crane jib.

Crane Driver 2 looked down and saw the after end of the port crane jib start to collapse (See *Photographs 2 & 4*). Crane Driver 2 then heard a loud bang and saw the aft port side crane jib slipping off its mounting cone. The crane jib then dropped back and under the tower of the crane until it became jammed against the raised hatch covers at the after end of No. 3 hatch (See *Photograph 2*). As a result of the two crane jibs failing, the bundle of logs landed on log stow and the load on the hoist wire was released. When the load settled down, the crane jib stopped toppling further. As soon as this stopped, Crane Driver 2 climbed down from the crane and spoke to the Shift Foreman. Crane Driver 2 suggested they should stop work and check the rest of the cranes to ensure that they were safe before work resumed. However, no action was taken at that time because the stevedores had a tight schedule to enable the ship to sail. Work was continued using the other three cranes, without incident, until the next 'smoko'.

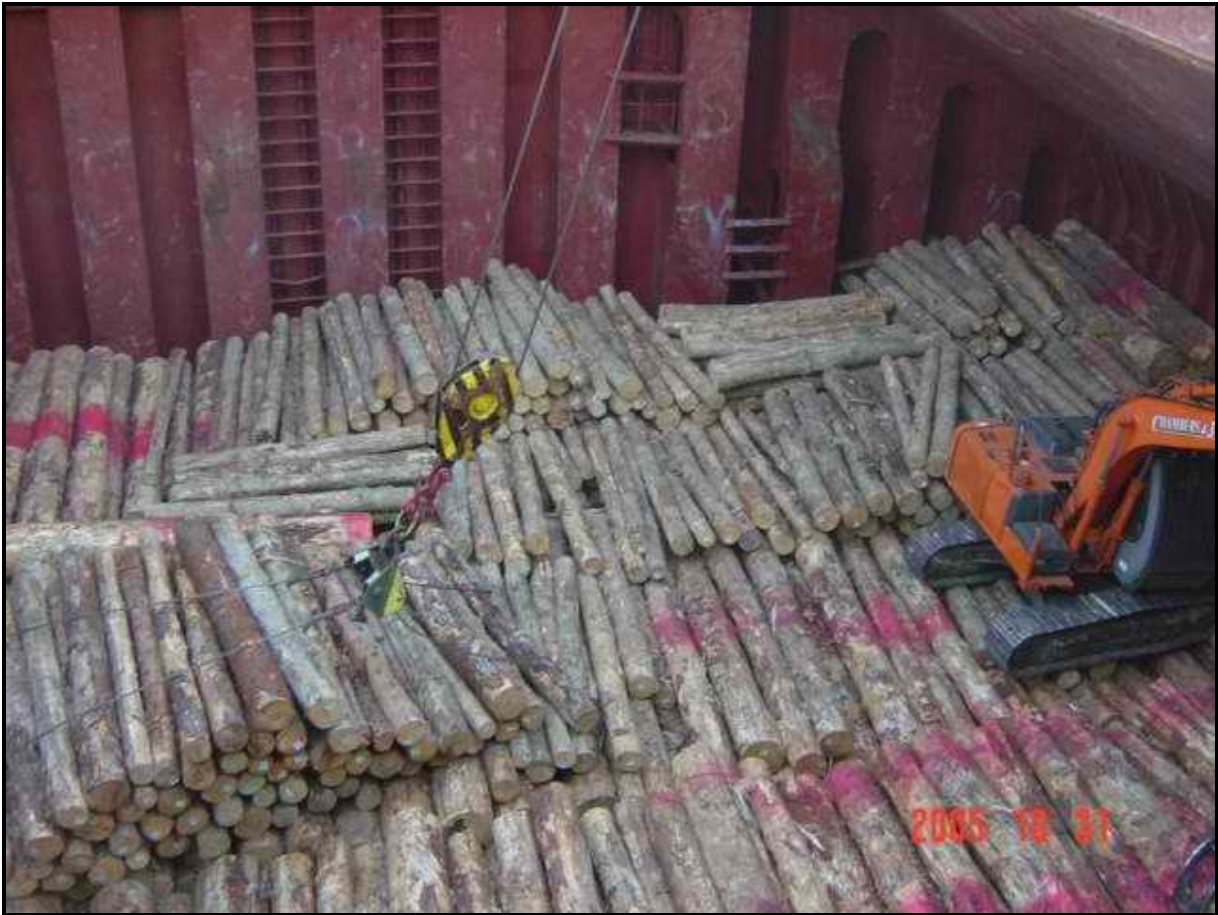
Photograph 3

No. 3 crane's luffing and hoisting wires did not part before the load of logs landed on the stow of logs and the weight was released. The two wire slings around the bundle of logs did not release and the whole bundle was laid and tilted towards the aft starboard side of the cargo hold at an angle of about 5 to 10 degrees (*See Photograph 3*).

The Investigator is of the opinion that the crane driver tried to reposition the bundle of logs to make it more convenient for the digger driver to stack them in the required position within the hold. When Crane Driver 2 lifted the bundle of logs to a height of approximately 400mm to move it towards the starboard side of the hold, the port heel pin bolts suddenly failed and the port crane jib heel bearing became detached from the shaft/pin. As a result, the port jib arm dropped and struck against the raised hatch covers at the after end of No.3 hatch. At the same time as this occurred the bundle of logs fell back onto the log stow in the manner shown on *Photograph 3*.

No. 4 cargo hold. Note condition/position of log sling and digger.

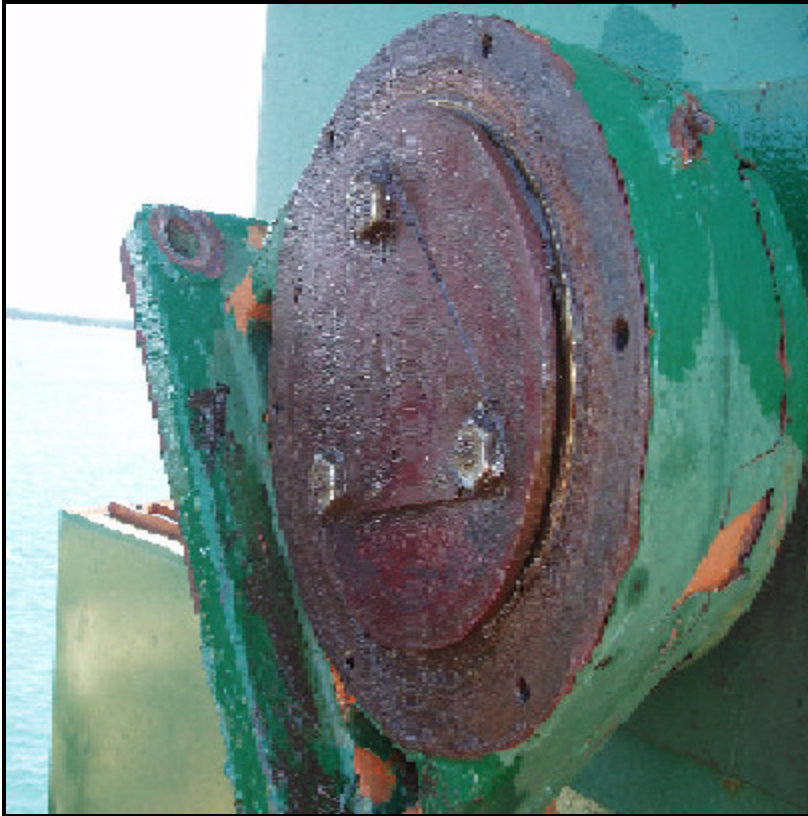
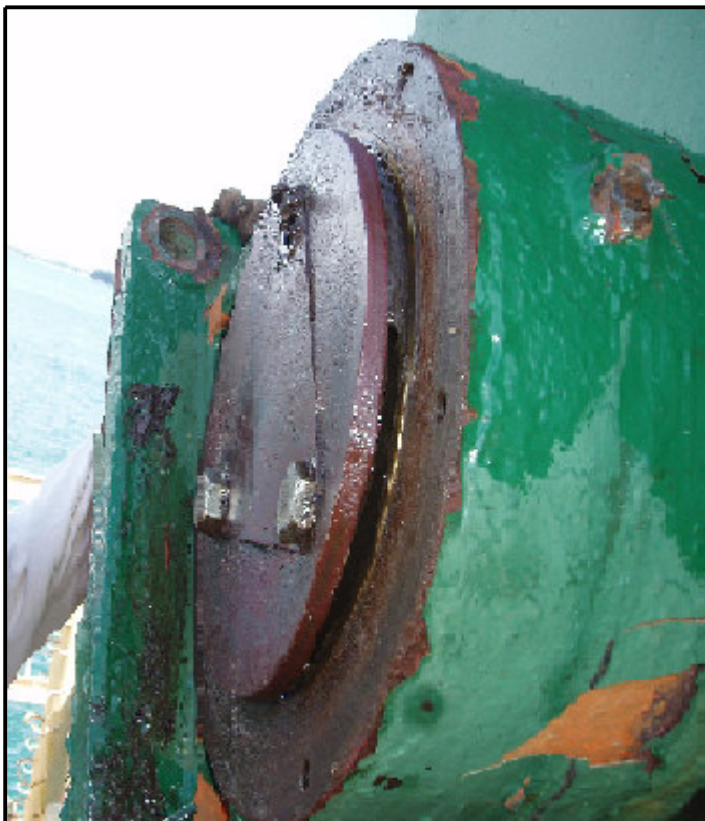
Both photographs show the No. 3 crane's right heel pin bolts and securing arrangement (*Note – a hammer test failed to detect the fractured bolt and it was found only by using a spanner*).

If there is any doubt about the condition of the cranes or whether inspections have been properly carried out, heel pin bearing cover plates should be removed and each bolt tested using a spanner.

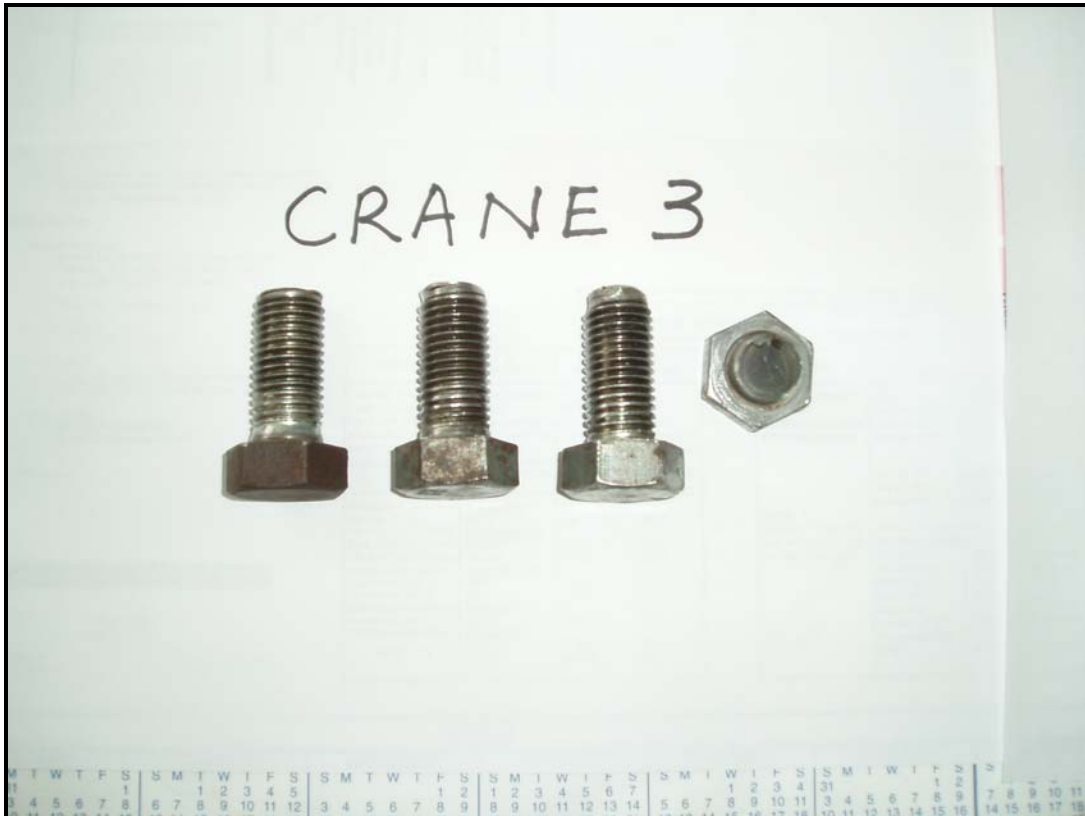
Photograph 7

A close visual examination of the three retaining bolts that had detached from No. 3 crane's port heel pin, showed that on all three, the last two threads, close to the bolts' outer edge, were stripped of any thread and that four of their threads, near the bolt heads, were partially stripped of thread. The remaining ten threads in the middle of all three bolts were found in good condition. When the three bolts were sent to the inspection company SGS, for a Non Destruction Crack Test, fatigue cracks on all three bolts were found at the bottom of the second threads and near the bolt head (*See Appendix 1 - SGS Magnetic Particle Inspection Report and Photographs 8 and 9, showing the location of the cracks found on all three bolts that had detached from No.3 crane. Note also the position where No. 3 crane's right heel bolt fractured*).

No. 3 crane heel bolts, 3 detached from left heel pin, 1 fractured at right heel pin.

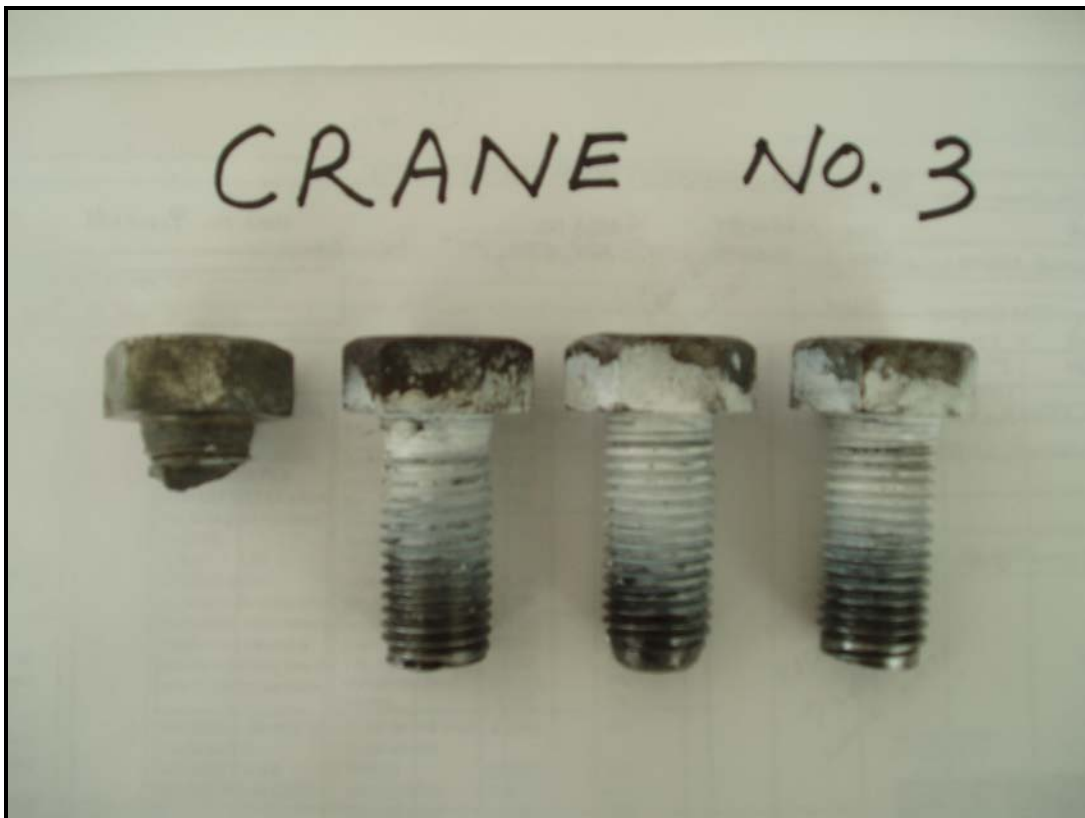
Photograph 8

No. 3 crane heel bolts indicating a crack, note position of cracks to fractured bolt.

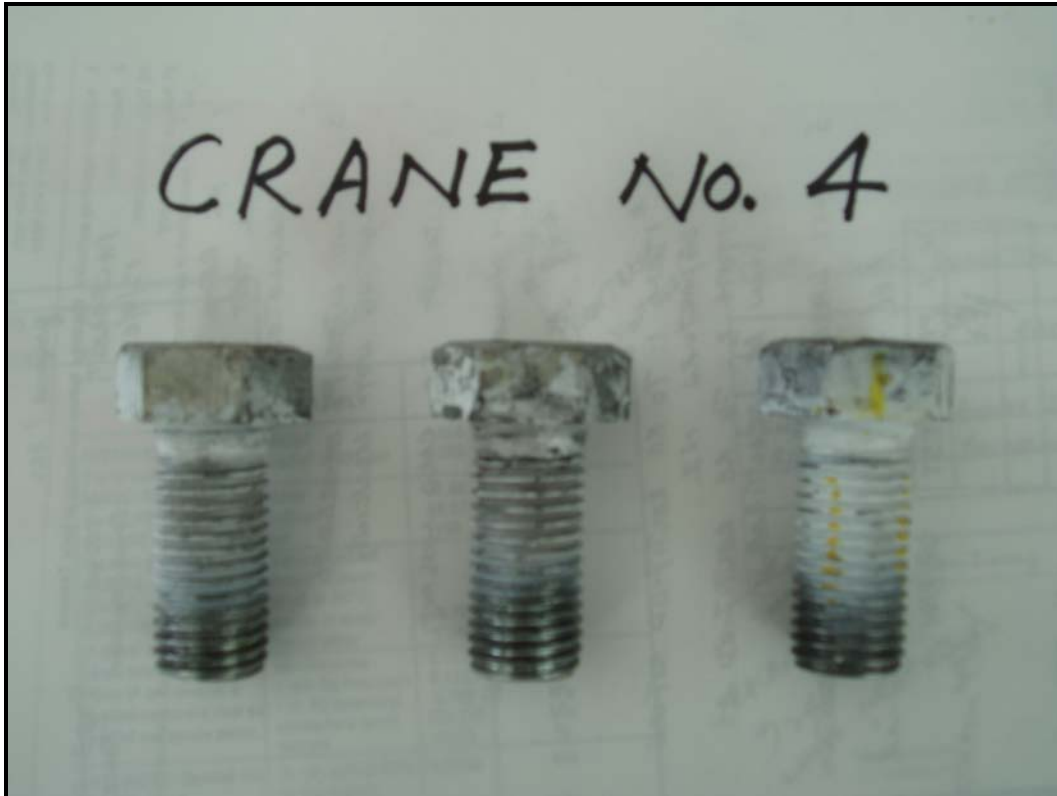
4 crane's six heel pin bolts, three of the heel pin retaining bolts were loose namely, two from the port heel pin and one from starboard heel pin/shaft. These bolts were removed and sent to SGS for a Non Destructive Test. Cracks were found on all three bolts. The cracks were similar to those found on the bolts on No. 3 crane's port heel pin/shaft (See Appendix 1 - SGS Magnetic Particle Inspection Report & Photographs below showing signs of crack on all three loose bolts found on No. 4 crane)

From the above inspections and the Non Destructive Crack Test results, it would appear that the cracks that were found in the loose heel pin bolts of No.4 crane, after the vessel arrived at Tauranga and prior to working cargo at that Port, could already have been cracked before the ship's crew re-tightened them to a torque of 54-60 Newton-metres maximum, following the crane accident.

After No.4 crane was put back into service, the pre-existing cracks in these re-tightened bolts could have propagated quite readily due to stress concentration. Therefore, the pre-tensile load in the tightened bolts would reduce gradually until such time that it was completely released and the bolts loosened. If the bolt was properly locked up by the locking plate and prevented from turning, as happened to the broken bolt found on **Sea Angel's** No. 3 crane right heel pin/shaft, the bolt would eventually fracture under fatigue cyclic stress. If the bolts were not properly locked up, as happened on **Sea Angel's** No.3 crane's port/left heel pin retainer bolts, the loose bolts would eventually work their way out of the bolt holes, allowing the jib to detach from the jib heel pin/shaft.

Photograph 9
No. 4 crane heel bolts indicating crack by Magnetic Particle Test

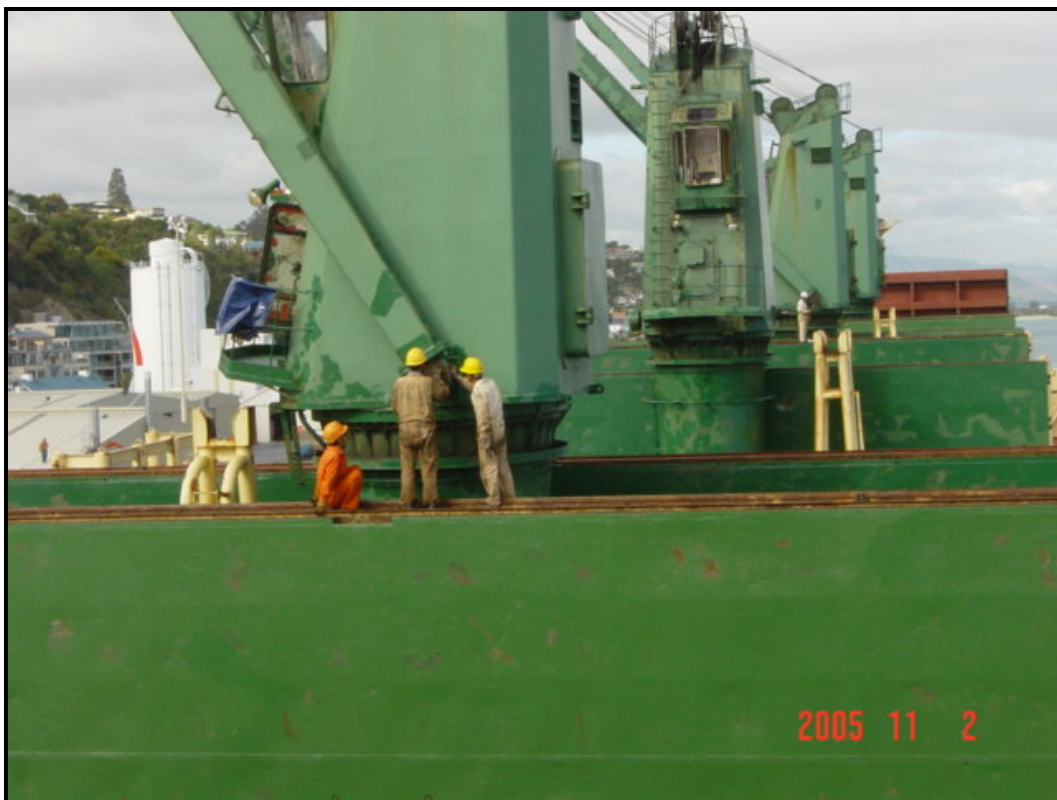
2. The ship’s crew did not follow the inspection & maintenance requirements/recommendations of *MHI Technical Information* because:
 - There was no safe access platform built on the cranes to facilitate inspection/maintenance (See *Photograph 10*).
 - The Master and Officers were not aware of the existence of the *Technical Information* that is attached in *Appendix 2* to this report.

Photograph 10
Showing crew standing on hatch cover while working on No. 4 crane because there was no working platform fitted.

1. A copy of the report be forwarded to **Sea Angel's** owner/operator with the following recommendations:
 - A platform should be fitted on all their ship's cranes to facilitate safe access when carrying out the required maintenance and inspections of cranes

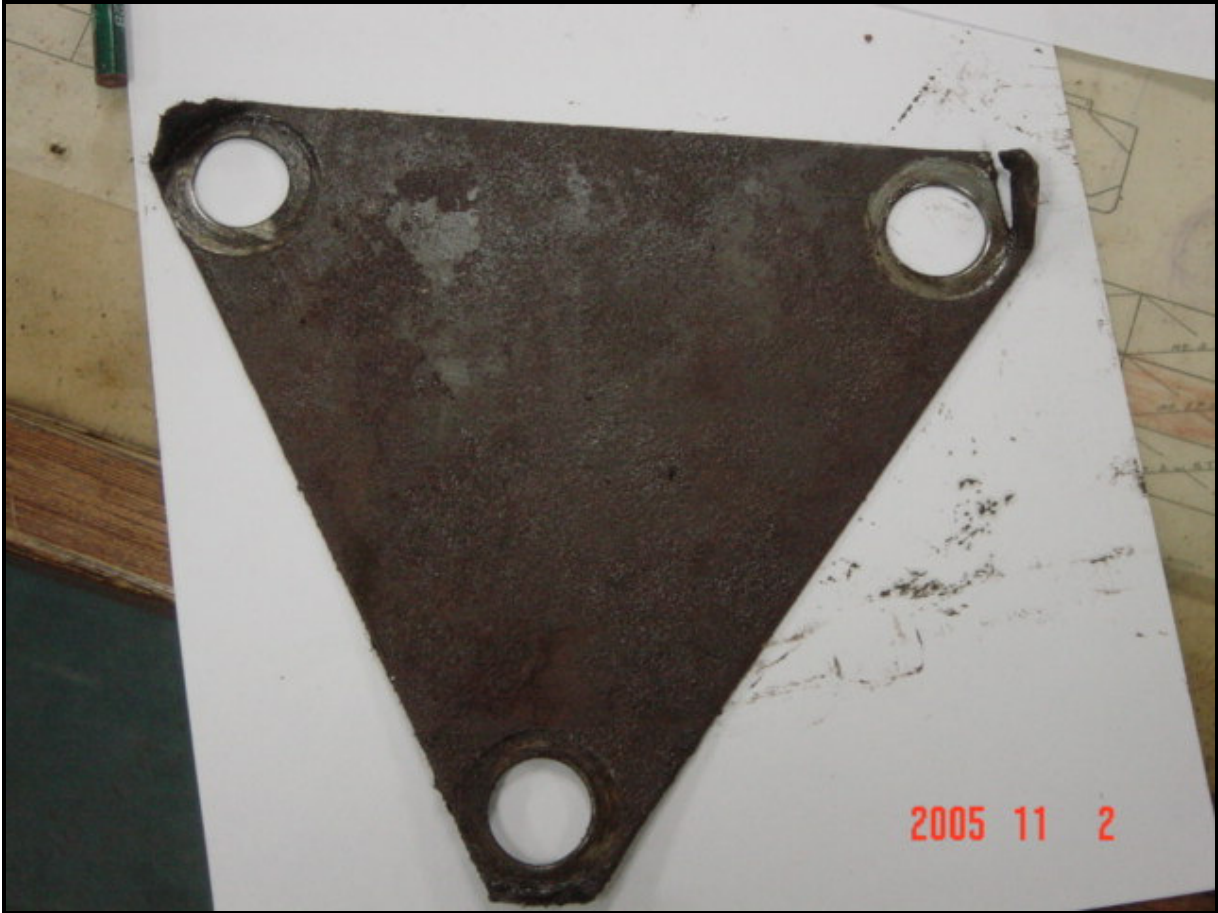
Examination of the heel pin threaded/tapped holes revealed that they were in good condition, except the outer most two threads that showed signs of damage. Examination of the triangular locking plate on No. 3 crane's port heel pin found that the locking plate edges were cracked or damaged through repeated use (*See Photograph 11*).

5. The poor condition of the heel pin locking plate/device was considered to be one of the possible contributing factors for the heel bolts to work loose. However, the discovery of cracks on all the loose bolts found on No. 4 crane and all the detached bolts from No. 3 crane would make the condition of the heel bolt locking plate/device only a minor contributing factor to the eventual failure of the crane jib, because, if the bolts were properly locked up, they could still fracture and fail, as occurred in the failure of the MHI crane aboard *S Venus* in 2004.

Photograph 11
No. 3 Crane heel bolts locking plate showing crack
