# Accident Report

Crane Failure

*Sea Harvest*

22 August 2005

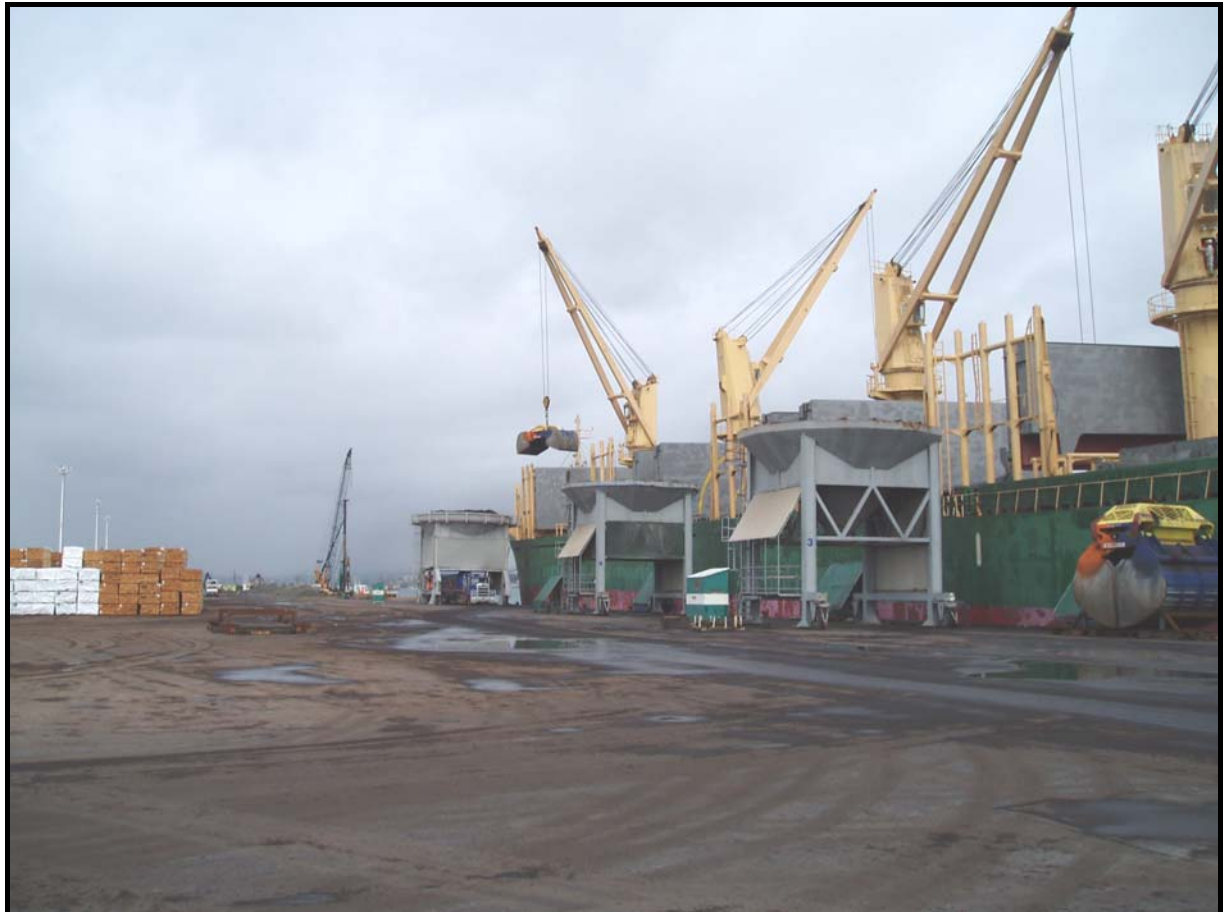
Photograph 1

On 21 August 2005, **Sea Harvest** arrived at the Port of Tauranga and berthed port side to at No. 9 berth, Mount Maunganui. At 2330 hours New Zealand Standard Time (NZST) the vessel commenced discharging coal into hoppers for loading into road vehicles (See *Photograph 1*). Work proceeded through the night.

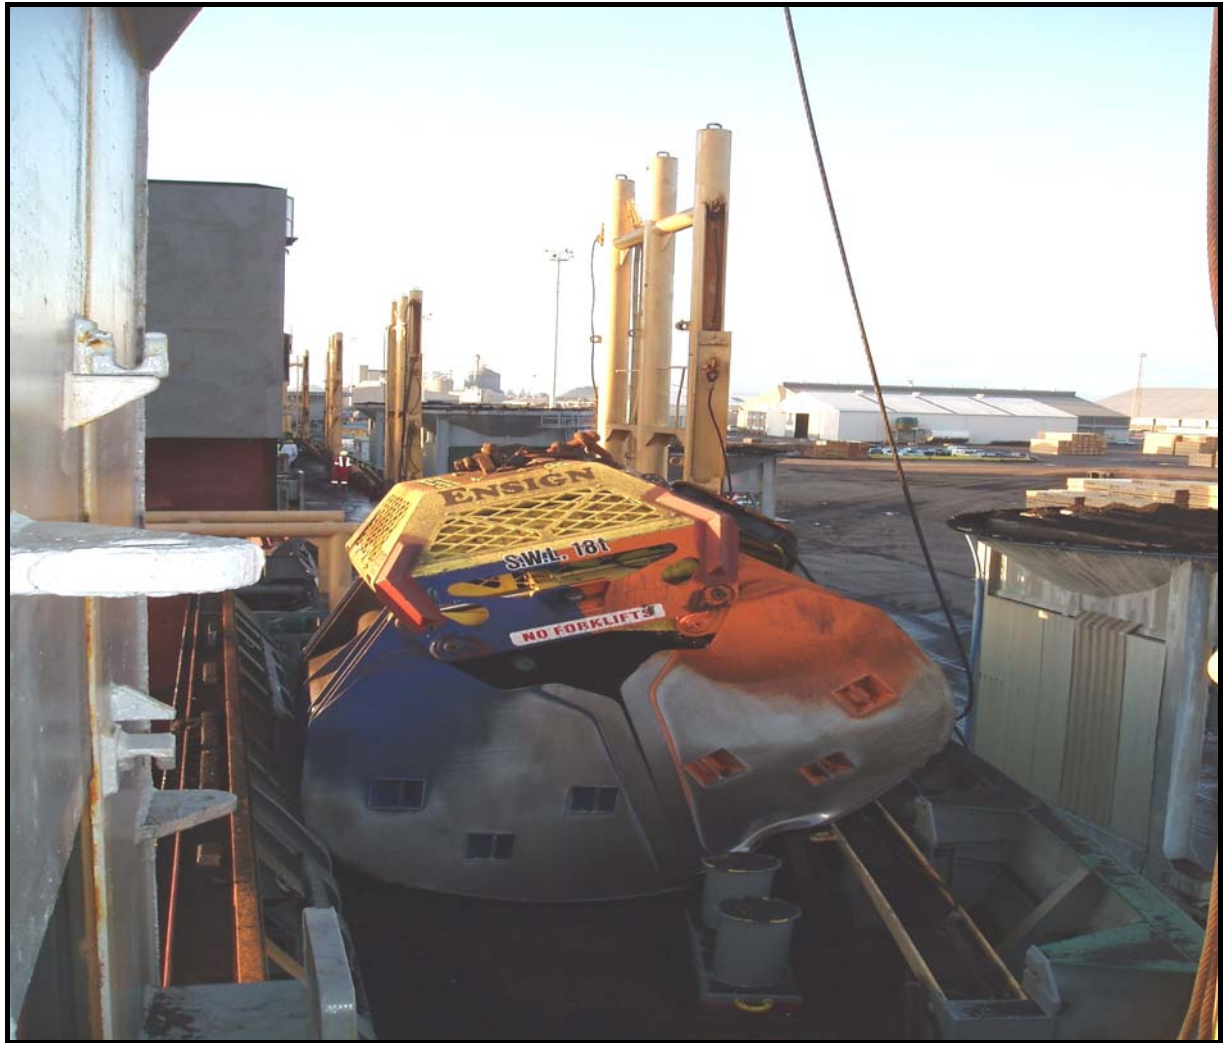
Photograph 2

On 22 August at 1550 hours, No. 1 crane lifted a grab filled with cargo from No. 1 hold and slewed it towards the hopper. When the grab was over the deck on the port side, the crane hoist wire parted, dropping the grab and its contents onto the narrow deck between the bulwark and hatch coaming (See *Photograph 2*).

There were no injuries. The deck plating was dented to a depth of about 25 mm but was not pierced. Two steel log stanchions stowed next to the bulwarks and the stiffeners alongside the hatch coaming were bent.

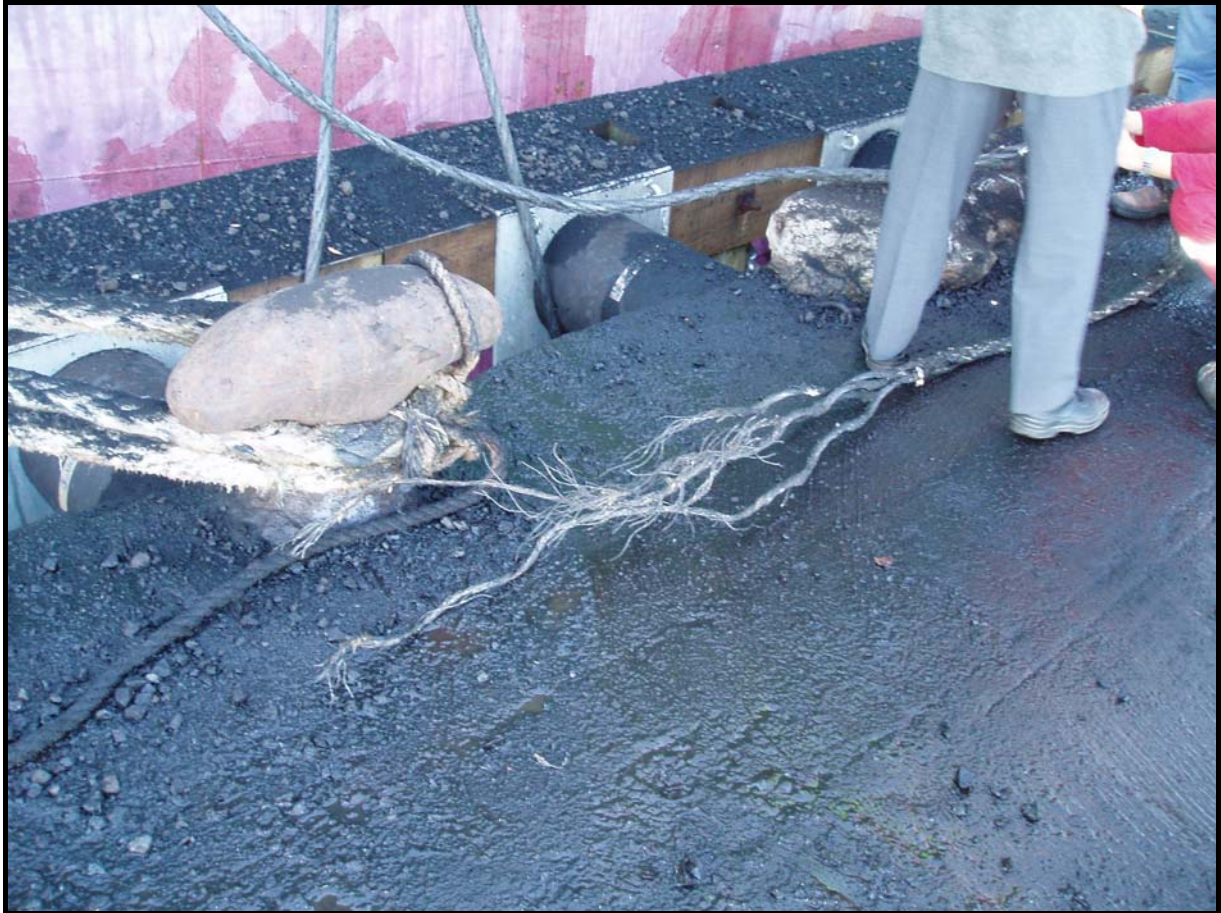
Photograph 4

The hoist wires fitted in 2003 were described as 4 x SeS(39), ie. 4 stranded wire rope with 39 wires per strand with a specified breaking load of 79.3 tonnes. Having 39 wires per strand, the replacement wire rope would be less flexible than wire rope of 48 wires per strand and therefore prone to suffer metal fatigue when passing through sheaves.

On the basis that the hoist wires fitted to the cranes in 2003 did not meet the manufacturer's specifications and that two hoist wire ropes had failed within a few hours of each other, the Master was advised that the cranes were not to be used to work cargo until the hoist wires had been replaced. Since there were only three replacement hoist wires on board, only three cranes were permitted to discharge or load cargo. The new wire rope fitted to No. 1 crane met the manufacturer's specification, but the other two wire ropes did not. They were 4 stranded ropes with 39 wires per strand and Class NK permitted their use for a maximum of one year.

Persons responsible for ordering wire rope for cranes should ensure that ropes comply fully with manufacturers' specifications.
