Accident Report

Grounding
Seawyf

26 August 2005

Class B

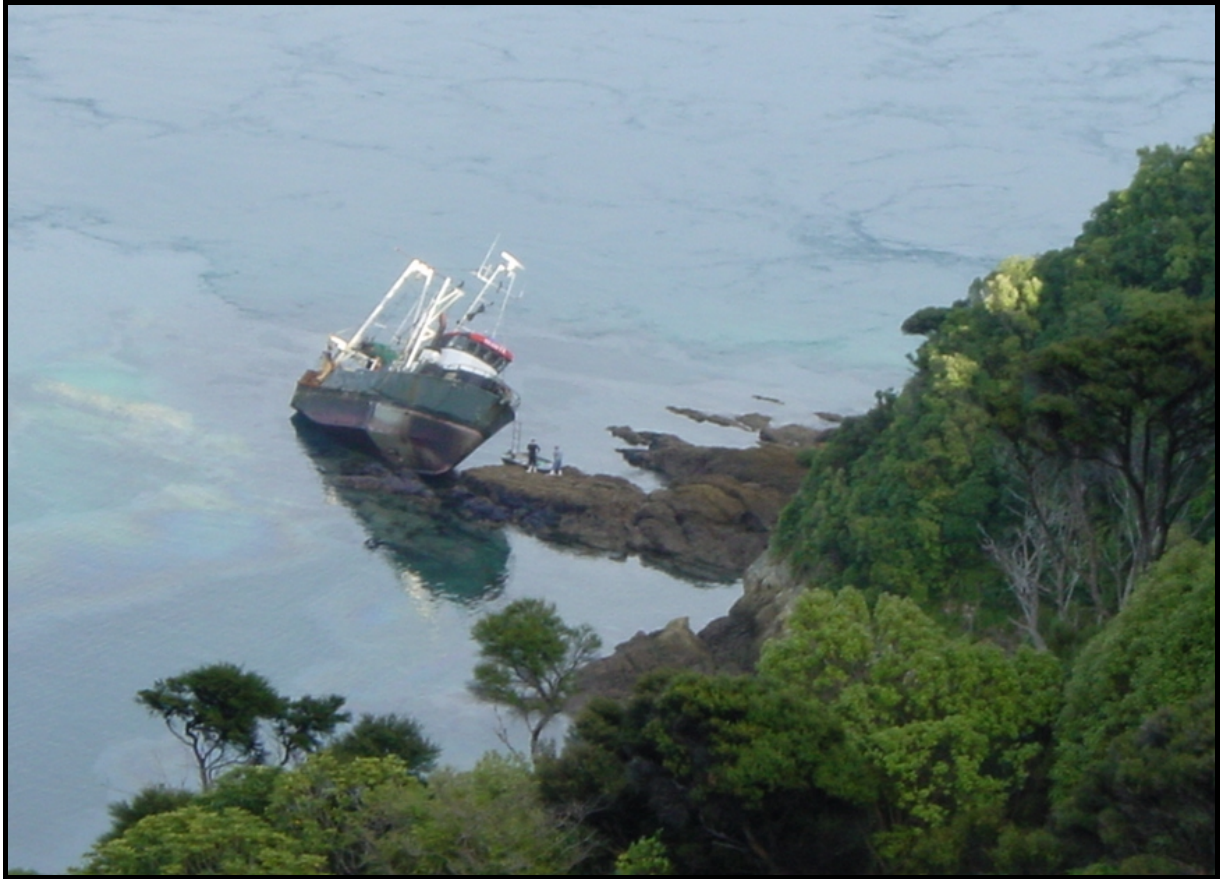
Photograph 1
Seawyf aground at French Pass

During low tide, **Seawyf** was completely out of the water and the Skipper and crew exited the vessel and made a visual inspection of the hull, which looked to be sound (See *Photograph 1*).

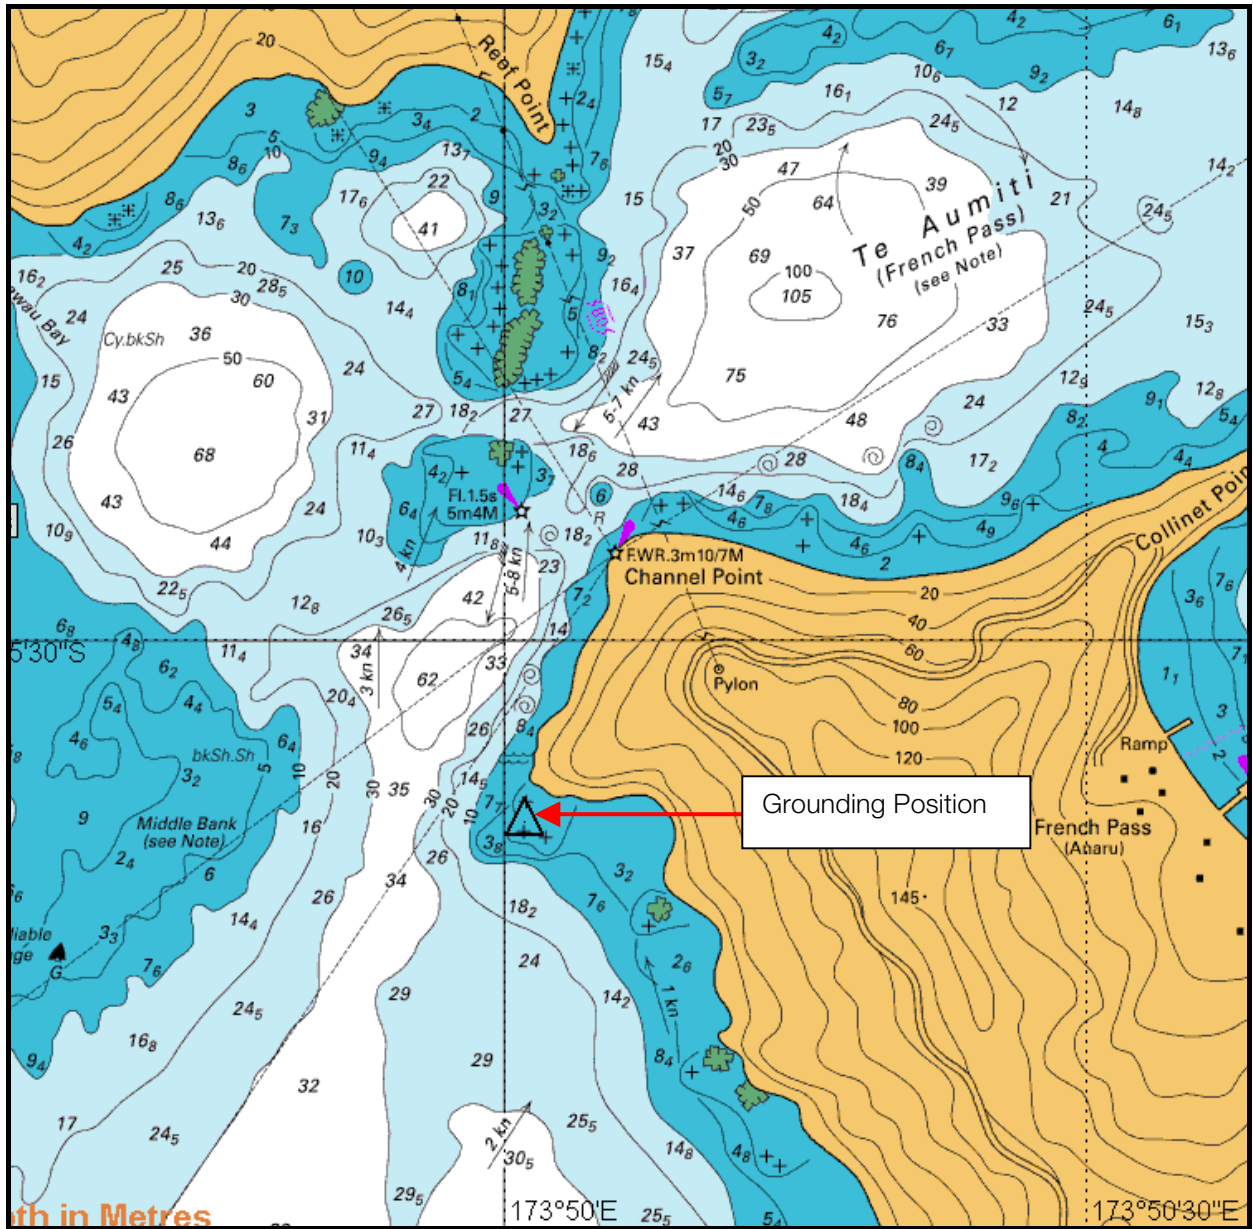
Diagram 1
Chart Extract

Seawyf grounded in position 40° 55.620' S 173° 50.618' E (See *Diagram 1*).

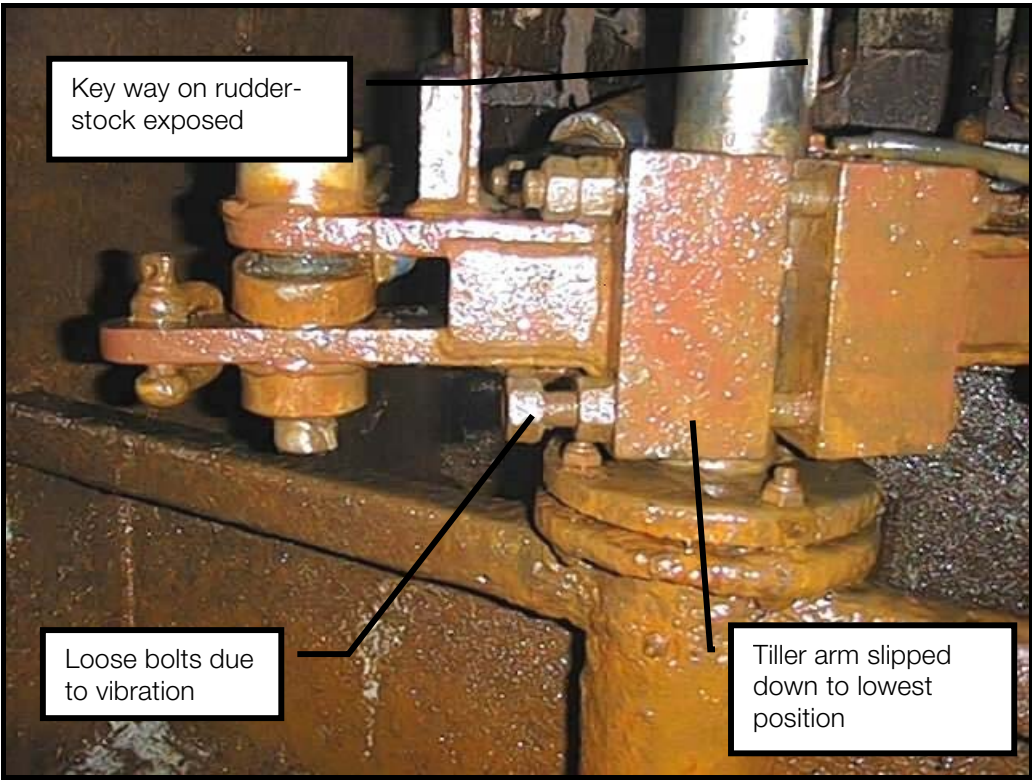
Photograph 2

Upon inspection of the steering gear it was found that the tiller arm had come loose from the rudderstock and had slipped down the shaft and off the key-way. This allowed the tiller arm to activate but did not have any purchase on the rudderstock.

Evidence suggests that the bolts attaching the tiller arm to the rudder stock were tightened but not setup in such a way as to prevent them loosening again in the future.

Since this accident, the marine engineers have now installed new high tensile bolts; they have used double nuts with the outer nut consisting of a Nylock nut.

They also installed a new key-way into the rudderstock and have attached a split collar below the tiller arm to arrest its movement should the bolts ever come loose again.

3. That this report be sent to Seafood NZ and Professional Skipper for inclusion.
4. It is recommended that a Safety Bulletin be issued to highlight the importance of ensuring that appropriate locking nuts are fitted between the tiller arm and rudder stock.
