Accident Report  
*Sinbad & Unnamed Dinghy*  
Collision at Bon Accord Harbour  
on 26 March 2005  
Class B

REPORT NO.: 05 3701

## *SINBAD & DINGHY – COLLISION*

Whilst on passage from Hokimai Bay to Sandspit, *Sinbad* was in a collision with an *Unnamed Dinghy* whilst in Bon Accord Harbour.

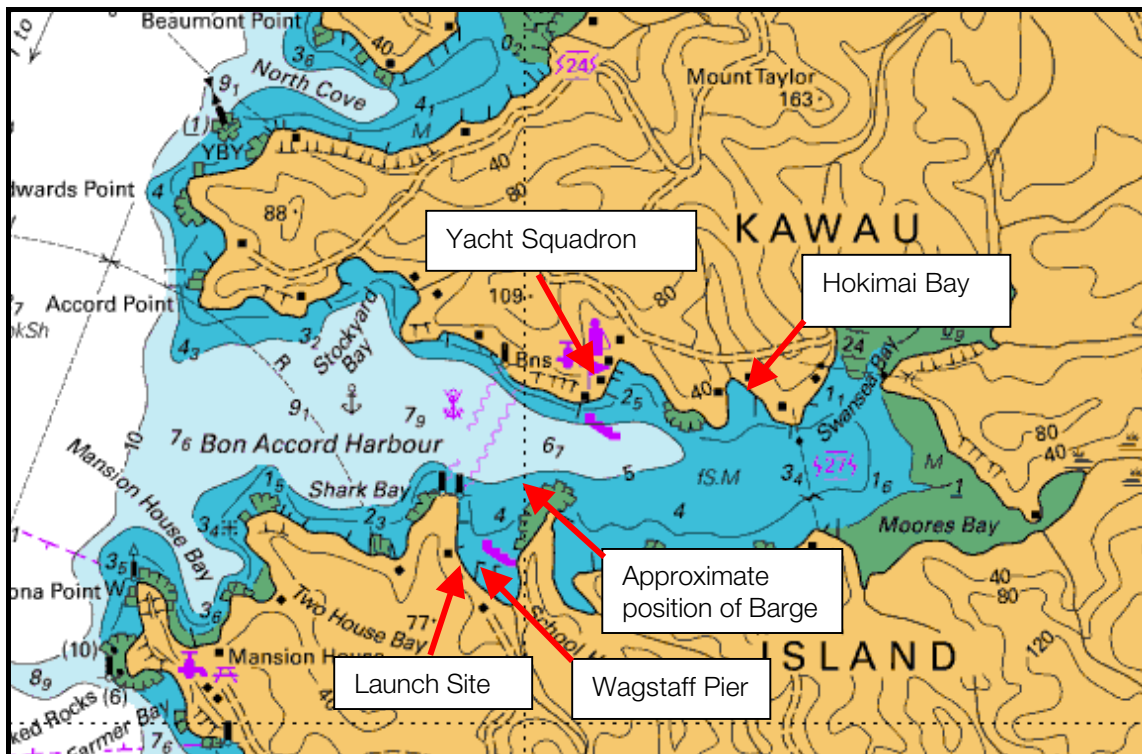
Figure 2

On Saturday 26 March 2005, at approximately 2000 hours New Zealand Standard Time (NZST), an unnamed dinghy was launched from the shore into Schoolhouse Bay, Bon Accord Harbour, Kawau Island (See Figure 2). The two crewmembers had borrowed the dinghy from its owner. The dinghy was rowed a short distance until the water became deep enough to use the outboard engine.

At approximately 2010 hours, *Sinbad* departed Hokimai Bay, Bon Accord Harbour (See Figure 2), bound for Sandspit. In addition to the Skipper, there were two adults and two children passengers onboard. *Sinbad* proceeded out of the Harbour at a speed of approximately 7 knots.

Upon passing south of the Yacht Squadron clubhouse, on the northern shoreline of Bon Accord Harbour (See Figure 2), *Sinbad* passed to port of *Lion New Zealand*, which was anchored south of the clubhouse, and the Skipper of *Sinbad* increased the engine revolutions to 3000 RPM (revolutions per minute) to give a speed of approximately 20 knots.

- The Skipper states that the barge was moored inside the heads of School House Bay. The position of the barge on *Figure 2* is representative of the position of the barge on the chartlet drawn by and signed by the Skipper of the dinghy. The owner of the dinghy states that the barge was moored inside the heads of Schoolhouse Bay
