# Summary Report

Collision

*Sinbad 6 & Double Agent*

3 July 2006

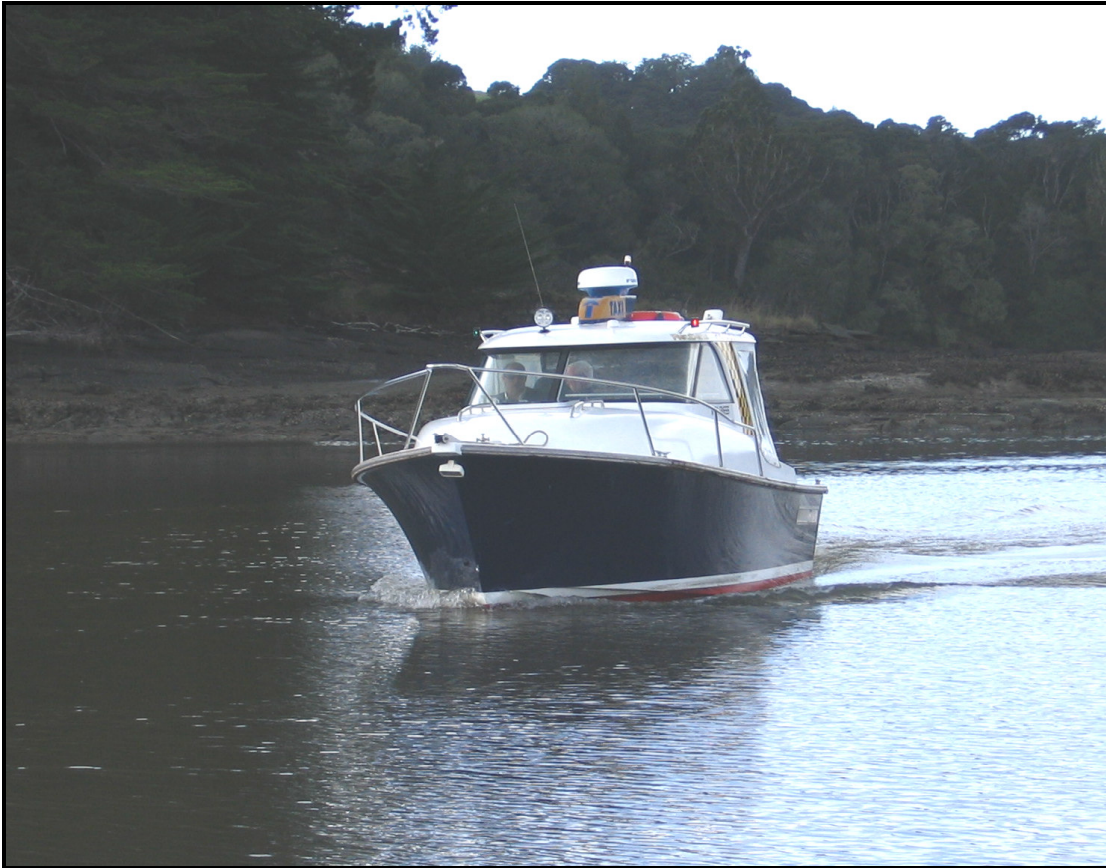
**Photograph 1**  
***Sinbad 6***

**Sinbad 6** sustained minor damage as a result of the accident.

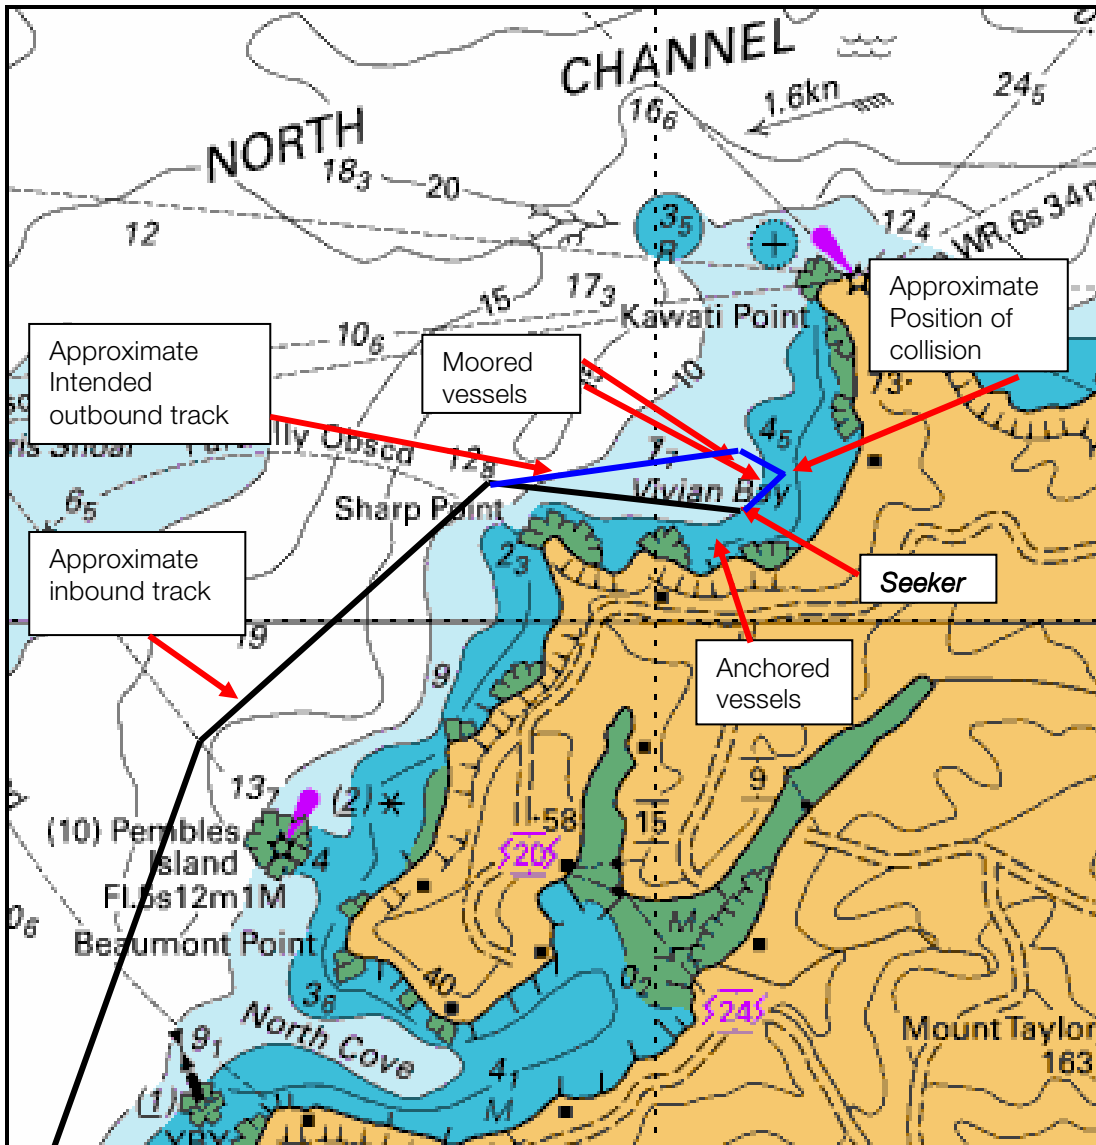
Figure 1  
Chartlet of Vivian Bay

After a voyage lasting approximately 10 minutes, ***Sinbad 6*** arrived in Vivian Bay (See Figure 1 – *Chartlet of Vivian Bay*) and moored port side alongside the anchored yacht, ***Seeker***, on its starboard side. At this time, ***Seeker*** was heading in a broadly north easterly direction.

It is believed that **Double Agent** was anchored approximately 150 metres to the north east of **Seeker**.

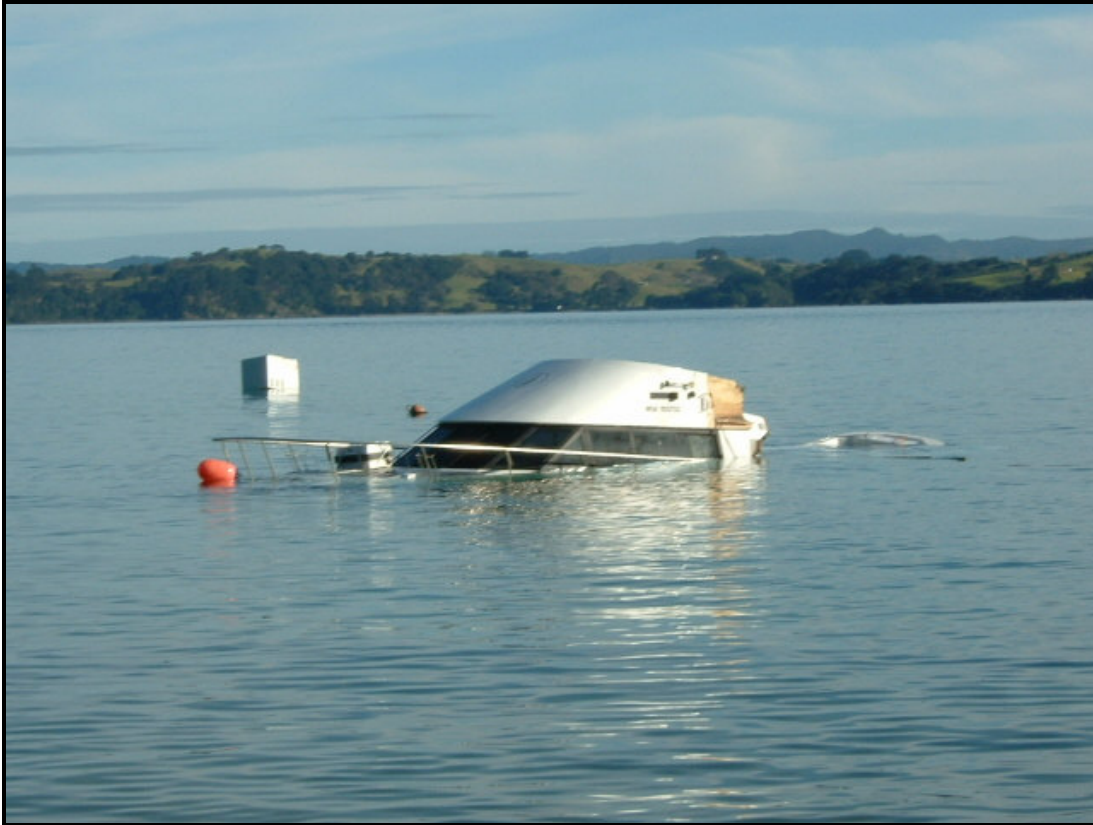
**Photograph 2**  
***Double Agent*** after the accident

The Skipper of **Sinbad 6** did not see **Double Agent** until the collision. He is of the opinion that **Sinbad 6** approached **Double Agent** from an angle of approximately 45° off its port bow and collided with **Double Agent's** port quarter. Examination of the damage sustained by **Double Agent**, however, appears to conflict with this theory as the majority of the damage was on the starboard quarter of the vessel. Due to the lack of witnesses, it is uncertain what the exact heading of **Double Agent** would have been at the time of the collision. However, if she was lying in the same direction as **Seeker**, which was also at anchor, then an initial heading of north east by **Sinbad 6** followed by a turn to port, would support a collision with **Double Agent's** starboard quarter. The collision occurred at slack water.

**Double Agent** was extensively damaged. She was later salvaged and repaired.
