Accident Report

Collision

Sinbad 7 & Stingray 1

23 October 2006

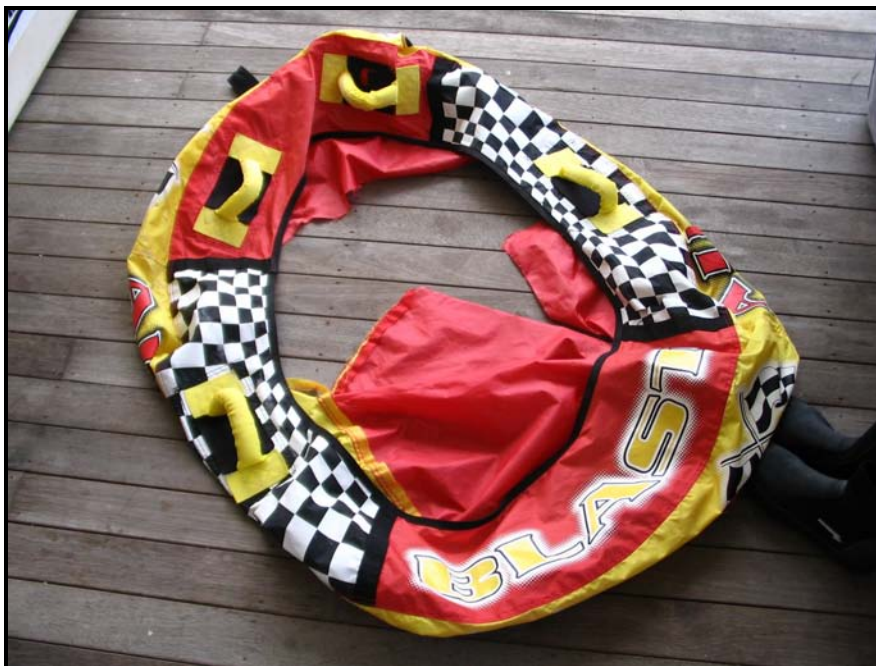
Photograph 1
Remains of Sea Biscuit

When **Sinbad 7** was approximately 25 metres off the port quarter of **Stingray 1**, the Skipper of the recreational vessel looked astern and observed **Sinbad 7** for the first time, just as the water taxi collided with the tow line of the sea biscuit. When this occurred, the child on the sea biscuit was thrown into the water and the sea biscuit was ripped apart by the propeller of **Sinbad 7**.

The sea biscuit, which was coloured predominately red and yellow, was 1.3 metres in diameter. The length of the tow a rope was approximately 27 metres. For the purposes of interpreting **Maritime Rule Part 22 – Collision Prevention**, a towing vessel and the vessel towed are treated as one vessel. Accordingly, in this accident, ***Sinbad 7***, as the give way vessel, was also required to keep clear of the sea biscuit.

It is believed that **Sinbad 7** collided with the tow line at a point close to the sea biscuit.
