Class A Accident Report

# Southern Winds Grounding

At Charles Sound on 14 October 2004

**REPORT NO:** 04 3581

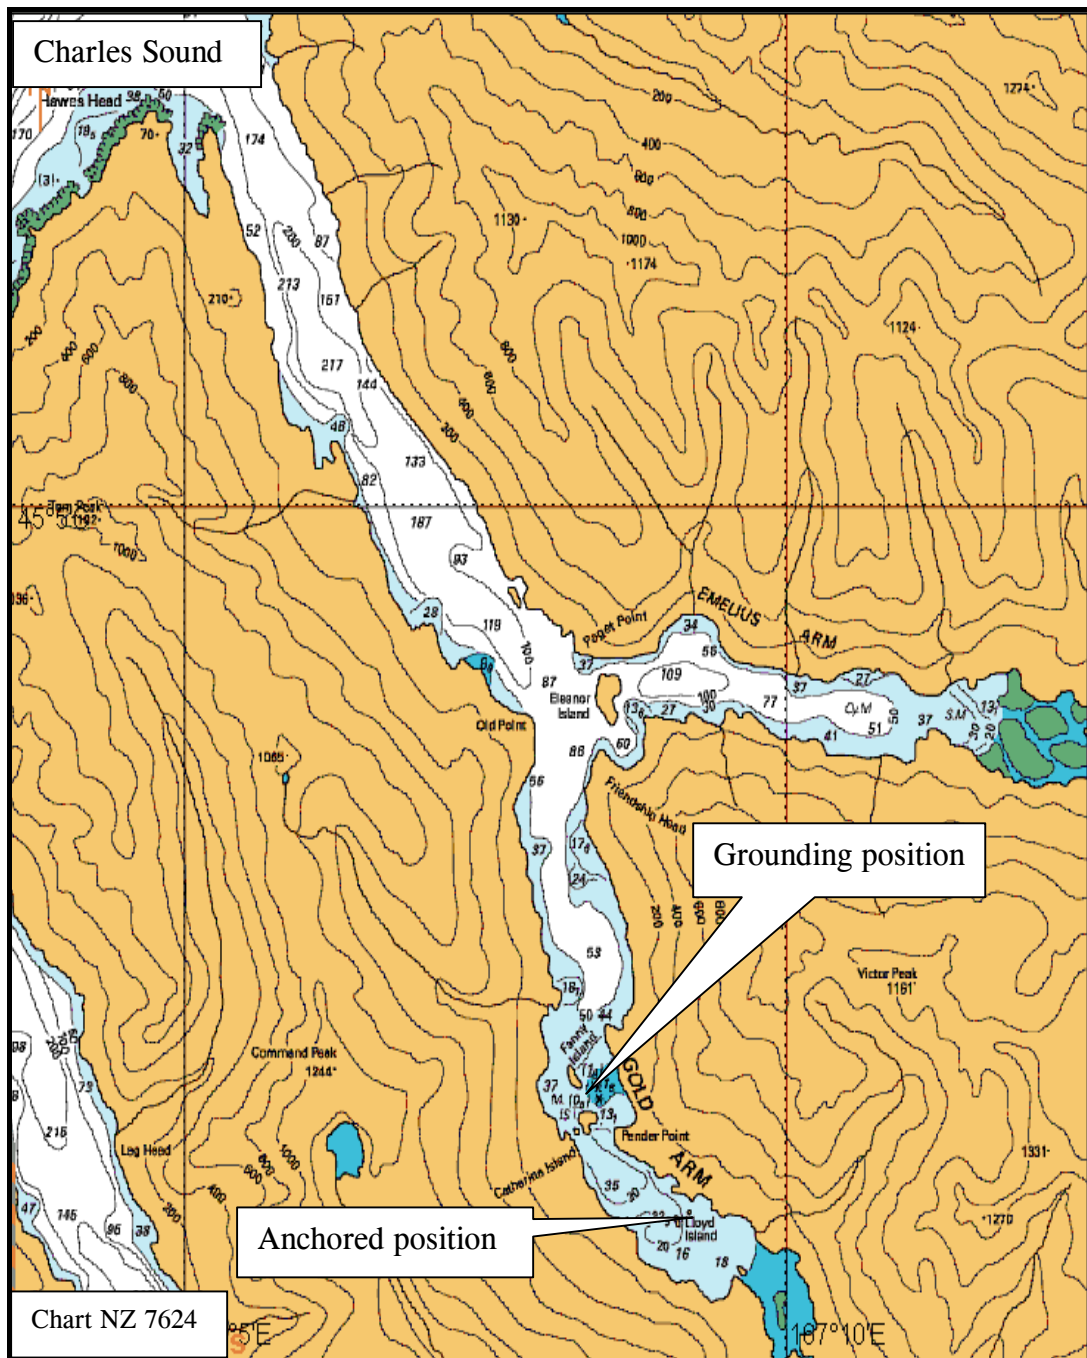
FIGURE 1

On Thursday 14 October at 1915 hours New Zealand Standard Time, the Skipper anchored the vessel in Gold Arm of Charles Sound (*See Figure 1*). At 1928 hours, after the vessel had settled at anchor, the Skipper shut down the main engines and the electronics. He then joined the other DOC staff and had a barbeque on the main deck of the vessel.

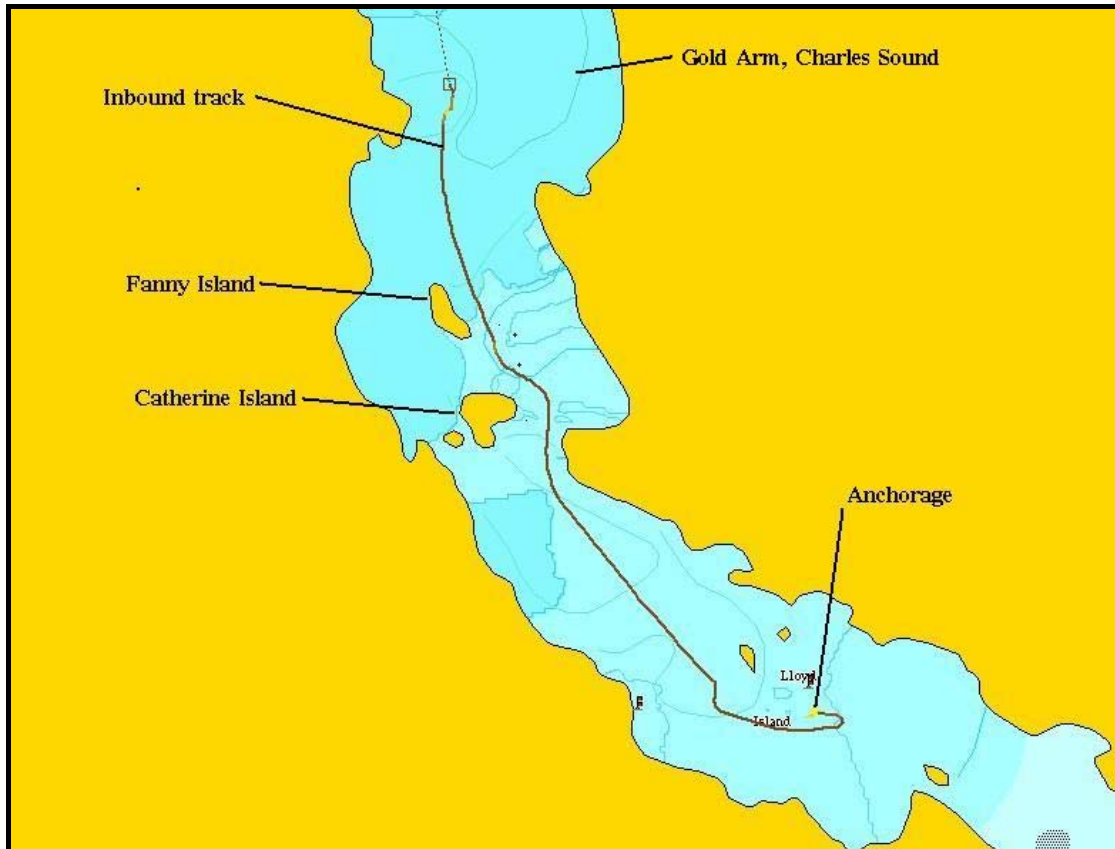
**FIGURE 2 - INBOUND *SOUTHERN WINDS* GPS TRACK FROM VESSEL.**

At approximately 1800 hours, the Skipper conned the vessel into Gold Arm of Charles Sound. He passed Fanny and Catherine Islands, leaving them both to starboard. The Skipper made passage towards Lloyd Island and came to anchor at approximately 1915 hours, 1.3 cables south east of Lloyd Island in 16 metres (m) of water (*See Figure 2*).

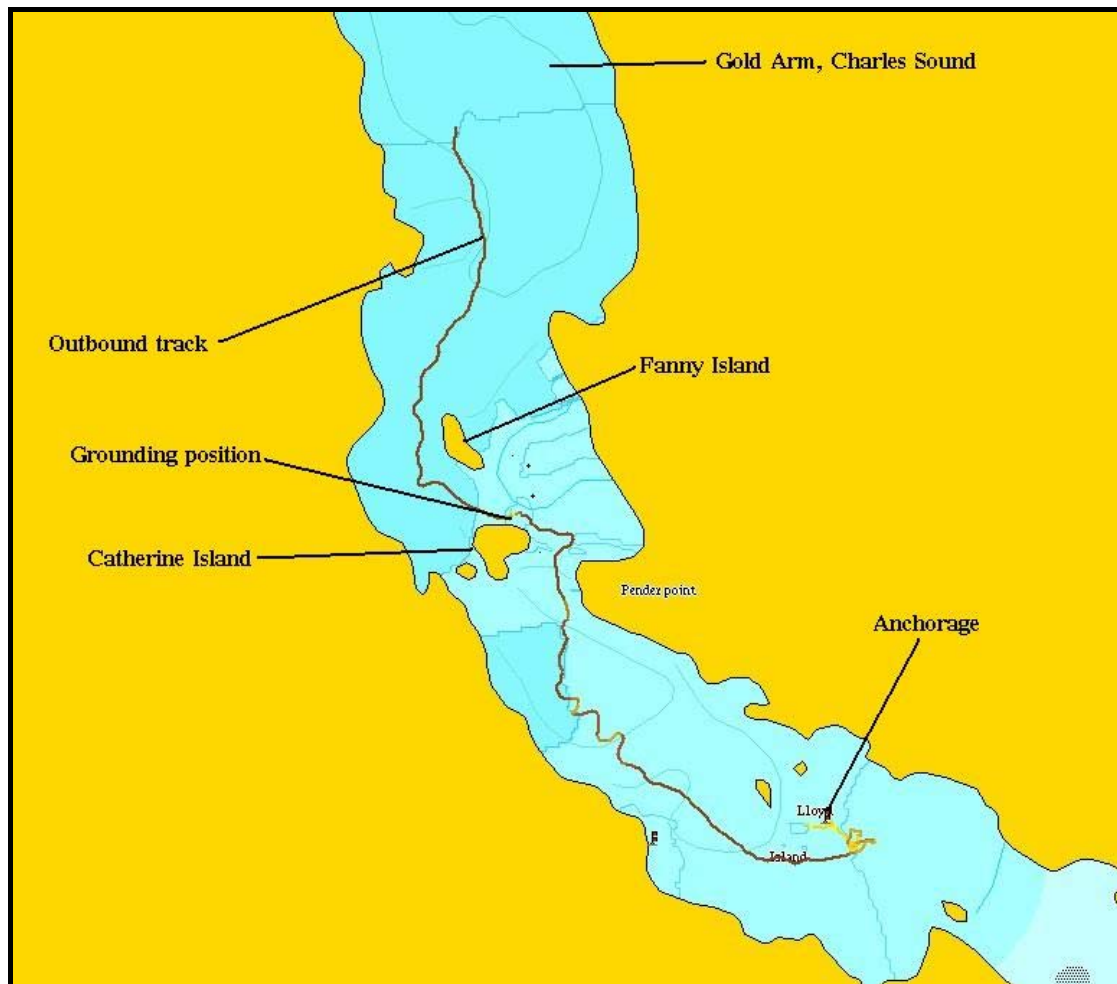
**FIGURE 3 - OUTBOUND *SOUTHERN WINDS* GPS TRACK FROM VESSEL**

At this point the Skipper decided to abort deploying the anchor, instead electing to steam the vessel at steerage speed north towards Pender Point (See Figure 3). Steerage became difficult to maintain however as the bow of the vessel was blown off track repeatedly due to the high wind speed. The Skipper decided to steam out of Gold Arm and look for a more sheltered position within Charles Sound.

The Skipper attempted to retrace his inbound track past Catherine and Fanny Islands. While at anchor the GPS plotter had been shut down and when restarted it had opened a new file with a clean chart display and he did not recall the inbound track.

Using the radar and GPS plotter, the Skipper positioned the vessel midway between Catherine Island and the area of shallow ground to the immediate northeast.

At approximately 2330 hours, as the vessel was midway between Catherine Island and the shoal ground, the vessel struck a submerged rock, rode up and then slipped off the side of it.

The Skipper conned the vessel to the south west of Fanny Island (*See Figure 3*) while all staff donned lifejackets. The damage was assessed and a check made for any ingress of water. Initially, no water was found on board. However, about 5 minutes later, crew reported that water was coming out of the deck floorboards in a forward space near some access stairs. They made some temporary repairs to reduce the flow of water using a bedroll, foam and sealant. The level of water could be controlled using the vessel's pumps. The Skipper made passage towards Eleanor Island and turned into Emelius Arm of Charles Sound (*See Figure 1*). At this juncture the Skipper slowly steamed up and down Emelius Arm. At about 0030 hours, on 15 October the Skipper was able to make a radiotelephone contact to his wife notifying her of the accident and asking her to contact the DOC project manager.

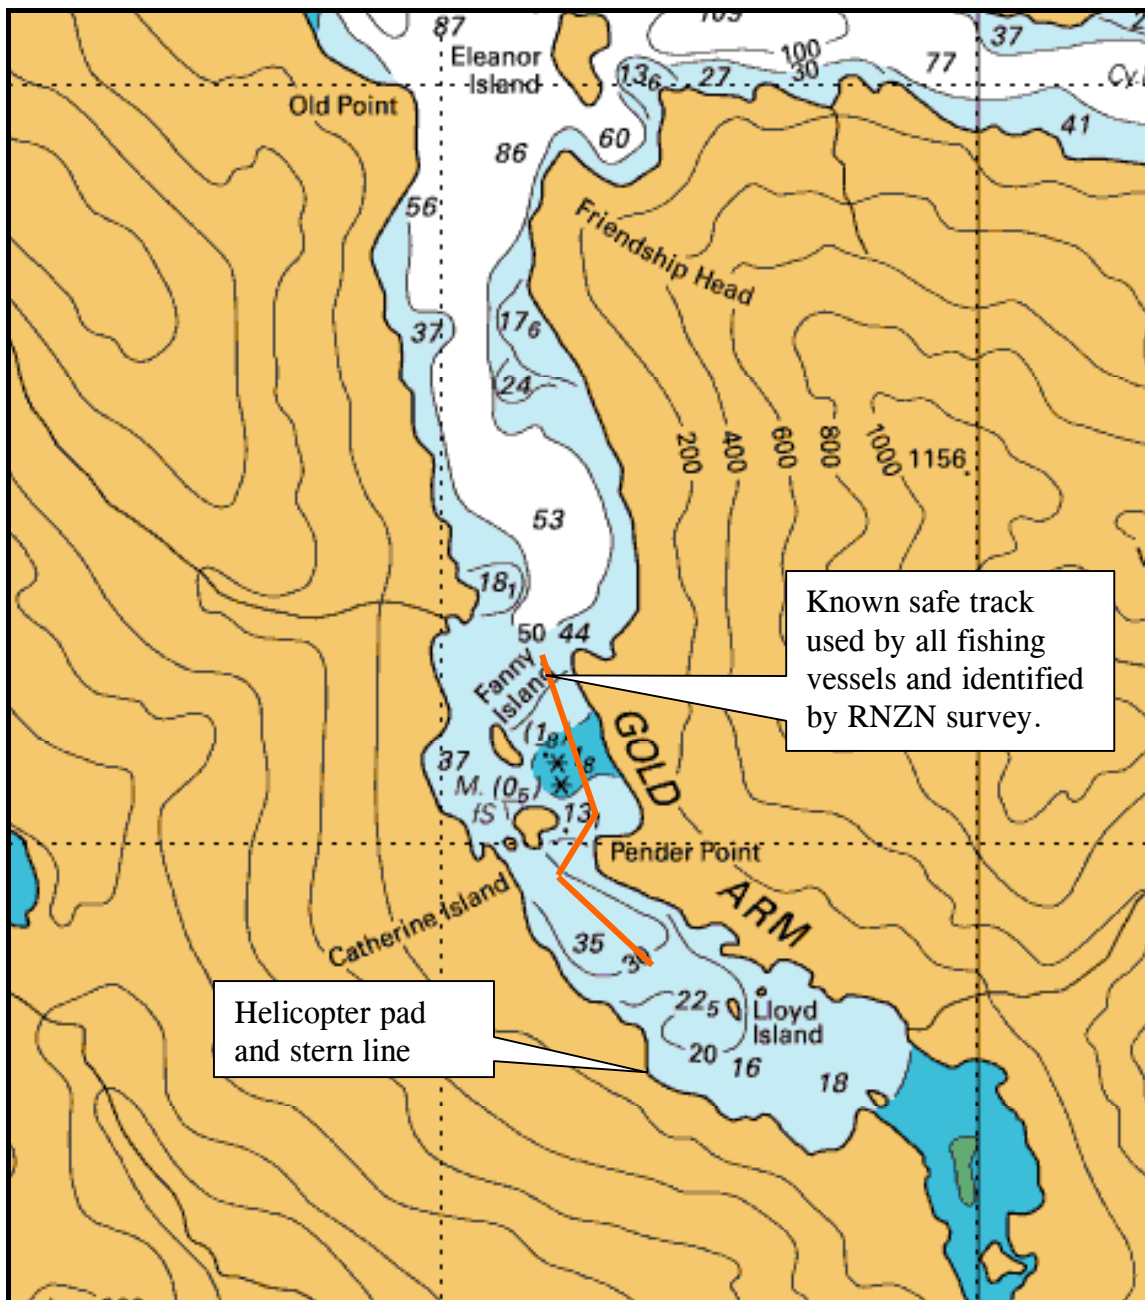
FIGURE 4

The Skipper had the radar, the echo sounder and the GPS plotter operating at the time of the grounding. He had transited the area immediately adjacent to Catherine Island at 1800 hours earlier that evening. Both he and the relief Skipper of *Southern Winds* had independently transited through the same area before. This Skipper had been into Gold Arm about 8 to 10 times before, 6 of those as Skipper. When the GPS plotter was re-started, the computer opened a new file for the area; the Skipper could not recall the previous inbound track for ready reference.

The Investigator spoke to two local Fiordland fishermen, both of whom had in excess of 25 years experience in the area. They stated that the accepted and only safe course past Fanny and Catherine Islands was to stay east of the dangerous rocks and west of a rock close in to the eastern shore (*See Figure 4*). They said that without local knowledge this passage should only be made during daylight hours, when the rocks to the west area easily visible above the sea surface. After making the passage several times during the day the passage can be safely made at night.

They independently expressed concern that the Skipper of *Southern Winds* took a track that was close in to Fanny and Catherine Islands, as this was particularly dangerous and risky. The Skipper of *Southern Winds* stated that he did not know of the western track or the helicopter pad until shown by the helicopter pilot.
