Class B Accident Report

**Spica**

**Cargo Gear Failure**

Freyberg Wharf, Auckland on 15  
October 2004

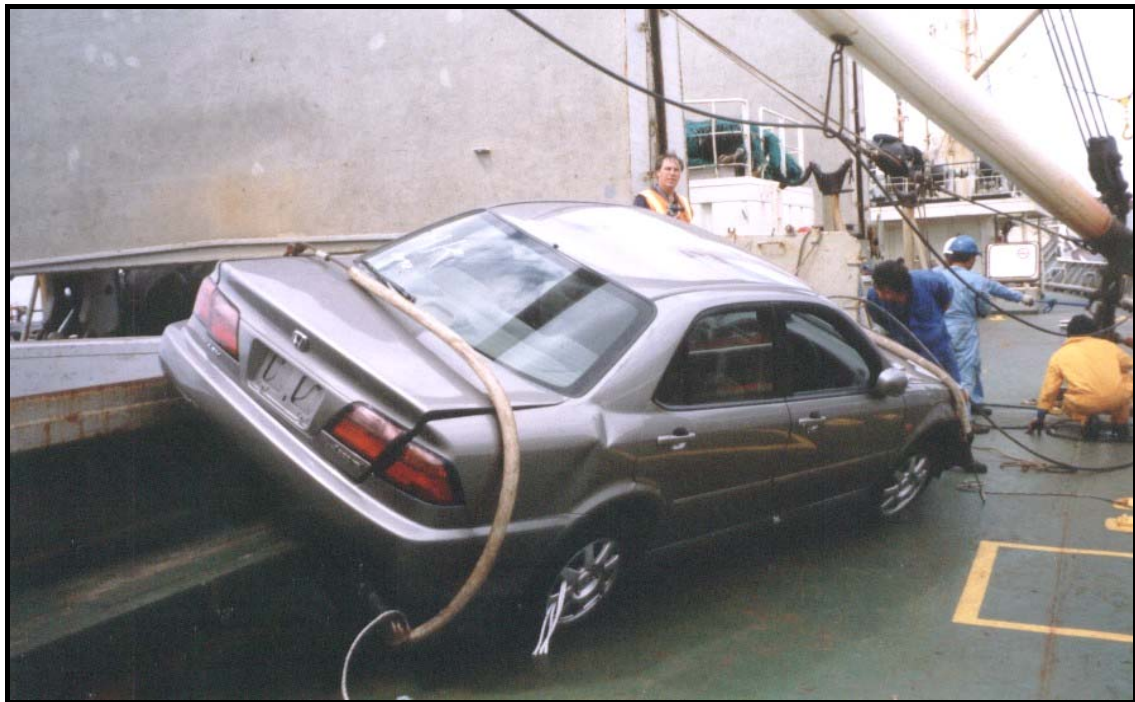
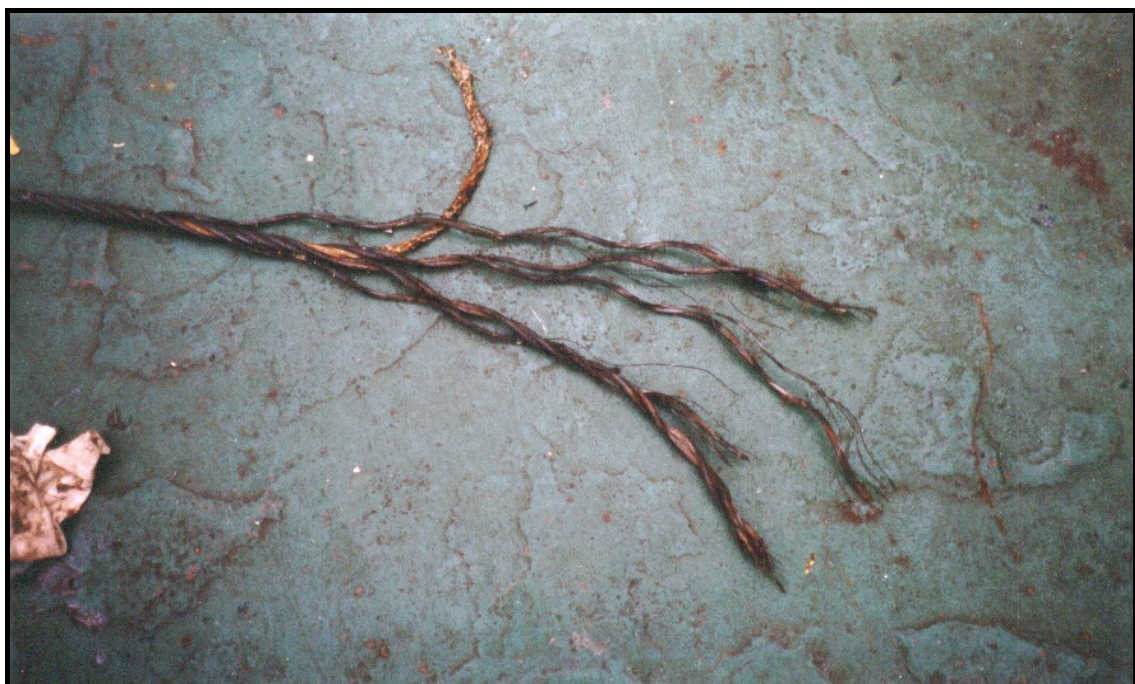
At approximately 1140 hours New Zealand Daylight Time (NZDT) on 15 October 2004, vehicles were being discharged from the reefer vessel *Spica* at Freyberg Wharf. Two gangs from the stevedoring company were operating on board at the time. At about 1140 hours, a 0.5 tonne lifting frame was lifting an approximate 1.0 vehicle from No. 3 hold. The stevedore operating the winch observed the starboard runner wire was starting to unravel. The winch driver immediately lowered the port runner allowing the vehicle to drop onto the starboard deck, as the wire on the yardarm of the union purchase parted.

- (a) The broken wire appeared to have been previously damaged as broken strands were found a short distance from the break.
- (b) The cargo runners that were shackled to the cargo hook monkey face were used to open and close the tween deck hatch covers.
- (c) When opening the above covers the weight of the lift is taken on one runner only, placing more strain on that wire.
- (d) The wires were observed to chafe on the hatch coaming.
- (e) It was observed that the breakage occurred at a point where chafing had occurred.
- (f) The remaining cargo runner wires appeared older and lacked sufficient lubrication.
- (g) The open wire lay of the broken runner wire at No.3 hold was very dry and rusty.

All cargo runner wires that are very dry and rusty be replaced.

All remaining cargo runner wires to be kept lubricated properly.
