Accident Report

Target & Unnamed Dinghy Collision

North of Urupukapuka Island, Bay of
Islands on 26 September 2004

REPORT NO: 04 3560

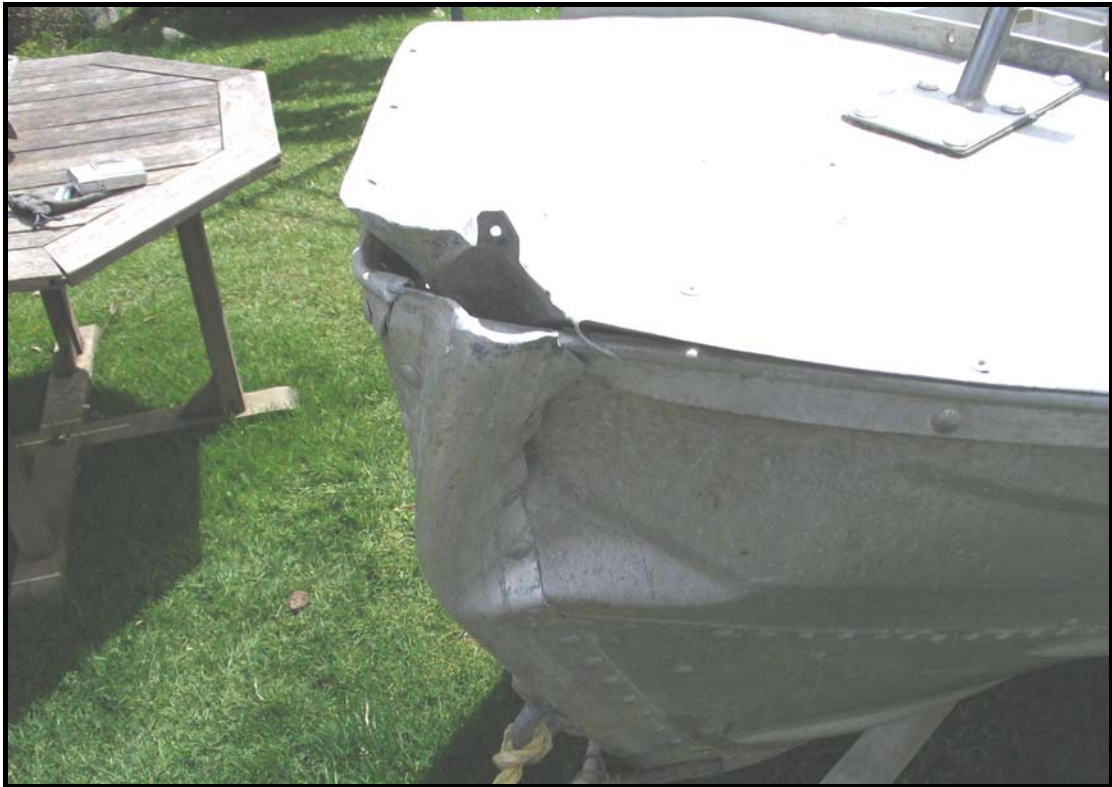
2.2.10 The damage to the dinghy consisted of a crumpled starboard bow (*See Appendix 1 – Photo 1*). The engine was also swamped and required repairs.

PHOTO 1 – DAMAGE TO BOW OF UNNAMED DINGHY

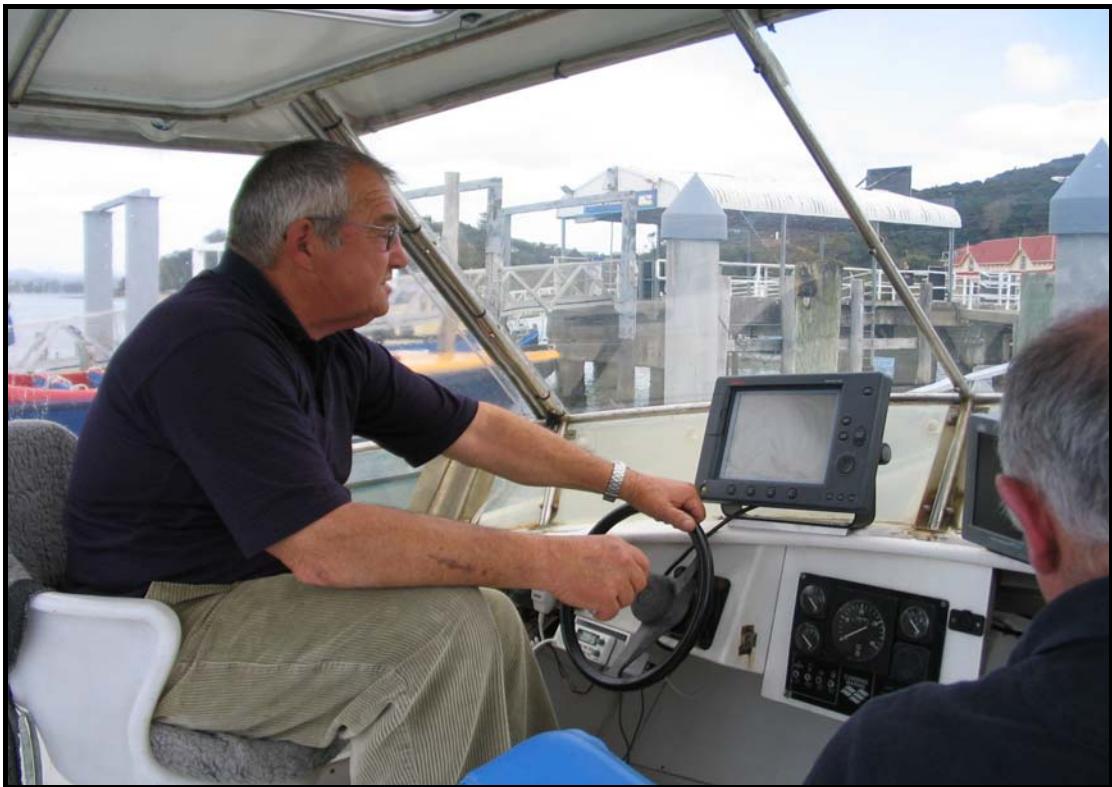
- 2.1.7** The plastic flying bridge windshield had been replaced with polycarbonate in 2003 in order to improve visibility.
- 2.1.8** *Target* is normally conned from the flying bridge as the visibility is better than from the wheelhouse.

PHOTO 2 – FLYING BRIDGE CONNING POSITION

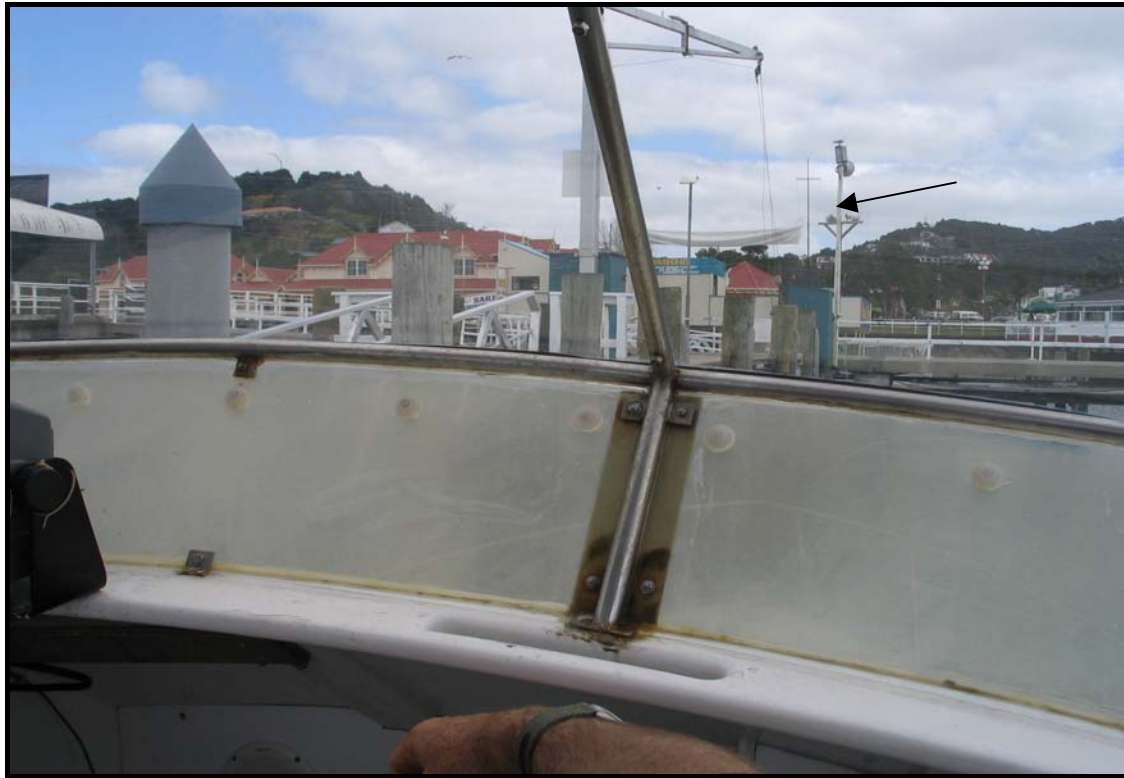
- 3.1 The position of the sun and its reflection off the water impaired the vision of *Target's* Skipper and passengers.
- 3.2 *Target's* windshield was covered in sea spray. This impaired the visibility of the Skipper and passengers.
- 3.3 The lower part of *Targets* windshield was constructed from plastic. This had become discoloured over time and was almost opaque, and impaired the visibility of the Skipper and passengers (*See Appendix 2 – Photos 2, 3 & 4*).
- 3.4 The dinghy was anchored near the interface of calm water and rough water.
- 3.5 *Target* was proceeding at a speed greater than five knots within 200 metres of the shore.
- 3.6 *Target* was not proceeding at a safe speed as defined in Maritime Rule 22.6.

- 5.1.1 A combination of sun strike and the build up of salt spray on the windshield impaired the visibility of *Target's* Skipper and passengers.
- 5.1.2 The discoloration of the lower section of *Target's* windshield impaired the visibility of *Target's* Skipper and seriously impaired that of the passengers
- 5.1.3 *Target's* speed was excessive in the prevailing circumstances and conditions.
- 5.1.4 There is some doubt as to whether the dinghy carried any lifejackets. If none were carried, this would be in breach of **Maritime Rule Part 91.4**.

PHOTO 3 – FLYING BRIDGE WINDSHIELD

- 5.2.1 The owner of *Target* should replace the lower plastic section of the windshield with new 'see through' material to improve the visibility from the flying bridge. This should be done within one month of this report being published.
- 5.2.2 It is recommended that the Maritime Safety Authority, censure the Skipper of *Target* for his failure to proceed at a safe speed.
- 5.2.3 It is recommended that the owner of the *Unnamed Dinghy* ensure that a sufficient number of lifejackets are kept on board at all times in accordance with the requirements of **Maritime Rule Part 91.4** and that these are worn in accordance with the requirements of **Maritime Rule Part 91.4(6)** which states:

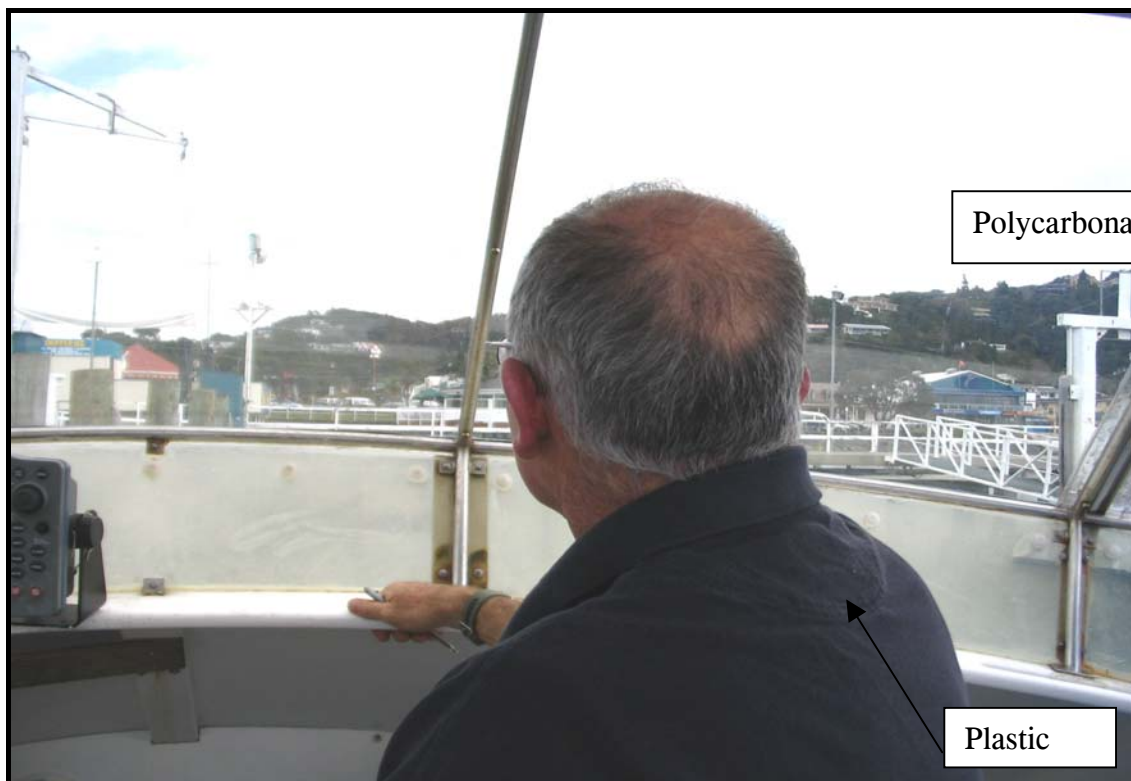
PHOTO 4 – VIEW OF PASSENGERS WHEN SITTING ON FLYING BRIDGE
