Accident Report
Tasman Independence
Cargo Gear Failure
Port of Bluff on 14 January 2004

REPORT NO.: 04 3557

Casualty Type: Cargo Gear Failure

Casualty Location: Port of Bluff

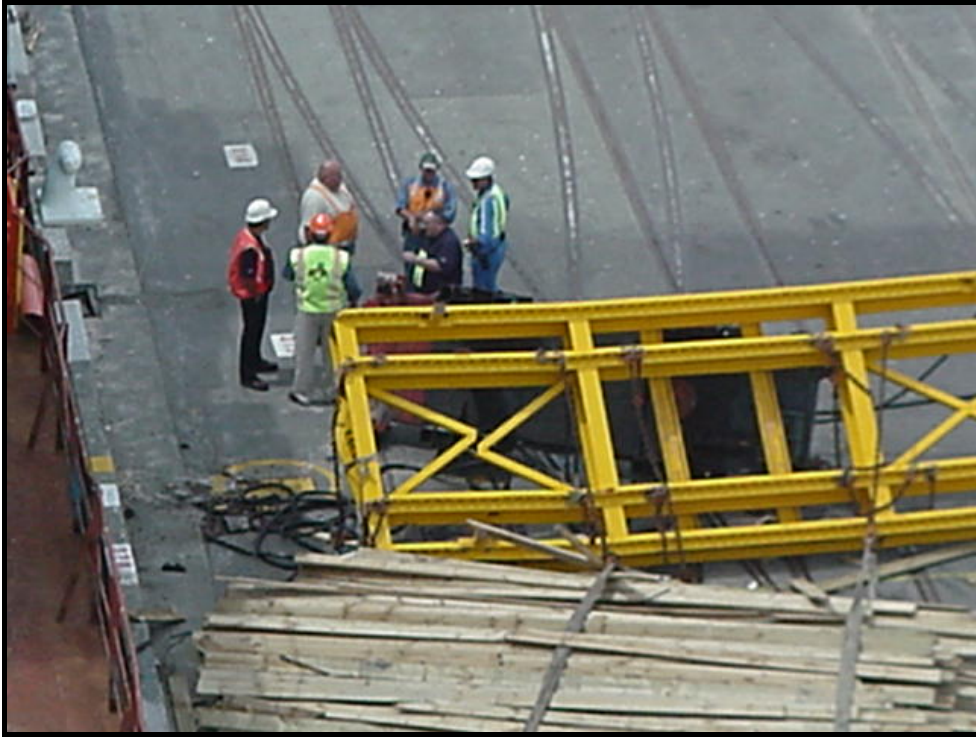
PHOTOGRAPH 1

- 1.7 At 1300 hours, the stevedores (who were now in control of the No. 2 after gantry crane) continued to prepare No. 5 hold for cargo. This included the need for a sling of dunnage to be lowered into the hold (*See Appendix 1 – Photograph No. 1*).

- 1.9 At approximately 1305 hours, during the first lift of the day with the No. 2 gantry crane, the MDF spreader and sling of dunnage, that was connected to the pulley frame of the crane, fell onto the quay. The resulting impact caused damage to the pulley frame and spreader as well as causing damage to the quay. All four hoist wires of the crane and the electric multi core wire, were severed (*See Appendix 1 – Photographs Nos 1 & 2*).

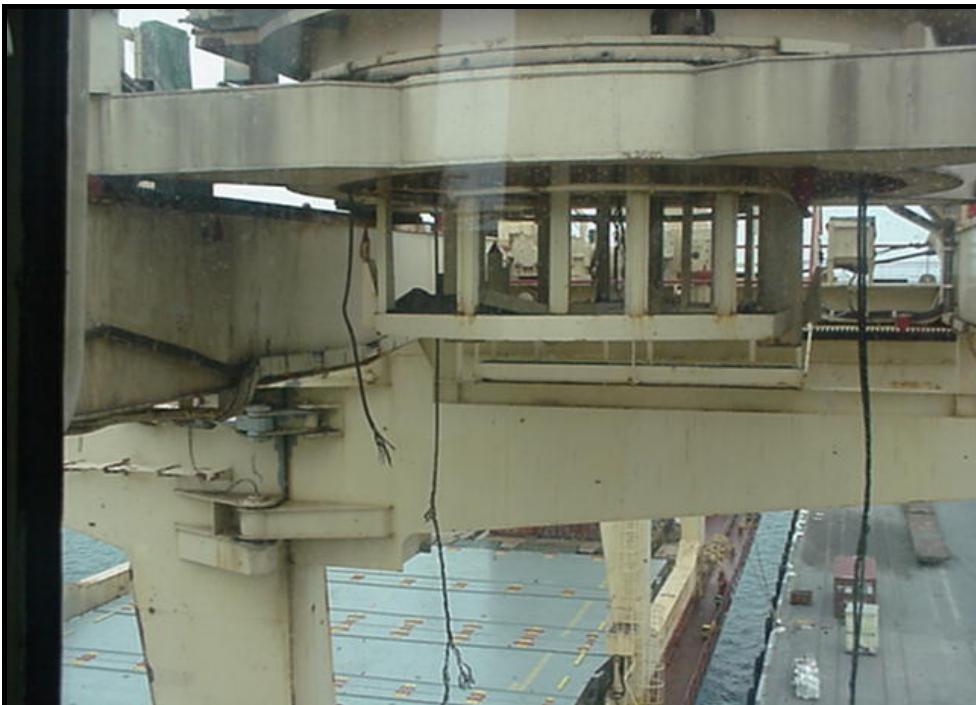
PHOTOGRAPH 2

- 2.2.10** The fact that the length of the wires hanging below the pulley frame after the accident was short (*See Appendix 1 – Photograph No.2 - Broken wires hanging down loose*), indicates that the pulley frame was up to or close to the turntable (upper housing) at the time the wires severed.

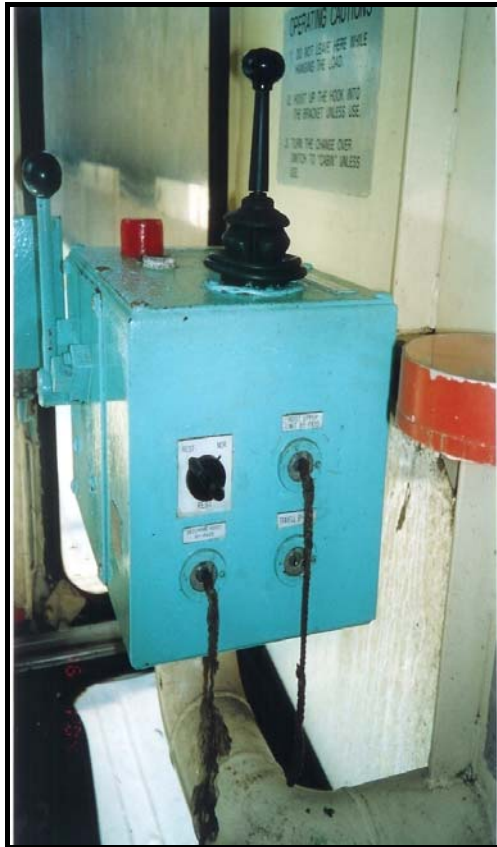
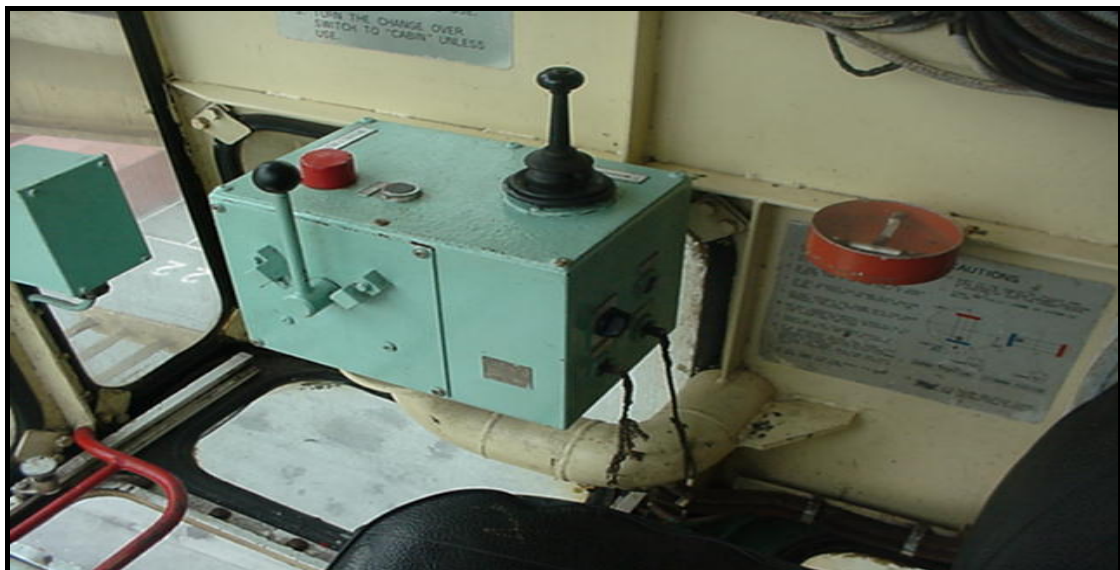
PHOTOGRAPH 3

- 2.2.5** Although statements from the witnesses contradict each other, it appears that the gantry crane was put in the hoist mode to lift the dunnage from the quay and that the pulley frame, with the spreaders and dunnage attached, was inadvertently hoisted hard up against the housing on the underside of the gantry frame turntable, (*See Appendix 1 – Photograph No. 5 - Damage to underside of Gantry turntable*). This, in turn, probably caused the hoist wires to sever and the pulley frame, spreader and dunnage to fall onto to the quay (*See Appendix 1 – Photograph No 6 – Equipment and dunnage, on quay*). For the above to have occurred the two limit switches for park and hoist respectively, would have had to be switched off i.e. switched from ‘safe cargo mode’, with the appropriate keys, to ‘housing/ stowing mode’ (*See Appendix 1 – Photograph No. 3*).

- 2.2.6** At the time of the accident, the limit switch keys had been left in place in the operating cab by the ship’s crew (*See Appendix 1 – Photograph Nos. 3 and 4 – showing keys in place*).

- 5.1 It is recommended that designated crews members only should hold the limit switch keys and that this should be formally documented in shipboard procedures. Limit switch keys should be removed by the said designated holders before cargo operations commence.
- 5.2 It is recommended that the operators of the vessel implement on board procedures to ensure the safe operation of gantry cranes by stevedores. This is to include the instruction that safety limits switches are correctly set prior to stevedore operations.
- 5.3 It is recommended that stevedoring companies implement formalised procedures to check that gantry cranes are in good working order before cargo operations commence; this is to include that safe working of limit settings.
- 5.4 It is noted that since the accident both the ship and stevedores have commenced implementing these new procedures.

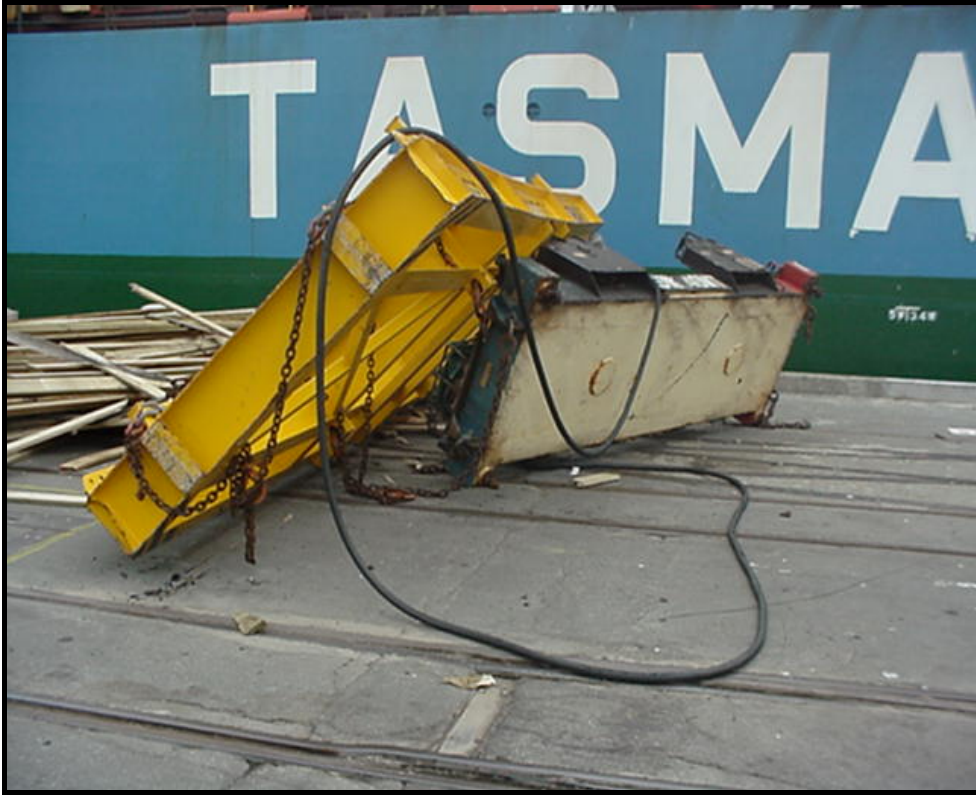
PHOTOGRAPH 6

- 1.8 A medium density (MDF) spreader (*See Appendix 1 – Photograph Nos. 1 and 6*) with a safe working load (SWL) of 28 tonnes, which belonged to S.S.S, was slung below the pulley frame of the No. 2 after gantry crane. A sling of dunnage was then attached to the spreader. This was the first lift of the day by the stevedores with No 2. gantry crane. The gantry turntable was positioned in the athwartship position, to facilitate the movement of the sling of dunnage between the legs of the gantry crane.

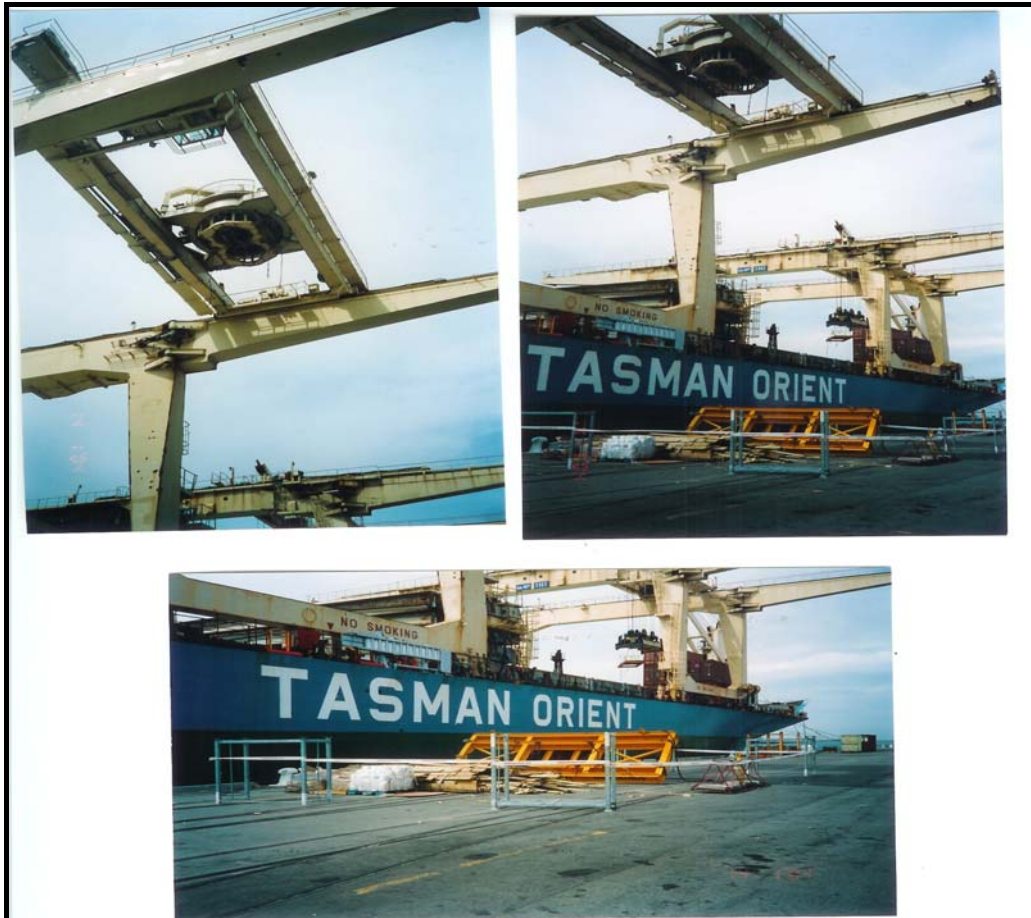
PHOTOGRAPH 7

- 1.5 When preparing the ship for cargo operations, the ship's crew lifted four hatch lids at No.5 hold. Two hatch lids were lifted by the forward gantry crane and the other two by the No. 2 after gantry crane. Each hatch lid weighed approximately 35 tonnes (*See Appendix 1 – Photographs Nos. 7 and 8*).
