# Accident Report

Failure of No. 2 Crane

*Tasman Mariner*

REPORT NO.: 05 3847

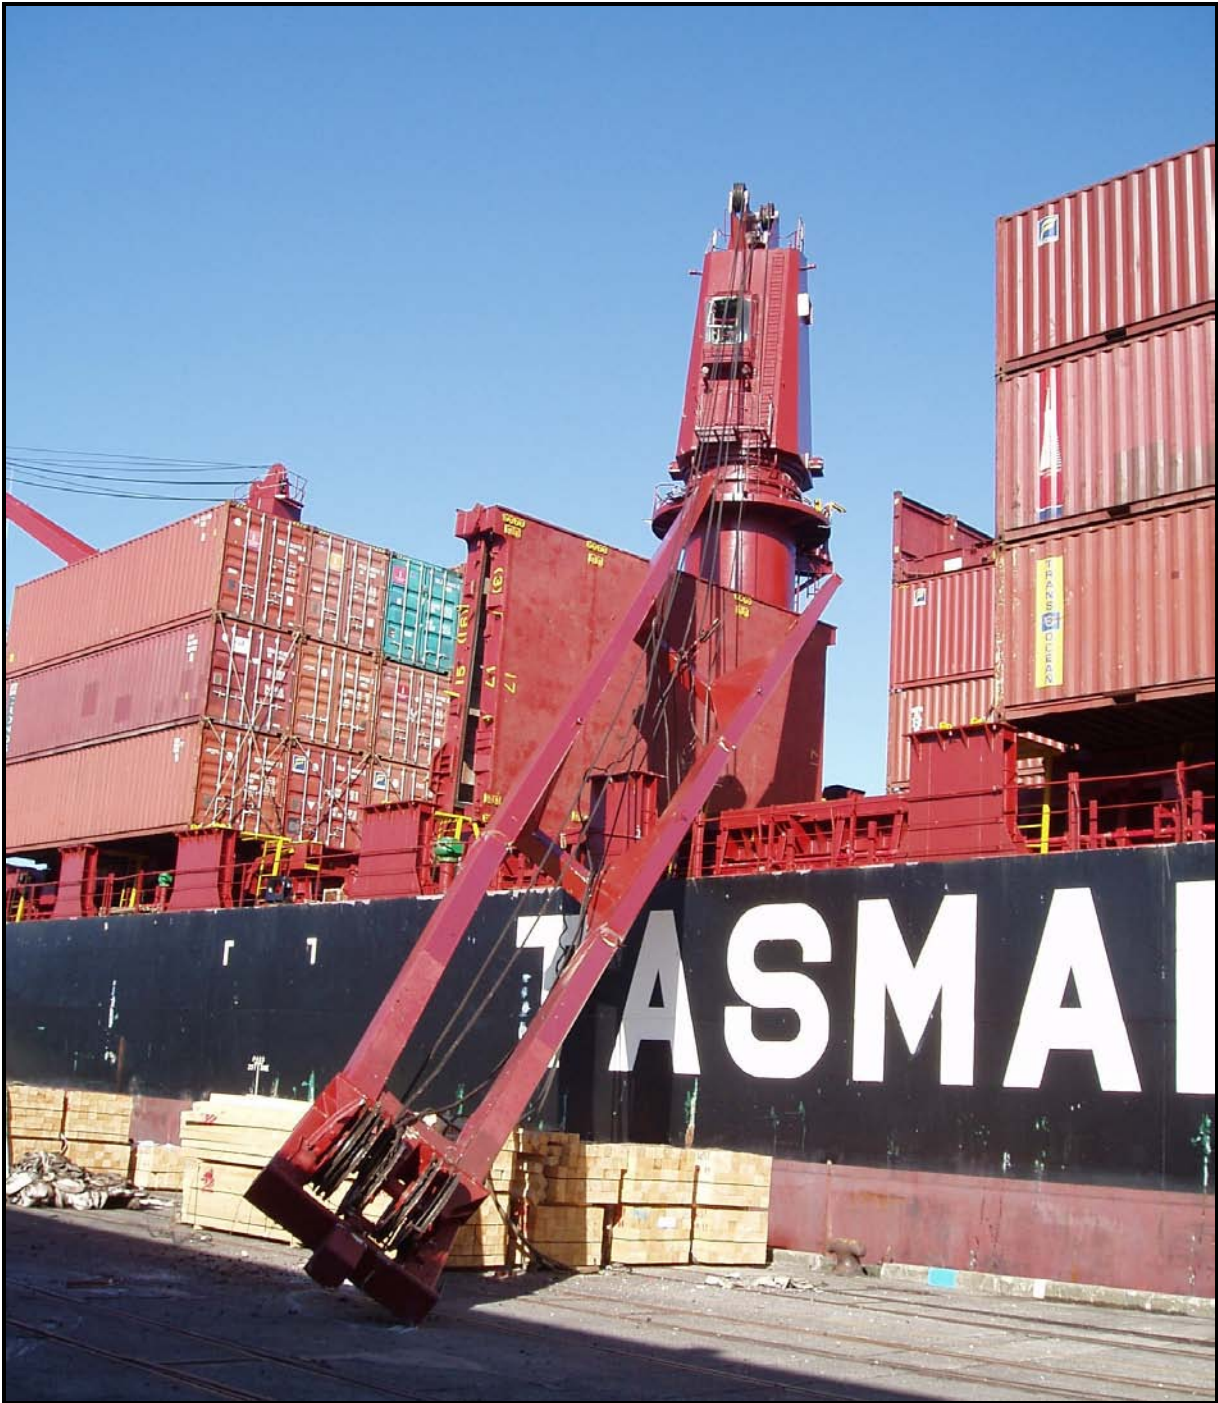
Cargo work stopped. The Ship's Master and officers and the Stevedore Supervisor assessed the situation. The jib of No. 2 crane had become detached from its gooseneck and was resting on the wharf and across the raised hatch-cover at the after end of No. 3 hold (*See Photograph 2*). Although its movement was restrained by the hoist wire, it was liable to settle and fall with movement of the ship, making it dangerous to approach. Low water was at 0219 hours and the tide was rising. The wharf near the crane was cordoned off with hazard tape and the stevedores asked the Port Company to notify ships to reduce speed while passing No. 6 berth (*See Photograph 3*).

**Photograph 2**  
No. 2 crane resting on the wharf and the No. 3 hatch cover

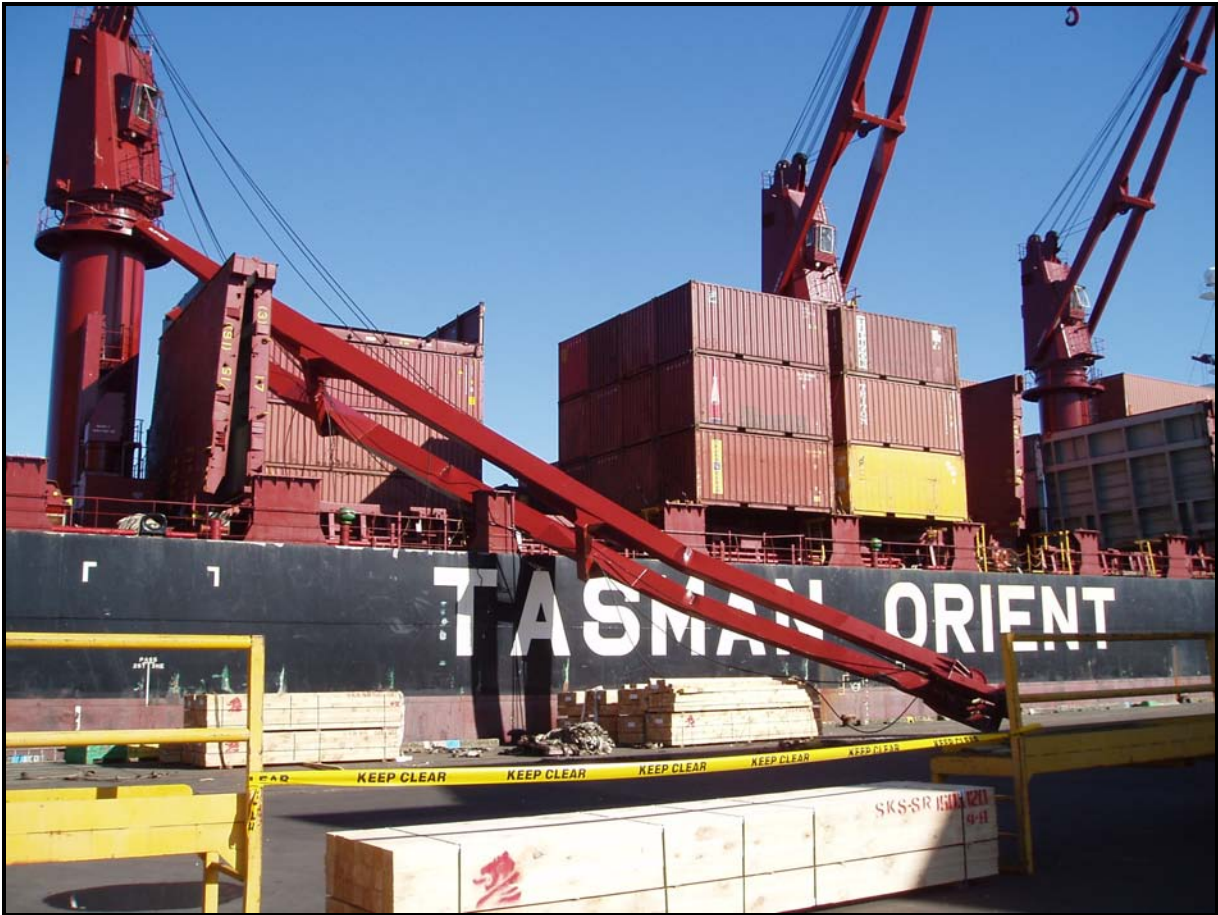
**Photograph 3**

No. 2 crane showing area cordoned off with hazard tape.

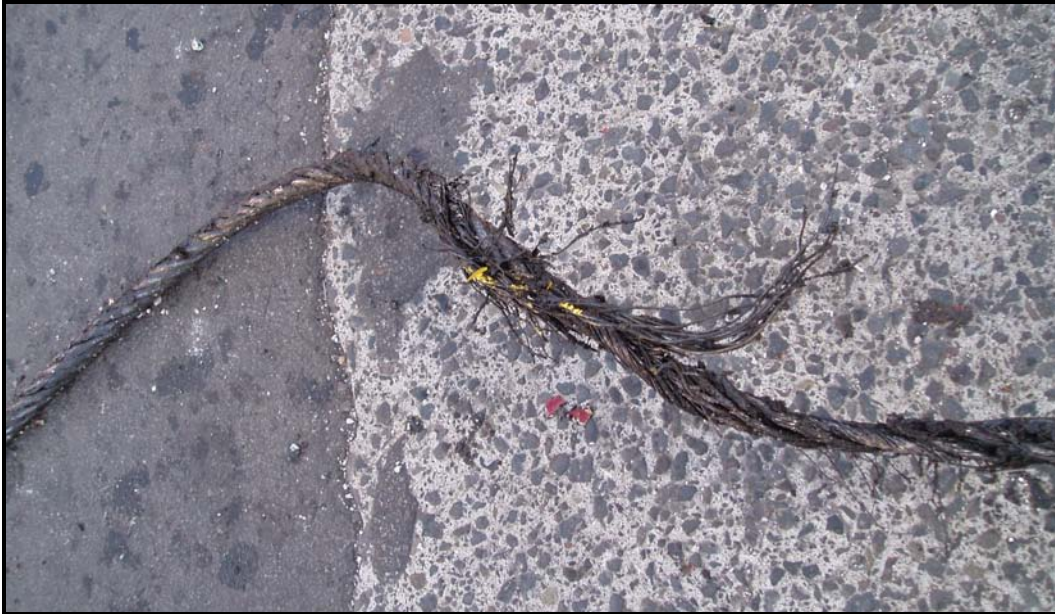
**Photograph 5**  
The broken topping lift wire from the No. 2 crane

1. The accident was the result of No 2 crane topping lift wire rope parting. Since:

- The cable failed due to severe abrasive wear predominantly of the crown wires of the outer strands. However, considerable wear also occurred in wires below the surface in the outer strands and on inner (core) strand wires.
- The cause of the wear was not determined. However, it is very likely to be associated with rotation of the cable relative to one or more contacting component(s).
- The material of manufacture was unlikely to have contributed to the failure.
- Fatigue was not observed to have been a significant factor in the failure.

1. It is recommended that the China Navigation Company Ltd urgently reviews its ISM procedures for the inspection and replacement of wire ropes to take account of these findings. It is requested that the Company advises Maritime New Zealand in writing of any steps taken to prevent a recurrence of this type of accident within two months of the final report being published.
2. It is also recommended that copies of this report be sent to all New Zealand stevedoring companies and to Mitsubishi Heavy Industries Ltd.

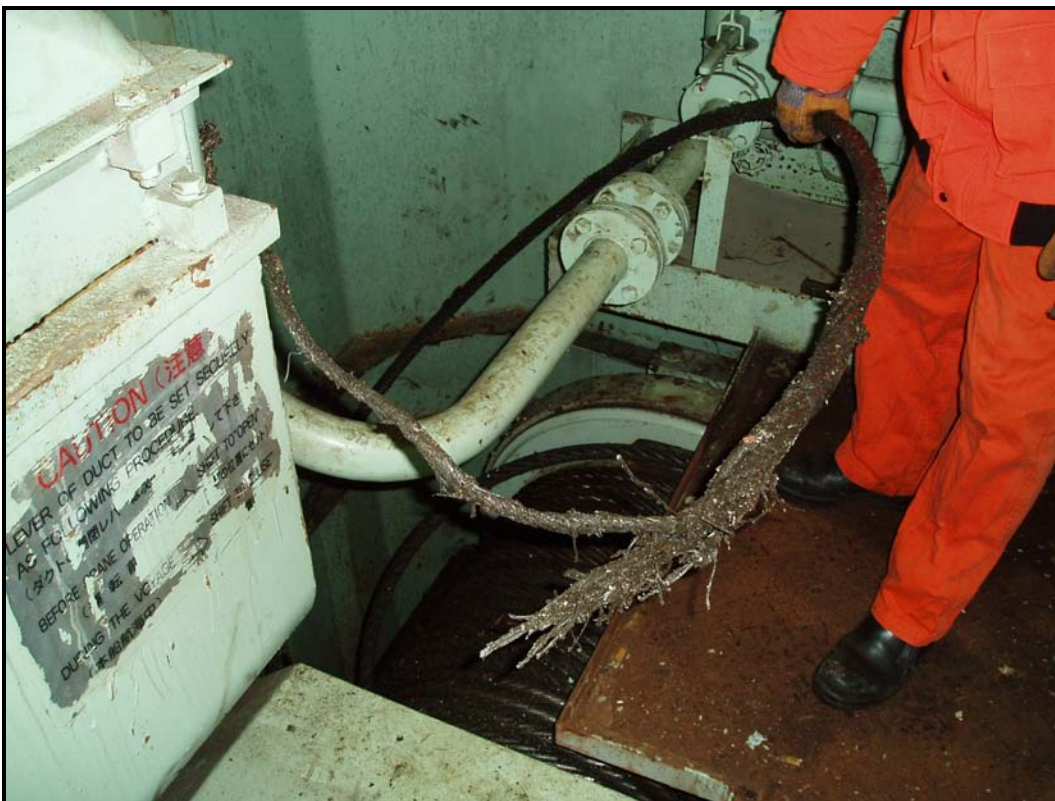
**Photograph 6**  
Inside the No. 2 crane, showing the broken topping lift wire.
