# Accident Report

Fatality

*Tasman Resolution*

11 January 2007

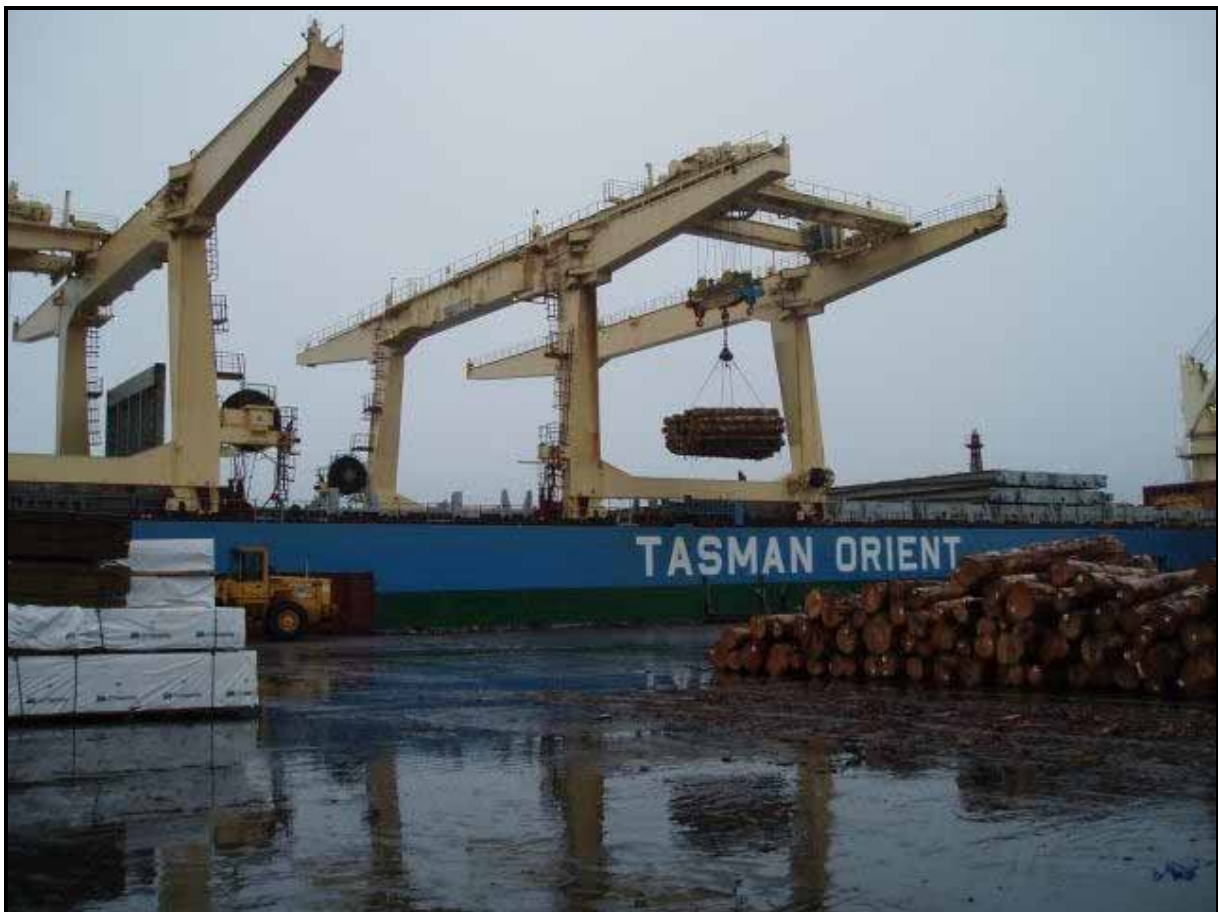
**Photograph 2**  
Gantry Cranes

Two gantry cranes straddle the hatches and run on rails set on the main deck, each side of the vessel. Each gantry crane has a Safe Working Load (SWL) of 40 tonnes and is controlled from a cab located in the centre of the traveller. The cab of Number 1 gantry crane (*See Photograph 4*) is located at the forward end of the gantry and faces aft. It is in a fixed position longitudinally, but moves athwartships, across the vessel, in conjunction with the crane hook. The drivers' position in the cab is approximately 14m above the main deck.

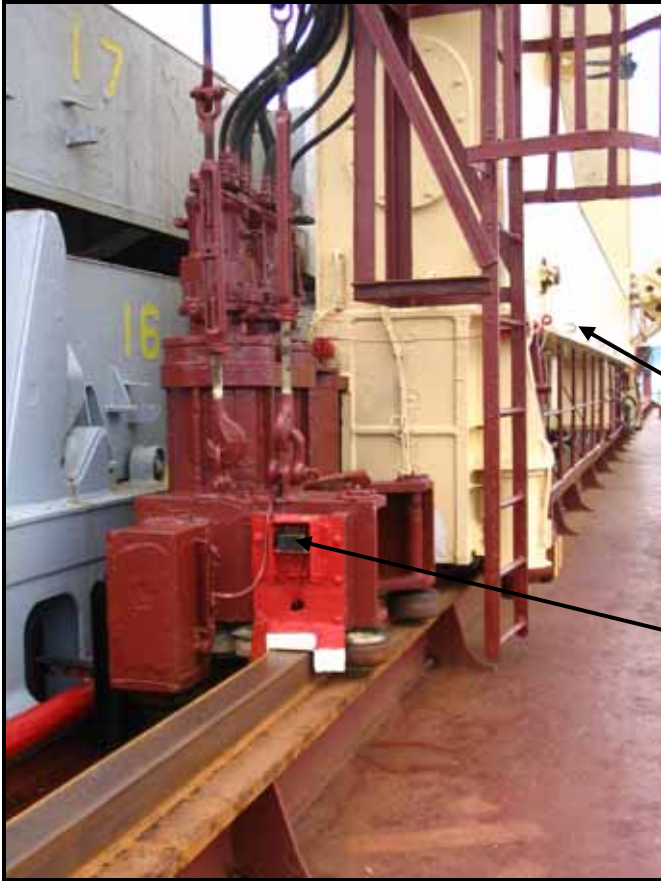
**Photograph 3**  
Number 1 Gantry machinery

Emergency stop wires (*See Photograph 3*) are provided along the outboard side of the main structure of each gantry. The wire is painted red and is positioned at a height of approximately 1.80m above the deck, reducing to 1.60m above the deck at the legs of the gantry. This wire does not extend around the machinery at the after end of the leg (*See Photograph 3*).

There is no emergency stop wire along the inboard side of the gantry crane. There is a proximity switch located on each leg, 350mm directly above the gantry track (*See Photograph 3*). This stops the crane should any obstacle be detected on the rail itself.

Emergency stop wire

Proximity switch

Due to the configuration of the emergency stop wire, it would have been impossible for the Boatswain to have activated an emergency stop from his position on the inboard side of the gantry crane.

1. Install emergency stop devices along the inboard side of each gantry crane and around the machinery on this vessel and her sister vessel *Tasman Independence*.

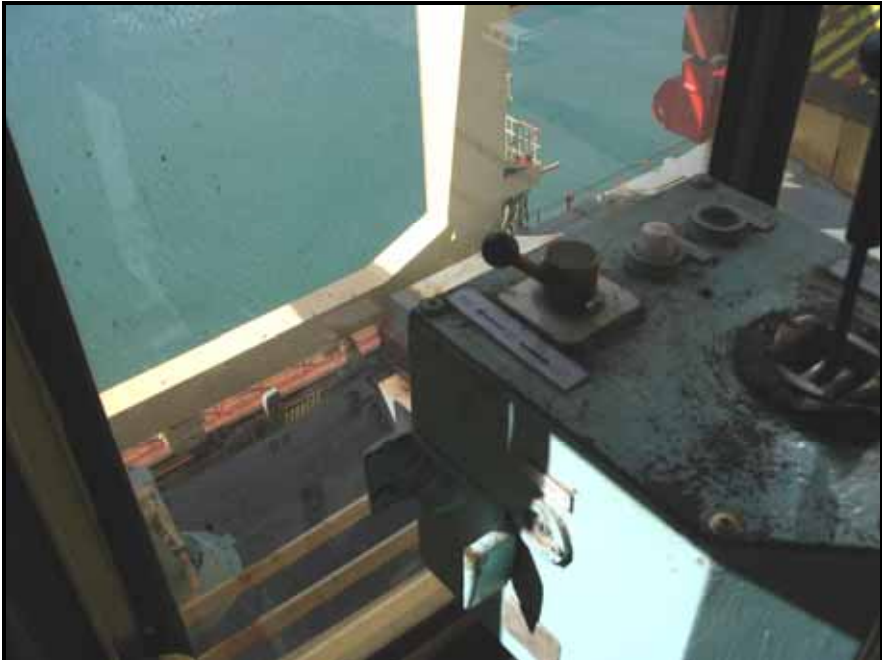
**Photograph 4**  
View from cab of Number 1 gantry looking to port.

The crane driver's visibility is restricted from the driver's position within the cab. The crane driver therefore relies on either radio contact or hand signals from a man on deck when he is operating the crane. The cab has glass windows, one of which was open at the time of the accident.

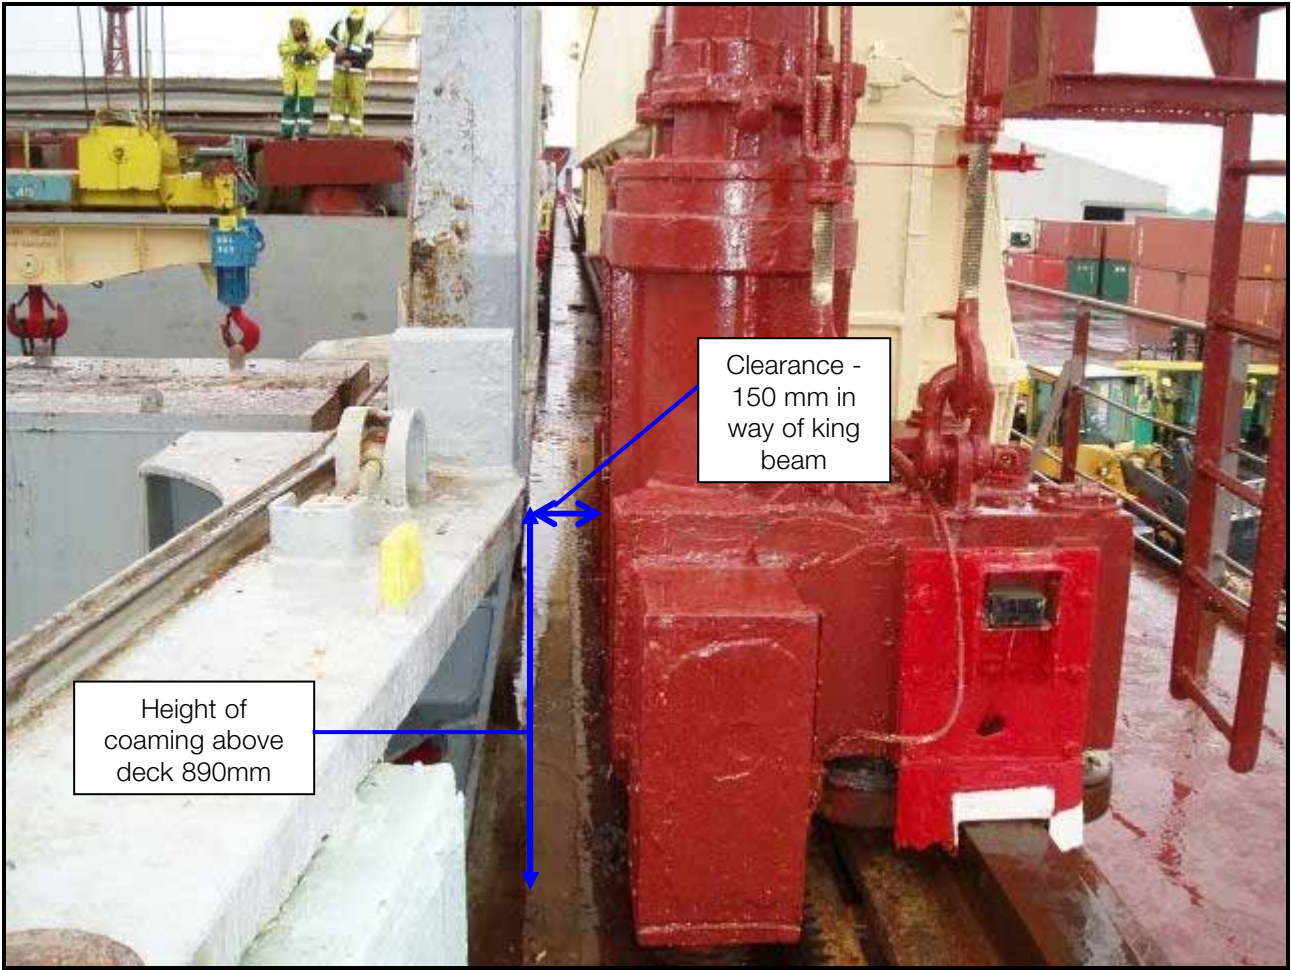
Camera footage from a Port security camera shows that thirty two seconds after the Boatswain climbed down off the pontoon cover, at 2244, the gantry crane lifted the pontoon cover clear of the number 5 hatch coaming and commenced travelling forward towards number 3 hatch. The Boatswain is thought to have been trapped between the after inboard leg of the Number 1 gantry crane and the number 5 hatch coaming at this juncture. The after leg of the gantry crane travelled past the king beam (*Photograph 7*) approximately thirty seconds after it started moving.

The two gantry cranes travel close to the hatch coamings. In places, there are additional obstructions such as electrical boxes, fire hydrants, hose boxes and lashing gear bins that protrude from the side of the hatch coaming, thus further reducing the distance between the hatch coaming and the inboard side of the gantry cranes. On numbers 3 and 5 hatches, the hatch coaming protrudes outwards, due to the location of a king beam in the centre of the hatch (*See Photographs 6, 7 & 10 and Figures 1 & 2*). In this position, the distance between the hatch coaming and the machinery at the after end of Number 1 gantry crane, measures approximately 150mm compared to the average distance of approximately 500mm away from the king beam protrusion.

**Photograph 7**  
Clearances between the king beam and the gantry crane machinery

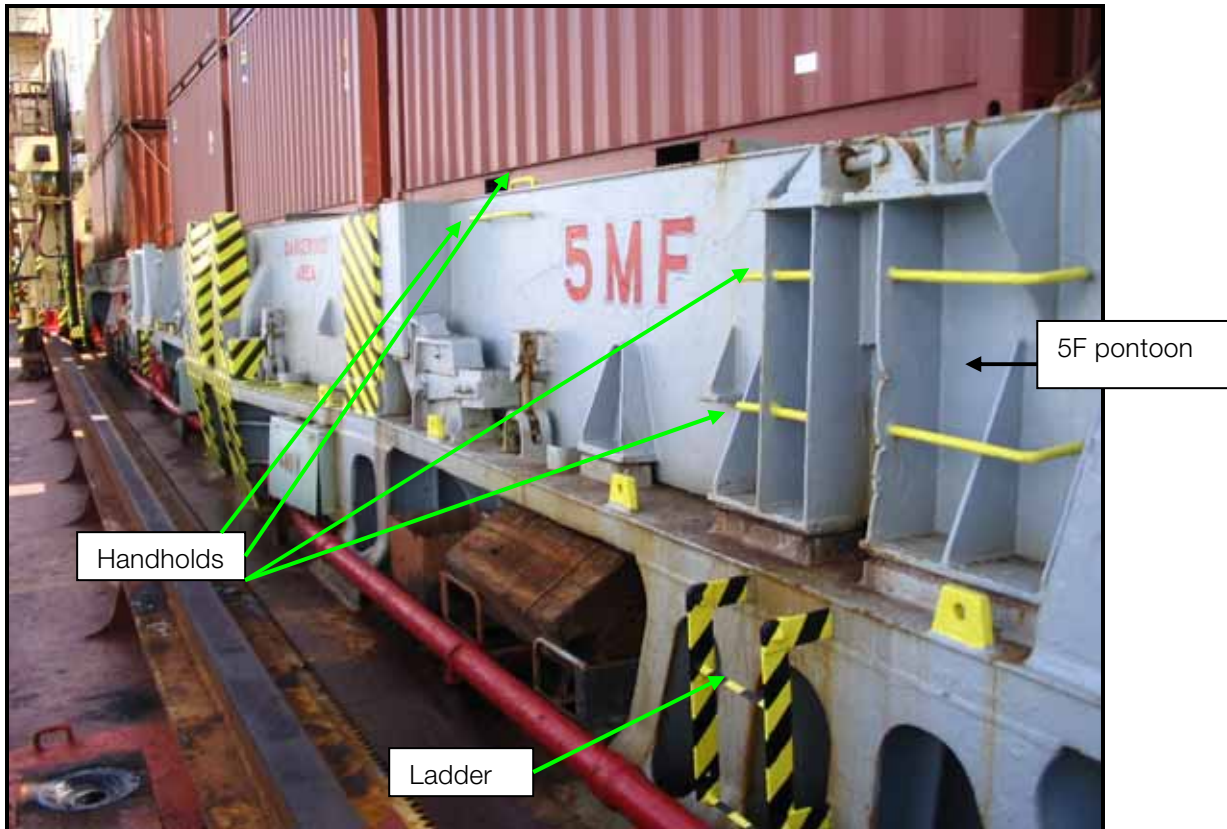
**Photograph 8**

There is a fixed ladder at the forward end of 5MF pontoon. Hand holds are welded to the sides of number 5MF and 5AF pontoons (*See Photograph 8*). These are used to climb on and off the pontoon covers.

The fixed ladder is located at the forward end of number 5MF. When number 5F pontoon is removed, it is unlikely that the ladder would be used to climb down from number 5MF pontoon cover as it would mean getting very close to the open hold. For this reason, it would be safer to use the hand holds further aft.

View of 5MF from forward following repainting that was conducted after the accident.

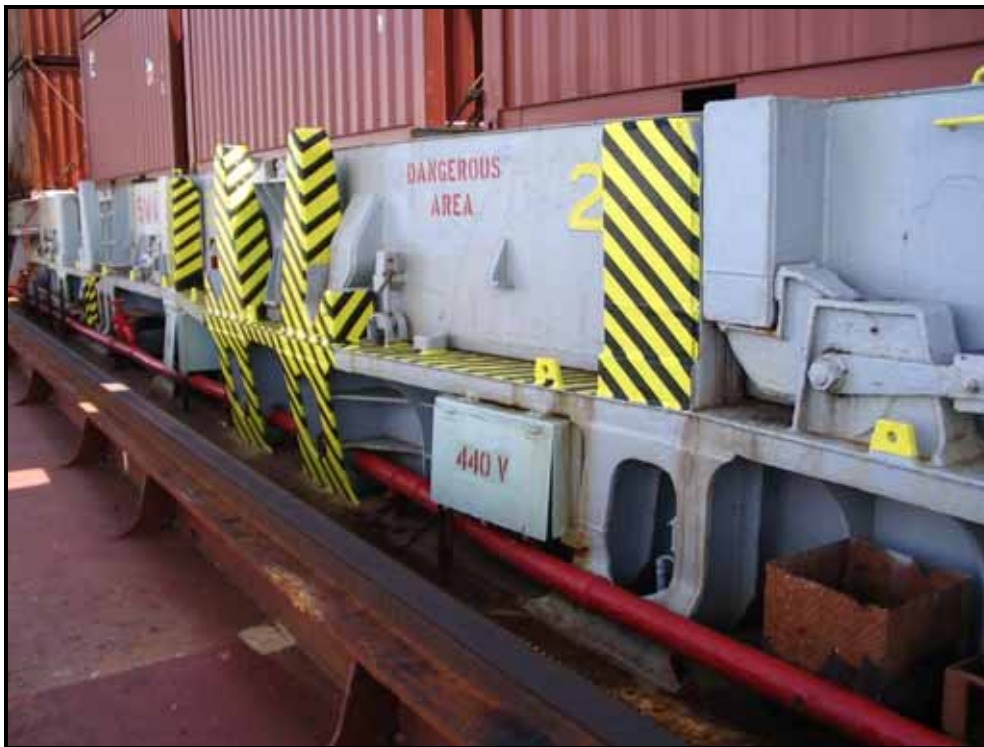
**Photograph 10**

Material and body tissue was found in the main rack teeth on the in board side of the gantry track in the vicinity of the Boatswain's body and of his shoe. A pool of blood was found below the 440v reefer plug box located forward of the extrusion (*See Photograph 10 & Figure 1*).

View of number 5 hatch from starboard forward after repainting corresponding with *Figure 1* below

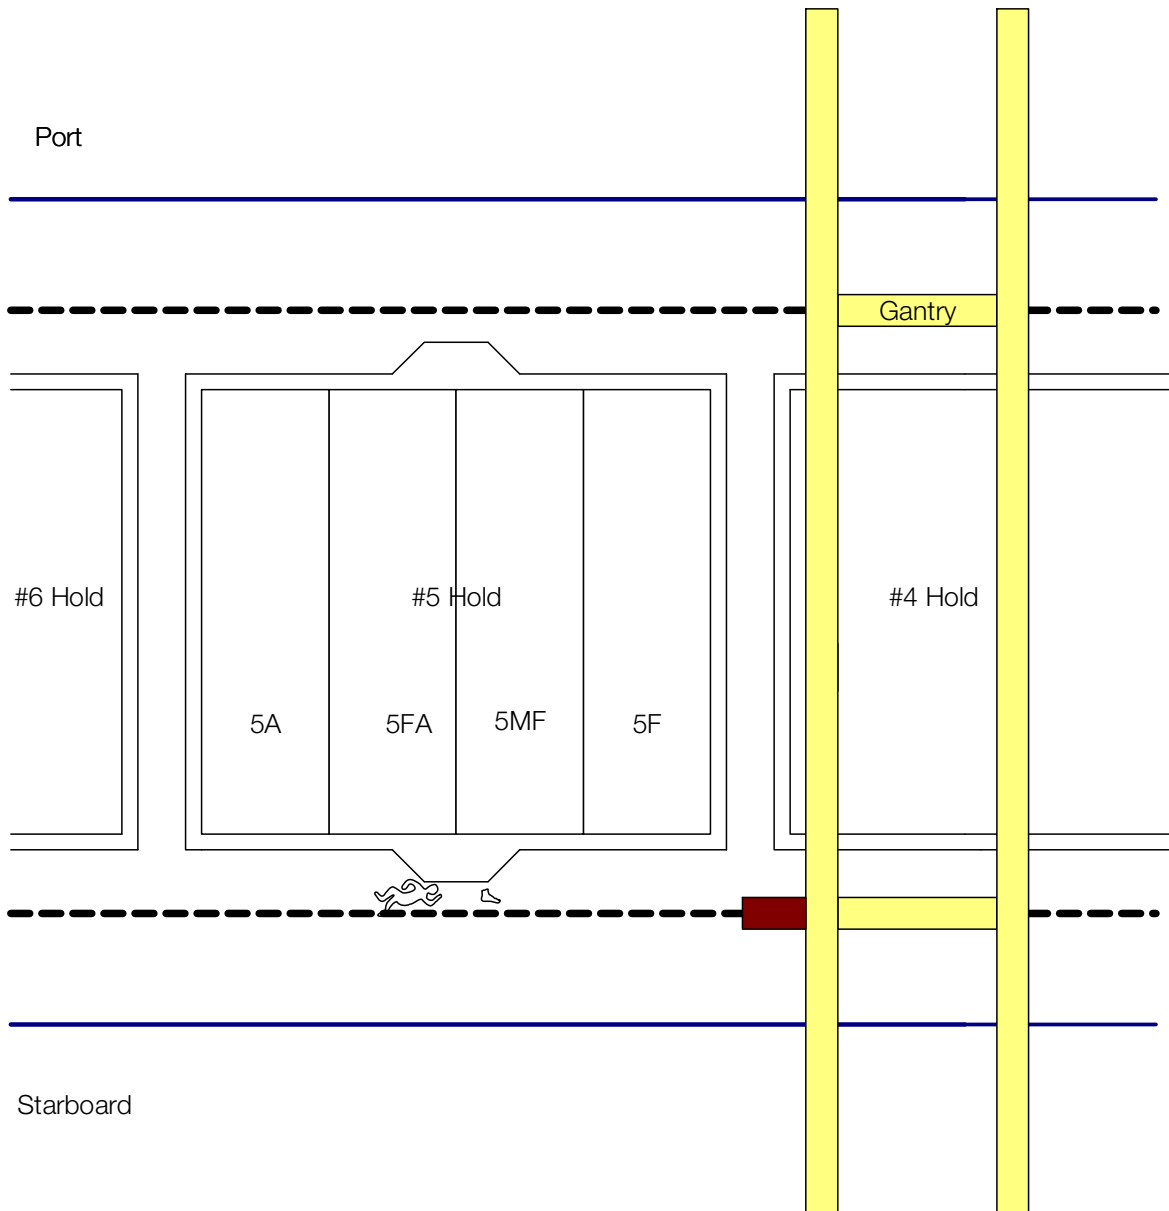
The Boatswain's body was discovered lying on the main deck in a position immediately aft of the king beam protrusion on the starboard side of number 5 hatch. His safety helmet was found on the main deck, approximately 1m aft of his body. His right shoe was found at the forward end of the king beam protrusion. Fragments of material from the Boatswain's overalls were found in the teeth of the timing pinion on the after inboard leg of the Number 1 gantry crane.

**Figure 2**  
Plan view of part of main deck showing location of the accident
