# Accident Report

*Tasnui*

Person Overboard, 70 kilometres  
South of Stewart Island on  
24 January 2004

REPORT NO.: 04 3365

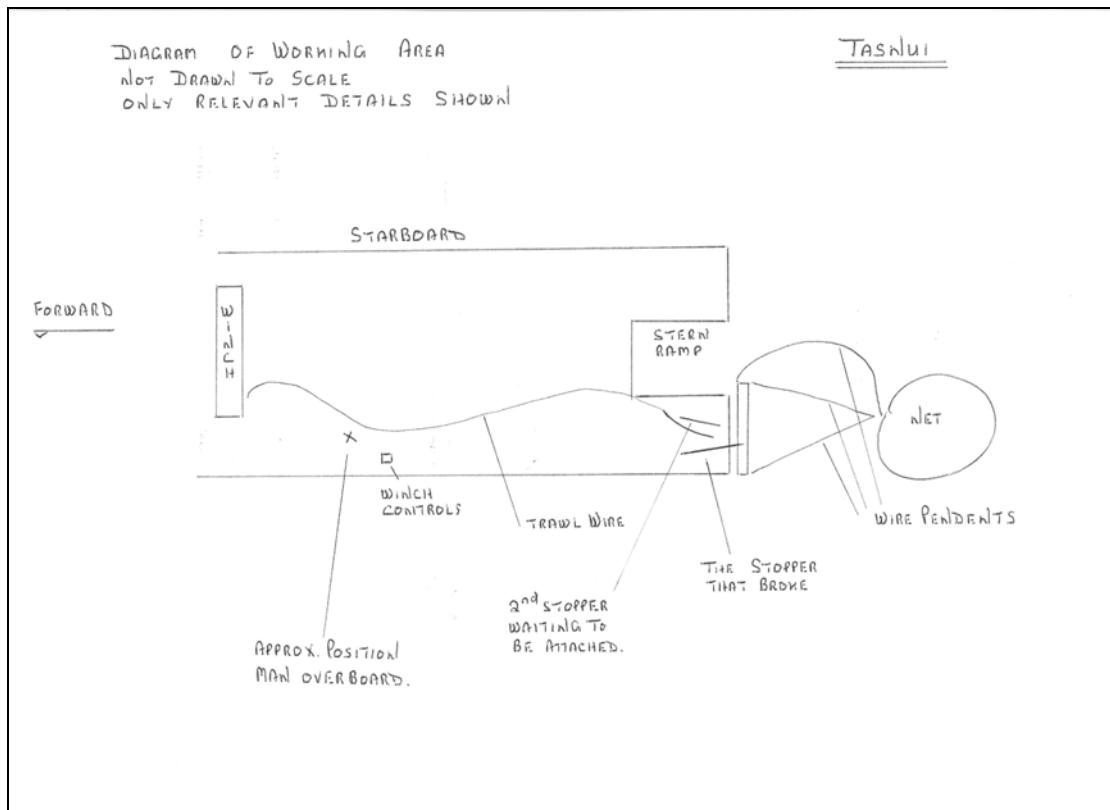
**Diagram 1 – Working Area (not to scale)**  
 See also photograph of the working deck to appreciate how cluttered the working area is

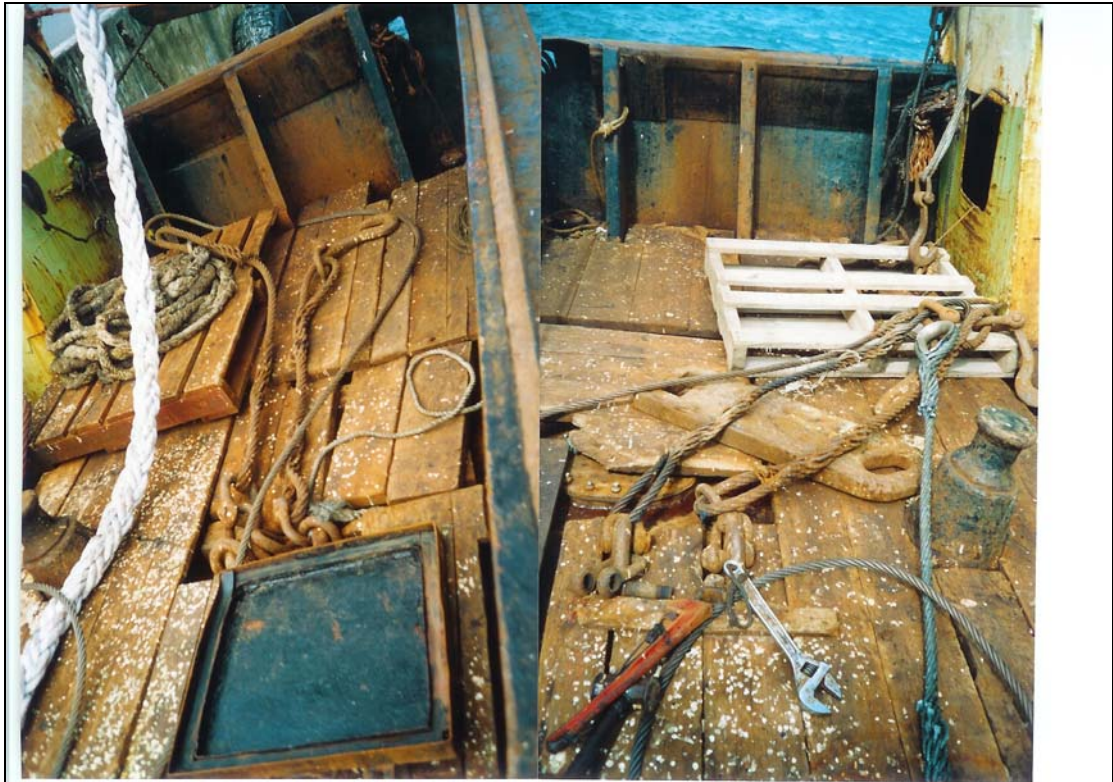
**Top Left** – After deck starboard quarter, starboard stopper wires lying on deck

**Top Right** – After deck port quarter new wire on deck with thimble.

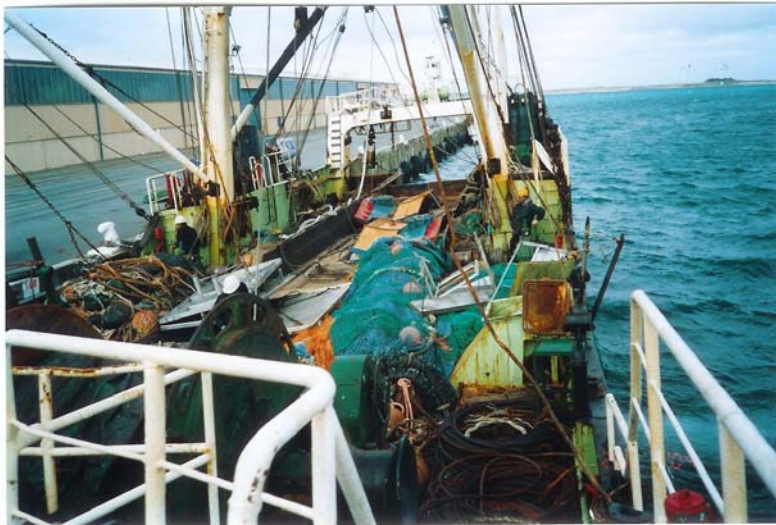
**Lower Photo** – Main working area with various equipment lying everywhere

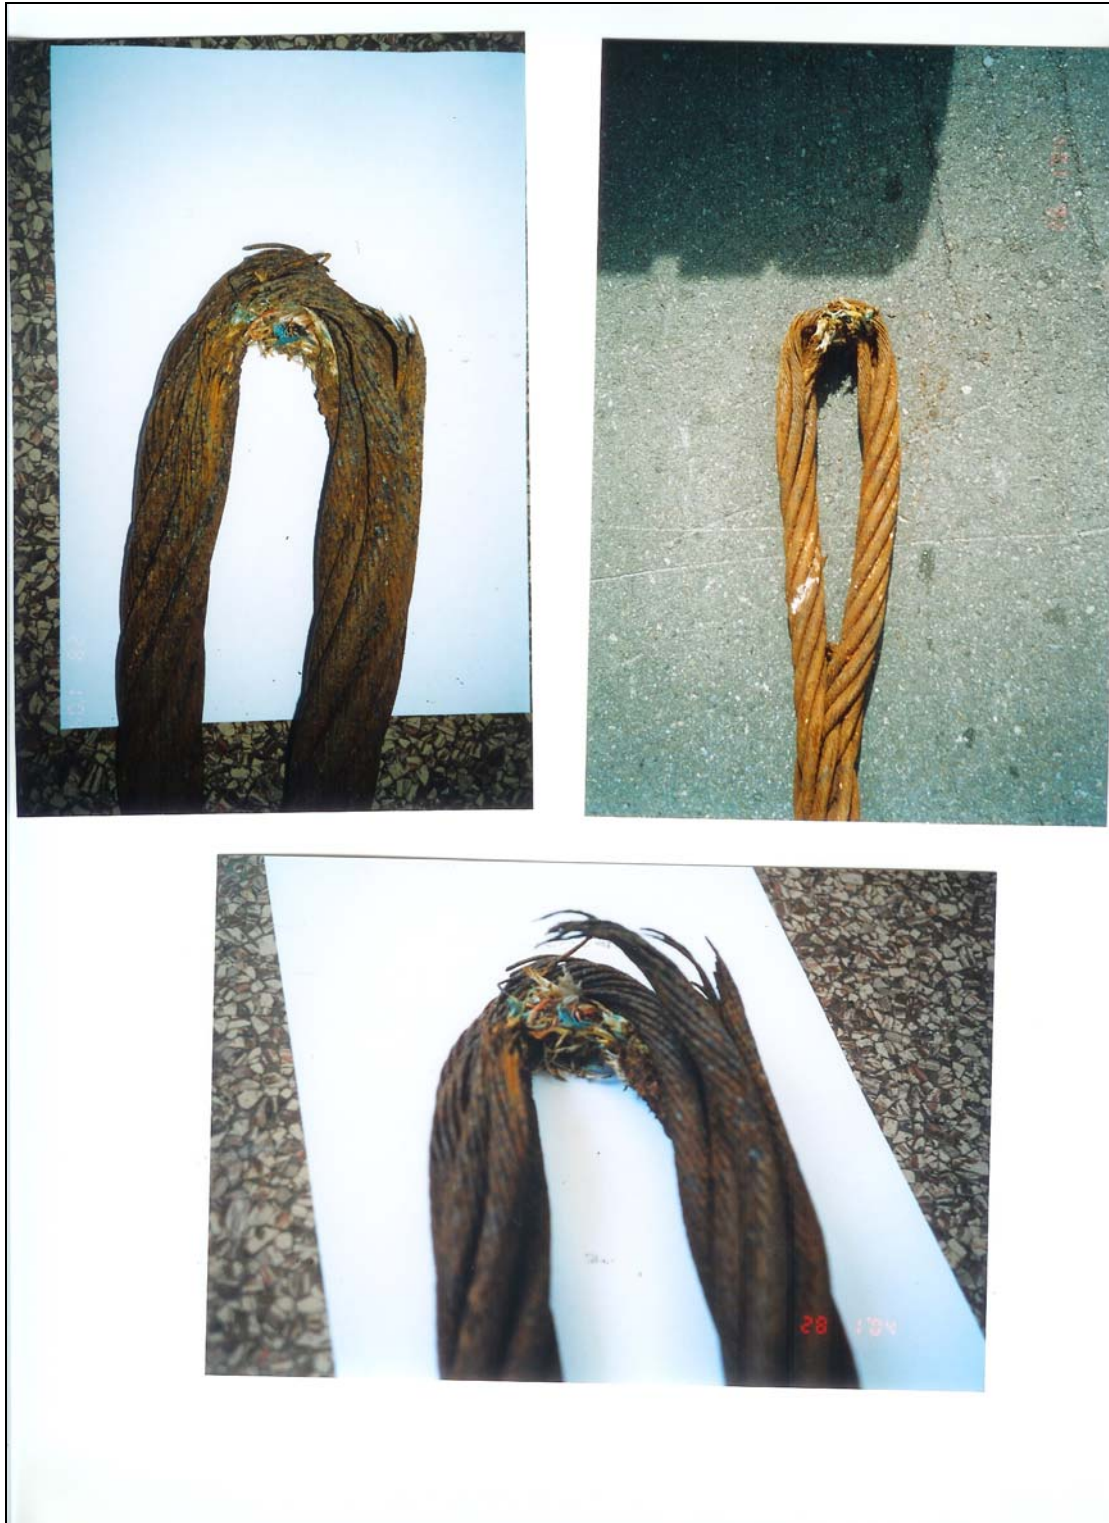
## Appendix 2

- 1.5 At approximately 1745 hours, as the deceased stepped over the trawl wire, the stopper holding the trawl door gave way and the door fell back into the sea. This resulted in the weight coming back onto the trawl wire quickly (See Appendix 2 – Broken wire). The wire tightened and returned to its normal working height above the deck. This sudden change in the wire's position, resulted in flipping the deceased over the side of the trawler.

2.4.2 It was the opinion of the Master that because of the pitching of the vessel, extra weight was put on the stopper wire with the result that it broke.

- No records were maintained about the dates of changing wires.
- There were no company or shipboard procedures when stopper wires should be changed.
- Under Korean Regulations, no records are required to be kept nor are the wires required to have test Certificates.
- The crew would only change stopper wires when they considered they needed changing.
- The stoppers in use had no thimbles in place, thus resulting in extra wear on the eye of the wire.
- On inspection, the stopper wire that parted was found to be very dry and had apparently not been greased for some time.
- There was no evidence to indicate that any other wire on board had been greased recently.
- At their location, at after end of the vessel, the stopper wires are frequently in contact with seawater and hence need regular and proper greasing to maintain their overall condition.

- 3.6 The poor condition of the stopper wire that parted.
- 3.7 The failure to establish and implement procedures to ensure that all wires on the vessel were inspected regularly; were maintained properly and changed at appropriate intervals as soon as any sign of wear and/or tear became evident.

Broken Wire

- a) *Tasnui* and other vessels operated by Sea Jho Cho Ltd, be equipped with a suitable rescue boat with appropriate equipment to include survival suits and lifejackets.
- b) The crew wear suitable P.F.D's when working on deck.
- c) The vessels SSM Manual to be translated into Korean.
- d) That the wires used for stoppers are suitable for the job, have appropriate certificates and that thimbles are used in the eye.
- e) Procedures are to be put in place for regular changing of the wire stoppers and structured maintenance programs are drawn up for this.
- f) Safe working procedures are put in place for fishing operations.
- g) Man over board and search and rescue drills are implemented and documented.
