Investigation Report  
Grounding of *Te Ika*  
17 June 2010

**Maritime New Zealand**

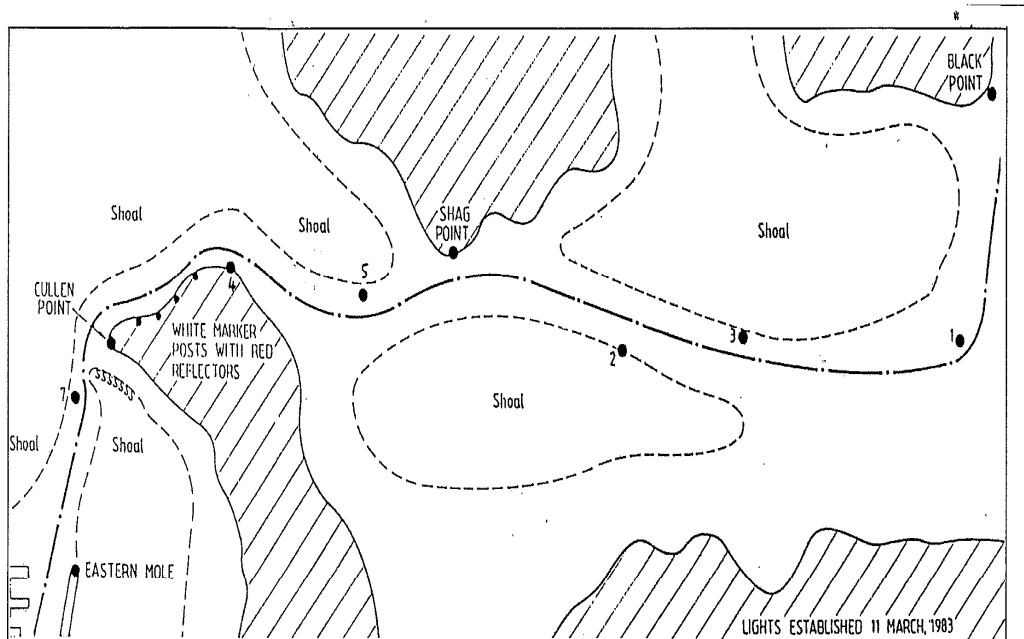
**Figure 5** Chartlet of Havelock approaches

13. The skipper cleared beacon number 5 and headed broadly towards beacon number 2. He said he could see the light of the next beacon through the fog (see figure 5).

- Do not attempt to head DIRECTLY from No. 2 Beacon to No. 5 Beacon, and to be safe your vessel should be within 50 metres adjacent to Shag Point before approaching No. 5 Beacon.

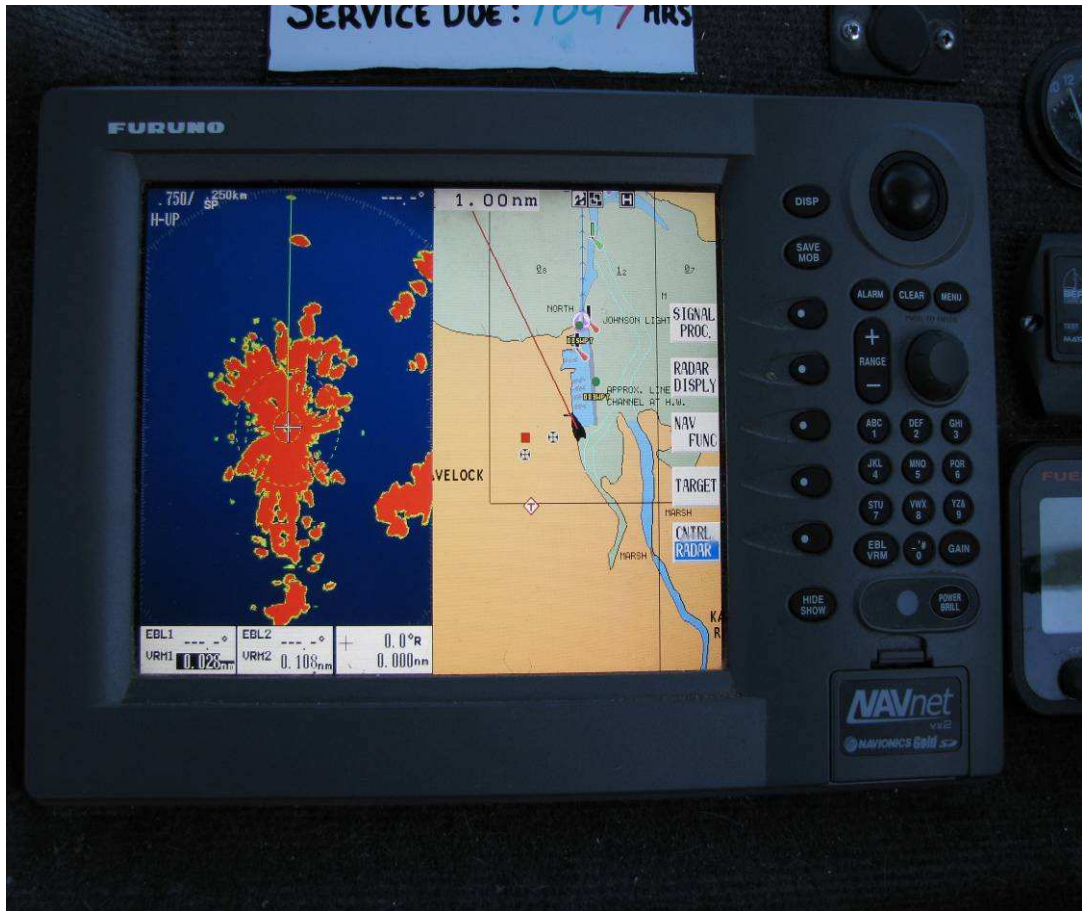
Figure 6 Furuno Navnet in split screen mode

52. The chart-plotting function uses Navtronics Gold© charting software. This receives a GPS signal from the internal receiver which is in-turn displayed in real time on a navigational chart of the area. The skipper confirmed that he thought the position as displayed on the chart was 20 to 30 metres off. He had become aware of this over a period of time although had not made it known to the Seafarms Manager until after the grounding.

59. The RADAR that **Te Ika** is fitted with has an auto tune function. This allows the unit to automatically tune to ensure that a clear picture is presented at all times. The skipper had this function activated at the time of grounding and was not sure how to change this or how to manually tune the RADAR. Operators need to know how to manually tune the RADAR particularly when there is a change in operating conditions such as rain, sea state or visibility. This helps to ensure that the unit is being used at its maximum potential and helps to give the operator confidence that the display is true.
60. The skipper said the following regarding manual tuning during his first interview:
- "...but if I'd had in hindsight if I had been using it on the manual setting and I might have been able to pick up that drying ..."*
