Accident Report

The Gem

Grounding and Foundering at
Taieri Island, Otago on

REPORT NO.: 05 3797

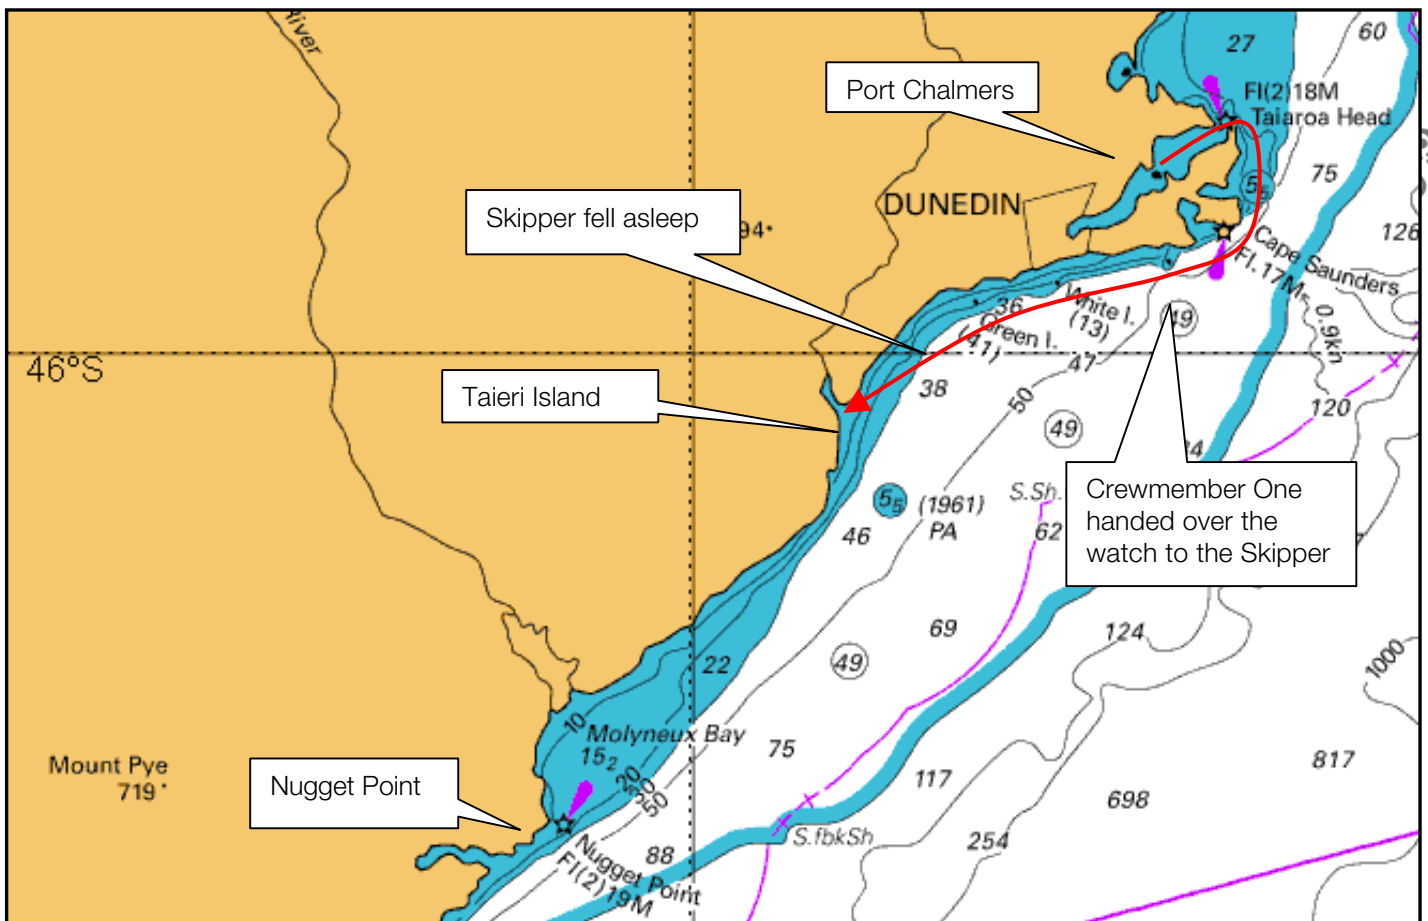
At 0400 hours, they sailed from Port Chalmers (See Figure 1 - Chart 1). The Skipper took *The Gem* out of the harbour. Once they were clear of the entrance to the harbour at Tairaroa Head, the Skipper handed the watch to Crewman A. The Skipper instructed him to wake him once they were south of Toe Rock. The Skipper then went below to try and sleep for an hour. He stated that he thought he may have got about 15 minutes sleep.

The Skipper remembered seeing Taieri Island three miles ahead on the radar (See Figure 1 - Chart 1). The radar was on the six-mile range scale. The next thing he woke up as he heard and felt the vessel ground. He looked at the GPS to check their position and saw that they had grounded on Taieri Island (See Photograph 1).

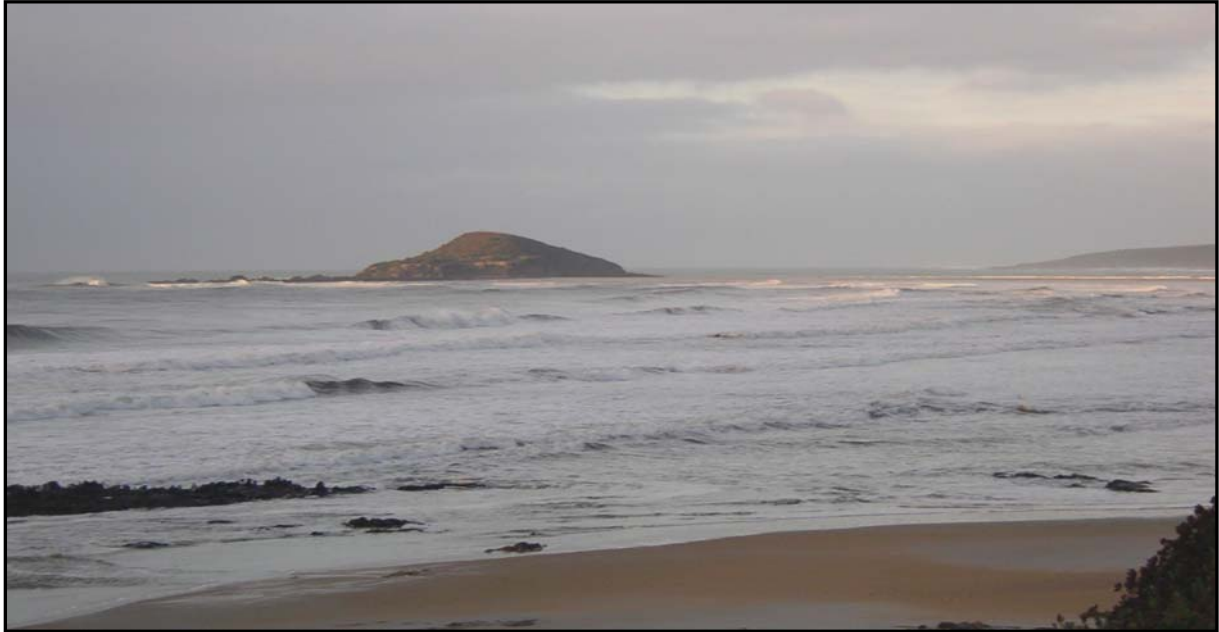
Photograph 1 - Taieri Island. The vessel grounded at the far side of the island

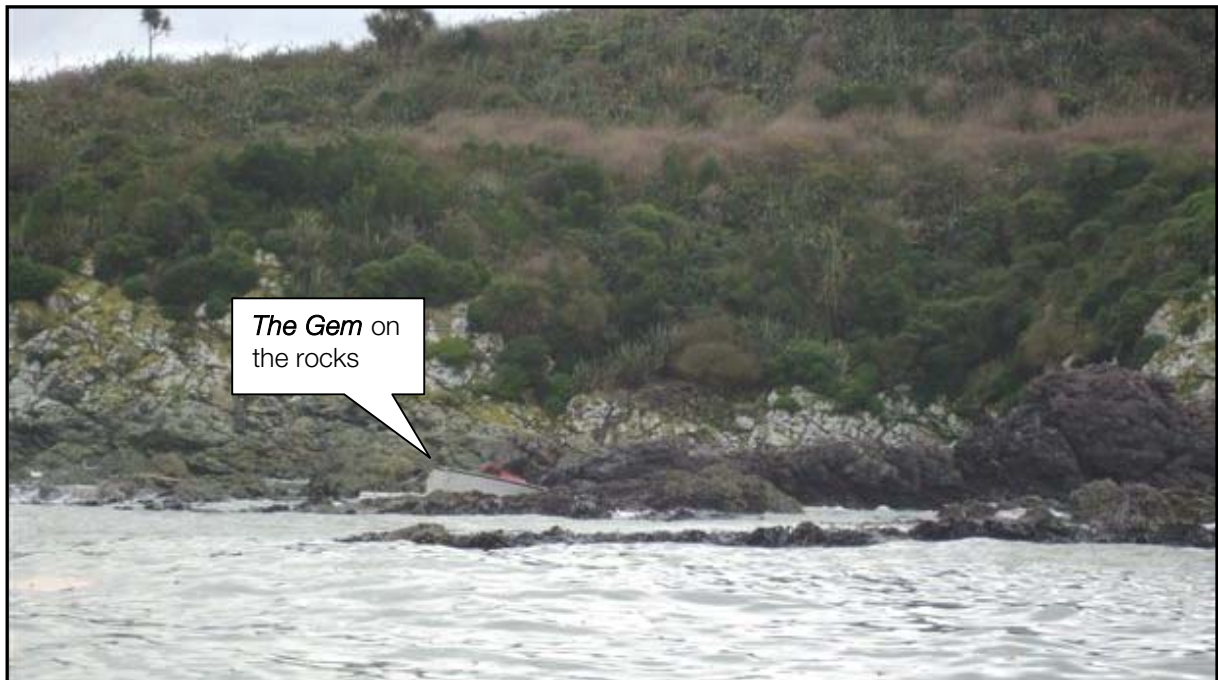
During this time the vessel was taking a pounding from the swell which was lifting it further up onto the rocks (See Photographs 2, 3 & 4). About 30 minutes after the grounding, cracks started appearing in the hull. The crew tried to stem the flow but they could not stop the flooding.

The Skipper reported the accident to Maritime New Zealand as soon as he got ashore. The Dunedin Maritime Safety Inspector attended the scene at about 1200 hours. By the time he arrived *The Gem* had broken up.

Photograph 4 - The rocks that *The Gem* grounded on. Part of the vessel can still be seen.

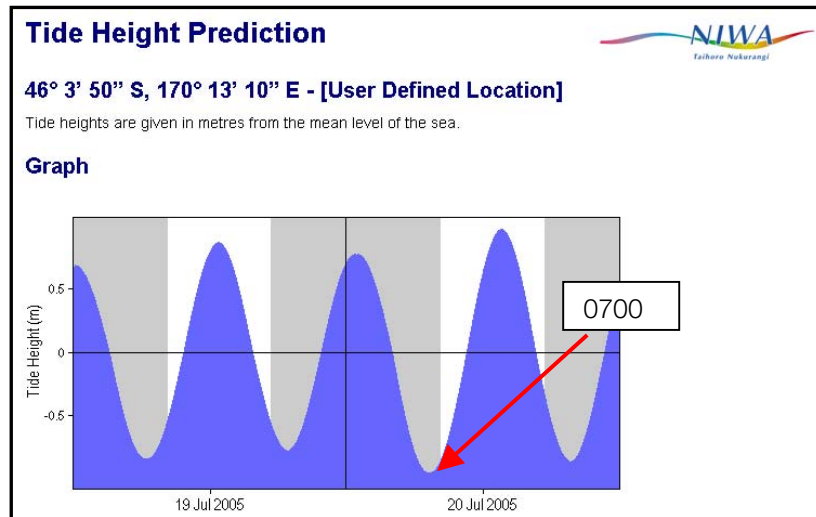
Tidal graph courtesy of the NIWA website

The tides at Taieri Island on Wednesday 20 July were as follows:

20 Jul 2005	00:56	0.78
20 Jul 2005	07:09	-0.94
20 Jul 2005	13:32	0.99
20 Jul 2005	19:46	-0.86
