Class A Accident Report

# Tiger III Grounding

At Cape Brett, on 18 December 2004

<b>REPORT NO:</b>	<b>04 3625</b>
<b>VESSEL NAME:</b>	<b>TIGER III</b>
<b>Ship Type:</b>	Restricted Passenger Ship
<b>Certified Operating Limit:</b>	Inshore: Northland, Auckland, Bay of Plenty.
<b>Port of Registry:</b>	Whangarei
<b>Flag:</b>	New Zealand
<b>IMO/MSA/Official No.:</b>	MSA 875120
<b>Built:</b>	1985
<b>Construction Material:</b>	Aluminium Alloy
<b>Length Overall (m):</b>	20.92
<b>Maximum Breadth (m):</b>	8.70
<b>Gross Tonnage:</b>	181
<b>Net Tonnage:</b>	135
<b>Registered Owner:</b>	Fullers Bay of Islands Ltd.
<b>Ship Operator/Manager:</b>	Fullers Bay of Islands Ltd.
<b>Classification Society/SSM Company:</b>	Maritime Management Services Ltd.
<b>Accident Investigator:</b>	Andrew Hayton

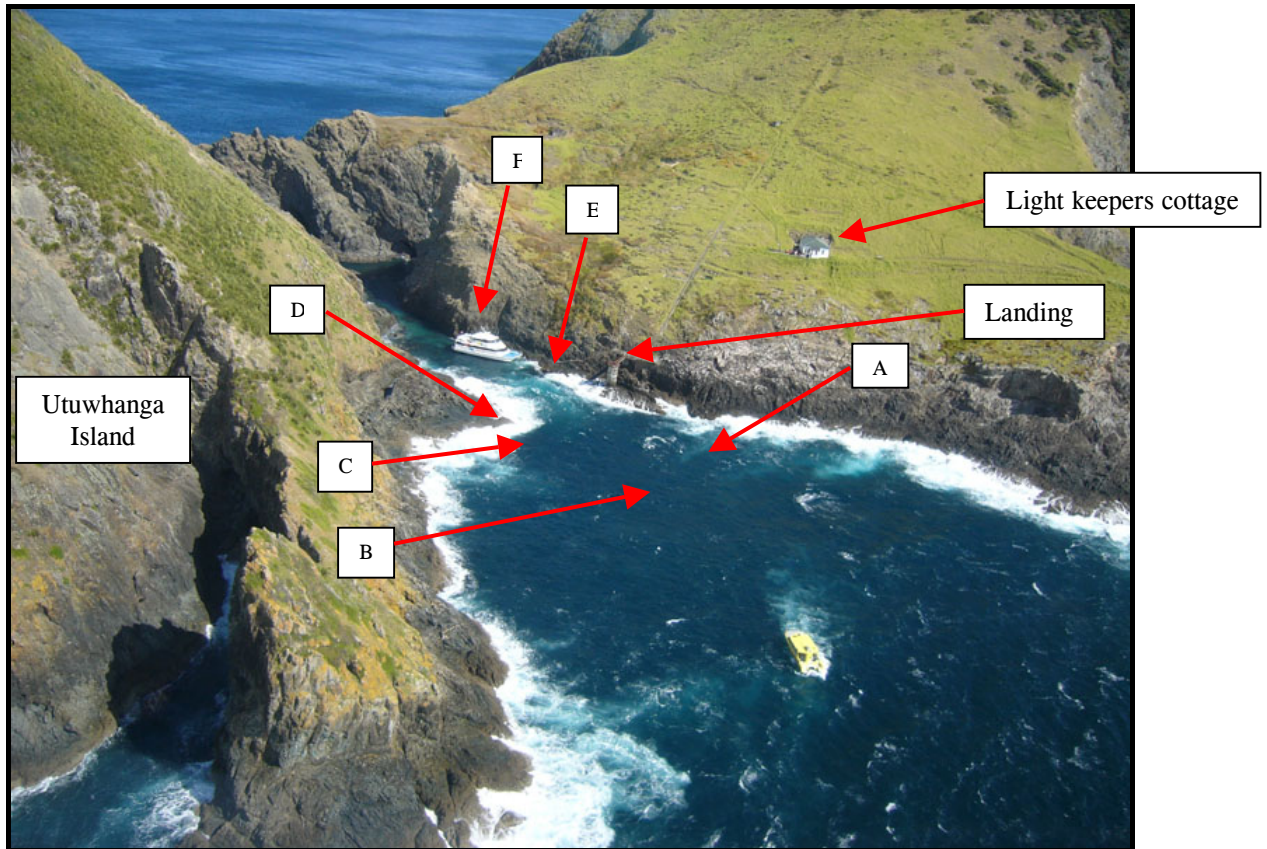
**FIGURE 3. VIEW OF COVE FROM NORTH WEST**  
 (PHOTO COURTESY OF NEST HELICOPTER)

He attempted to take all way off the vessel using the starboard engine. This action screwed the stern of *Tiger III* around to port. The vessel stopped approximately 40 metres from the shore to the west of the landing (See Figure 3 - Position 'A').

The Skipper wanted to try and get the wind on the port quarter of the vessel and by going astern on the starboard engine hoped to be able to keep the wind on the port quarter and 'walk' the vessel astern out of the cove. He put the helm hard to port and went ahead on the starboard engine. The engine was stopped before hitting the rocks on Otuwanga Island and the vessel was set towards the 'Gut' (See Figure 2 & Figure 3 - Position 'C').

The towline was passed from *Dolphin Seeker* and the eye put over a bollard on the starboard bow of *Tiger III*. The towline was then made up on the port quarter of the towing vessel. At about this time, *Tiger III*'s port quarter made contact with the rocks off Otuwhanga Island (See Figure 3 - Position 'D'). Soon afterwards, the towline parted.

*Tiger III* was set towards a position where its port shoulder was close the rocks just to the east of the landing (See Figure 3 - Position E). The swell was pushing the vessel astern and the Skipper saw an opportunity to make the vessel fast alongside a natural rock ledge that was cut into the rock face. The Skipper was concerned that the vessel would be pushed further into the Gut after ripping its port side on the rocks.

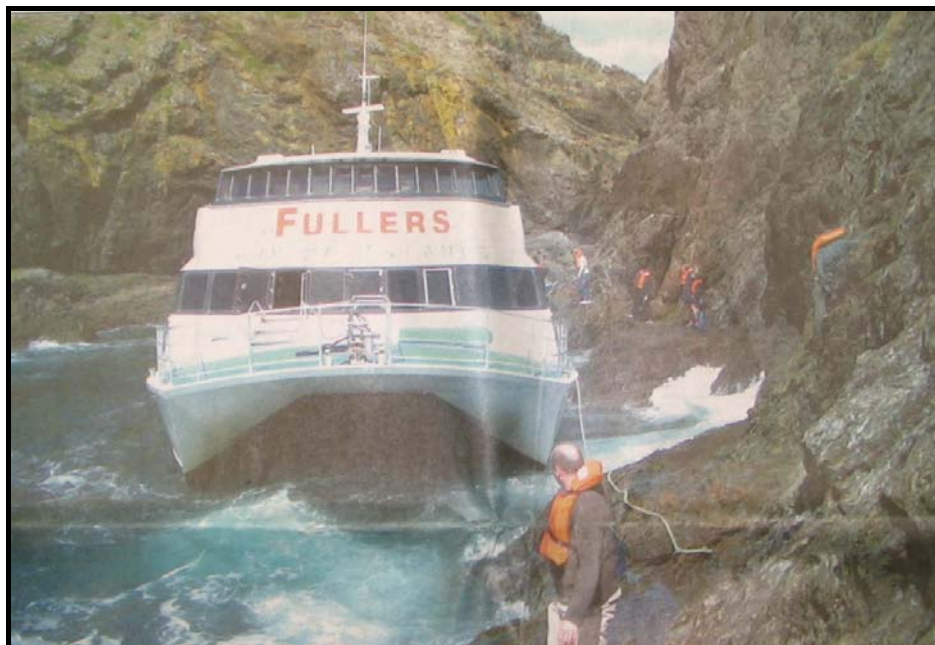
**FIGURE 4 - PASSENGERS ABANDONING *TIGER III***

Once the vessel was secured, the Skipper decided that the passengers should abandon ship. With the Skipper and Deckhand 1 assisting on the vessel and Deckhand 2 assisting on the rocks, all of the passengers were disembarked one by one via the port quarter sea door. During this time, *Tiger III* was surging against the rocks. The passengers had to time their move between the waves and step down onto the vessel's belting and thence onto the rocks.

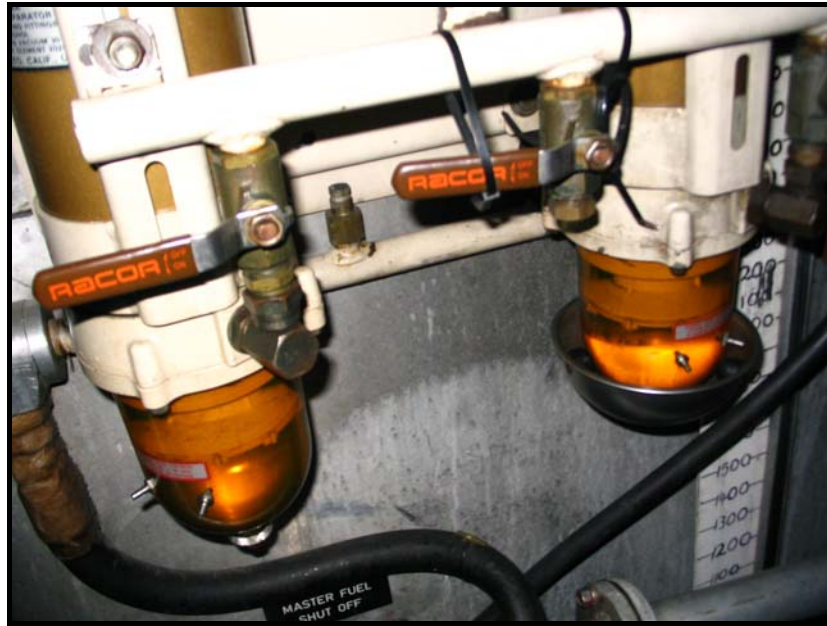
**FIGURE 5 - RACOR FILTERS ON STARBOARD ENGINE.**

There are two Racor fuel filters for each engine. Of these filters, only one is in use at any one time. On the port engine, the Racor filter is the primary filter for the generator as well as the engine. The filters have taps, which can be closed accidentally when checking the forward end of the engine. If closed, the engine would run for approximately 10 minutes before stopping, due to fuel starvation.

When salvaged, water was found in the primary Racor fuel filter. There was also water in the generator's secondary fuel filter. There was some dirt in the filter bulb. On each engine, there was one filter tap in the 'open' position and one in the 'closed' position, thus the tap had not been closed accidentally, shutting off the supply.

Although it is not known exactly what caused the engine to fail, it is suspected that the failure was due to an abnormality in the fuel system. This is due to the fact that both the port engine and the generator failed within a short period of time and the fact that the fuel system was one of the few common links between the two.
