Accident Report

Capsize

Time to Burn

31 August 2008

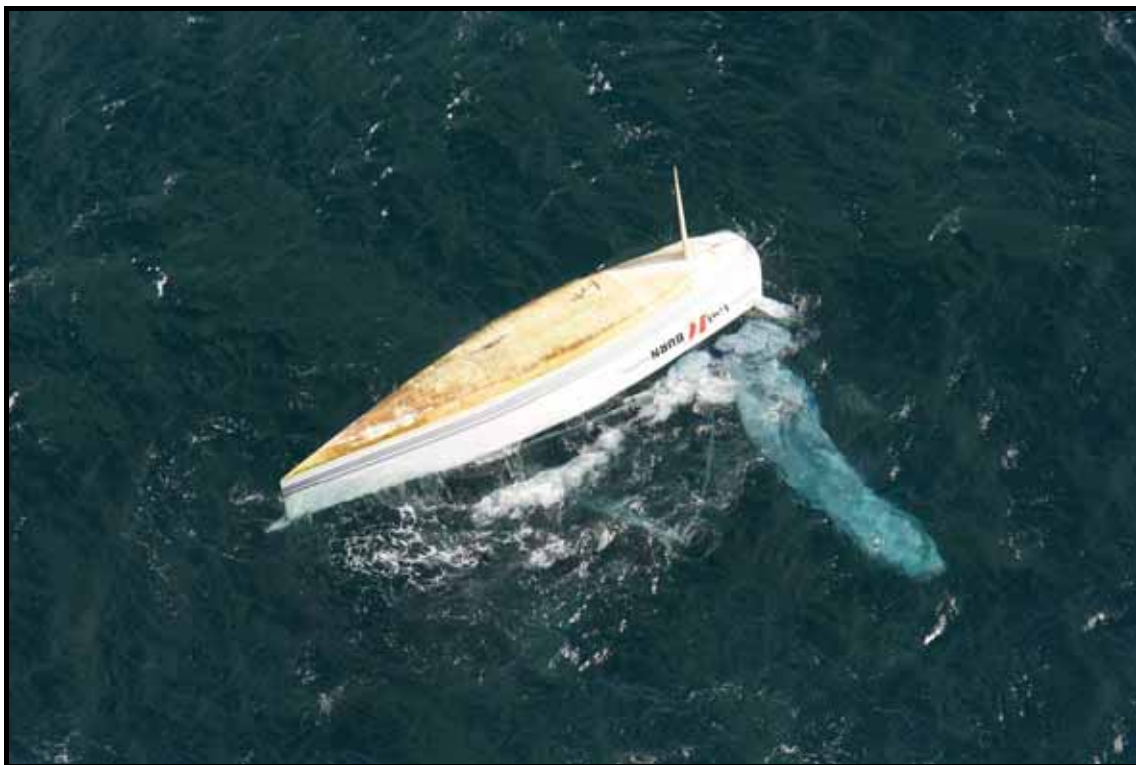
Photograph 2

Time to Burn in a state of capsize after the keel became detached from the vessel's hull.

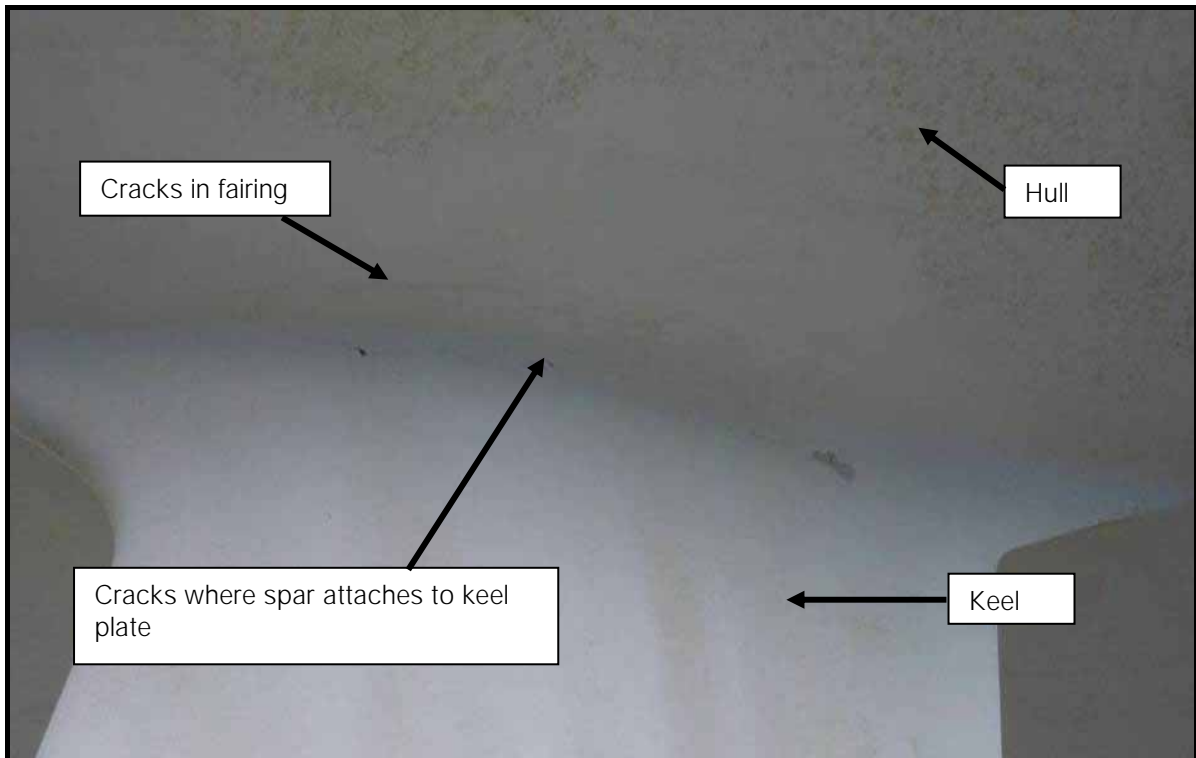
Photograph 4
(Courtesy of Hunter Marine Surveying Ltd) *Time to Burn's* keel showing cracks in the outer fairing after the impact from the whale.

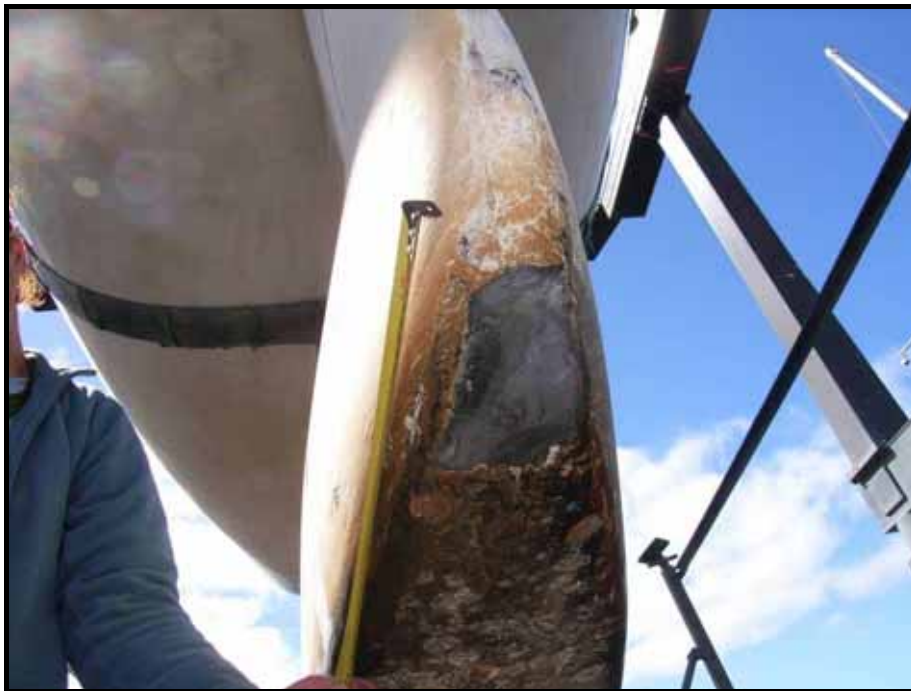
3.18 On this occasion Stevensons again replaced the rudder and repaired the damage to the keel's fairing on the Z keel. (See photograph 5 of damage to the keel.) The fairing was not removed to examine the main structural components of the keel.

Photograph 5
(Courtesy of Hunter Marine Surveying Ltd) Damage to the lower keel.

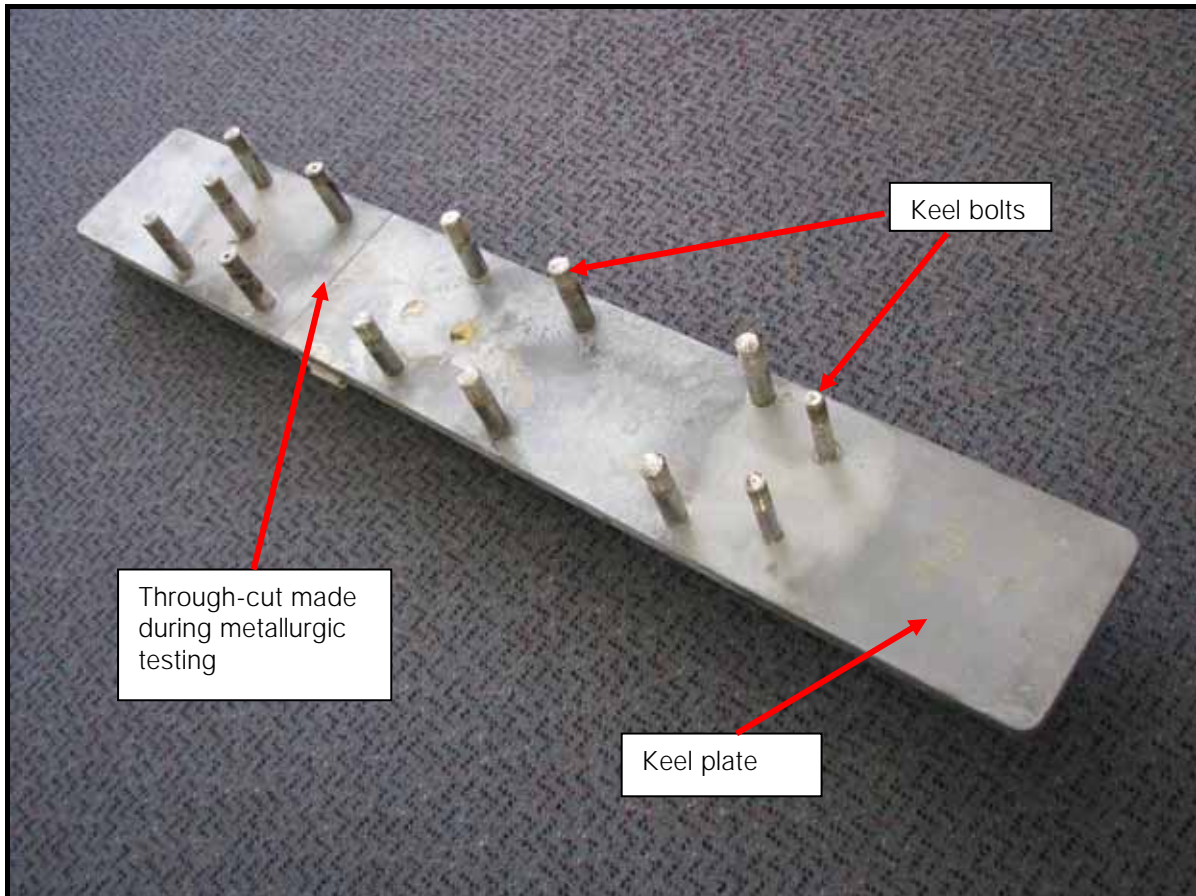
Photograph 6
Upper-section of keel plate.

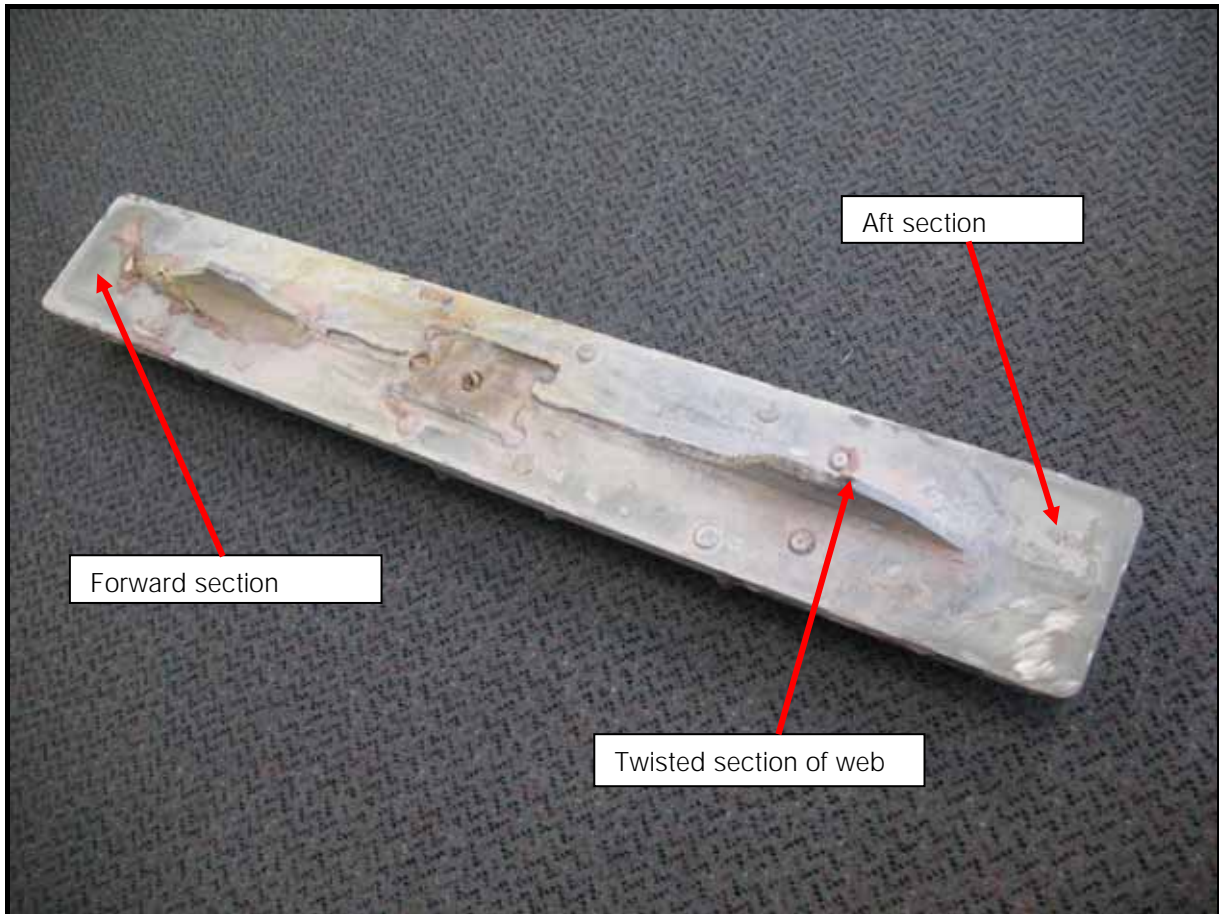
Photograph 7
Under-section of keel plate.

- 3.46 The remaining section of web on the keel plate has been twisted. (See photograph 7.) This indicates it may have been the last section to fail. The reduction in speed described by the survivor may well have been caused by the failure of the forward section of weld, allowing the keel to twist sideways (most likely to port, as indicated by the angle of twist in the remaining aft section of web). This would have caused the vessel to slow down as described until the aft section tore through under the pressure. Once this occurred, the stability of *Time to Burn* was compromised and resulted in its eventual capsizing.

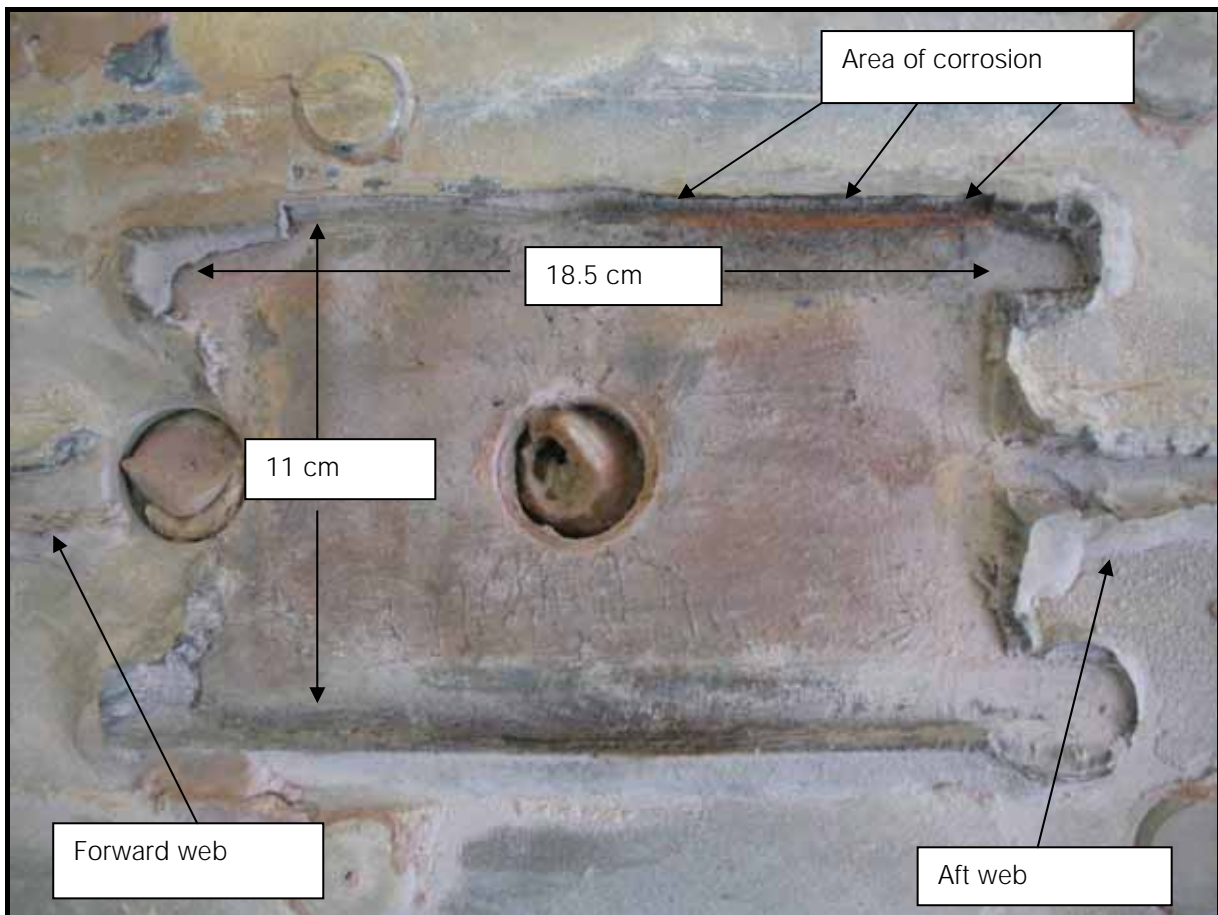
Photograph 8

- 3.43 When first viewed, the section of the weld on the port side of the rectangular hollow RHS spar where it attached to the keel plate showed signs of corrosion that suggested a section of weld may have been compromised prior to the capsizing. (See photograph 8 of failed section of keel plate.)

The weld failure where the spar was welded to the keel plate.

- 3.44 In the opinion of the MNZ investigator, it is not unreasonable to speculate that the weld failure may have started with the collision with the whale in 2006.

- 3.45 With one section of the weld compromised this may have caused additional pressure on other sections of weld. As a result, latent incremental degradation of the remaining intact sections of weld occurred causing the spar section to detach from the keel plate.

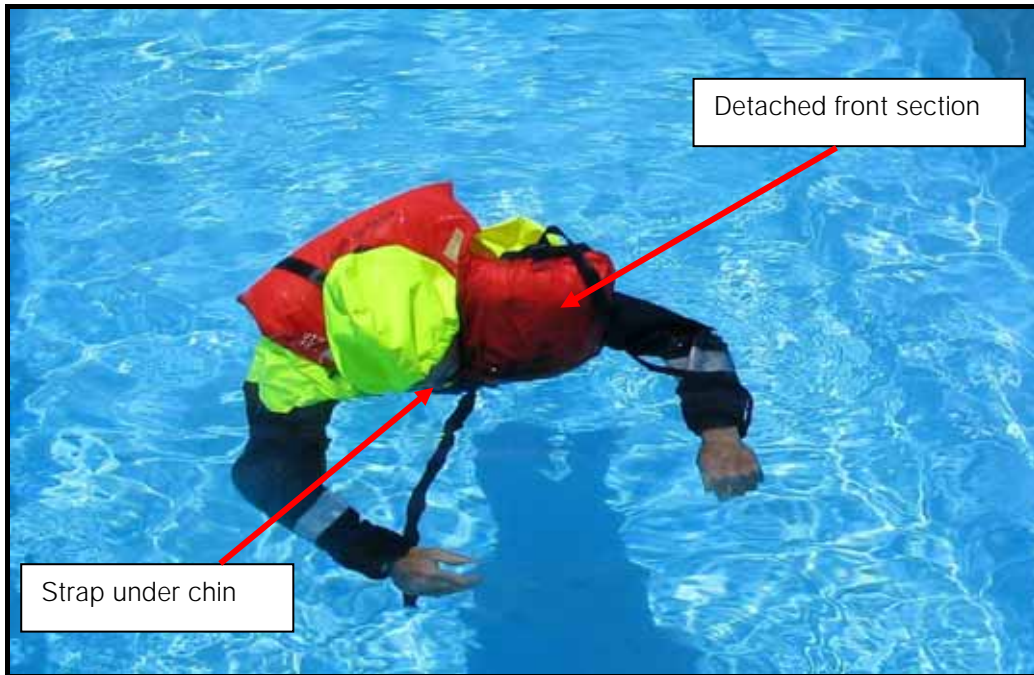
Photograph 9

- 3.69 The same test was conducted with the jacket incorrectly fastened. It was found that the front section came loose from the chest with the strap going under the wearer's chin. The wearer remained face down in the water allowing the airways to be submerged under the water. (Photograph 9 shows an MNZ investigator testing an incorrectly fastened lifejacket.)

Salt water trial of incorrectly fitted lifejacket.

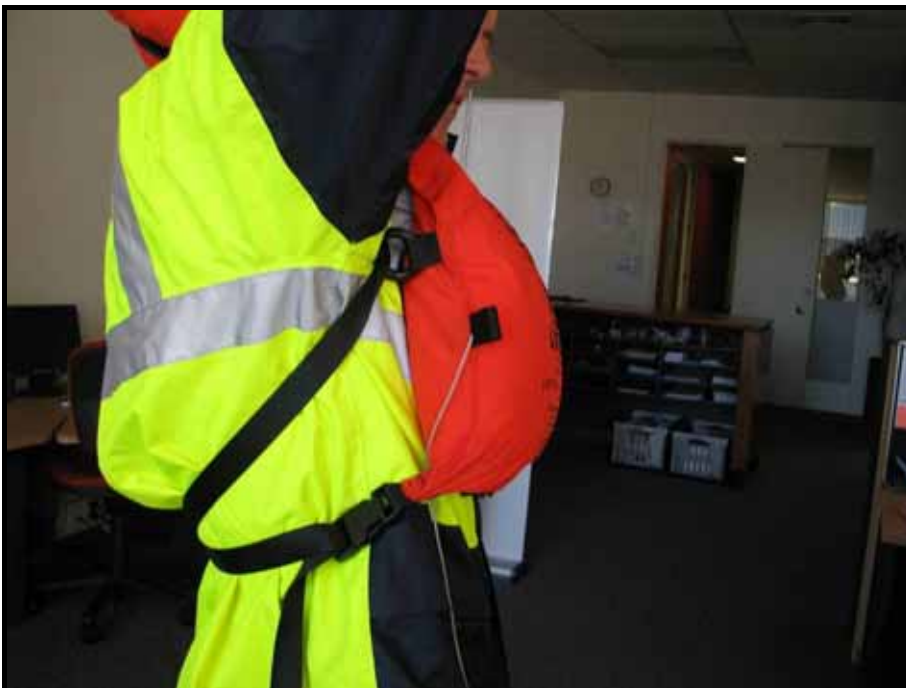
- 3.74 The survivor also commented that the skipper may have donned his lifejacket incorrectly with the front section of the jacket toward his chest. If this was the case this may have caused the skipper to floated face down after losing consciousness.

Photograph 11
Incorrectly fitted lifejacket.
