Class B Accident Report

Tokerau & Kawau Kat
Collision

At Auckland on 11 December 2004

REPORT NO: 04 3624

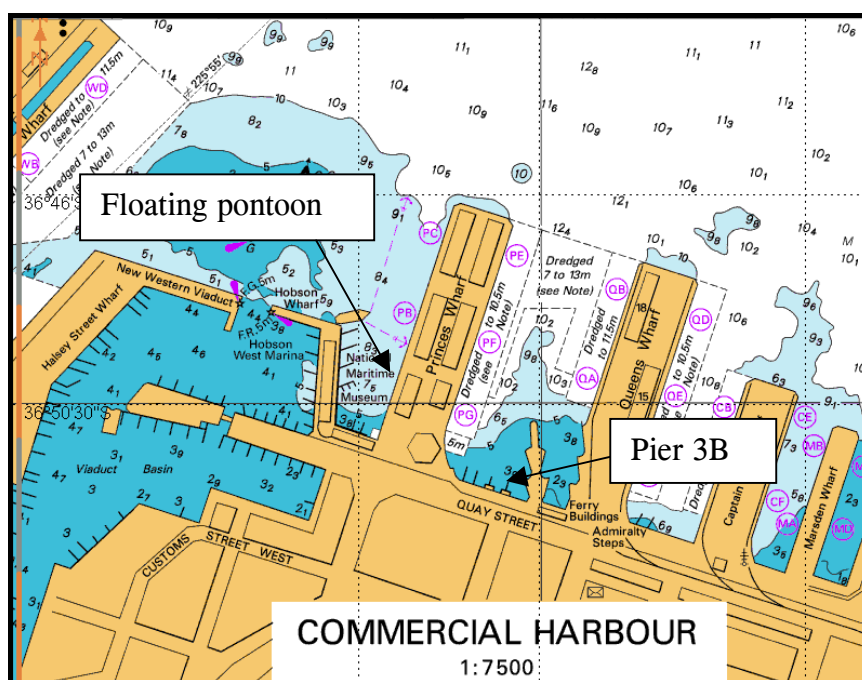
FIGURE 1

On Saturday 11 December 2004, at approximately 1640 hours NZDT (New Zealand Daylight Time), *Tokerau* departed Bayswater marina. It proceeded across Waitemata Harbour towards the Auckland Ferry Terminal. After some difficulty manoeuvring, due to the wind conditions, it berthed port side alongside to the western face of Pier 3B (See Figure 1). The vessel was longer than the floating pontoon and its stern overhung the pontoon. The vessel was made fast with a spring line forward and a spring line aft.
