Accident Report
Tray Line & Norma
Collision North of Puretua
Peninsula on 19 March 2005
Accident Report

NARRATIVE

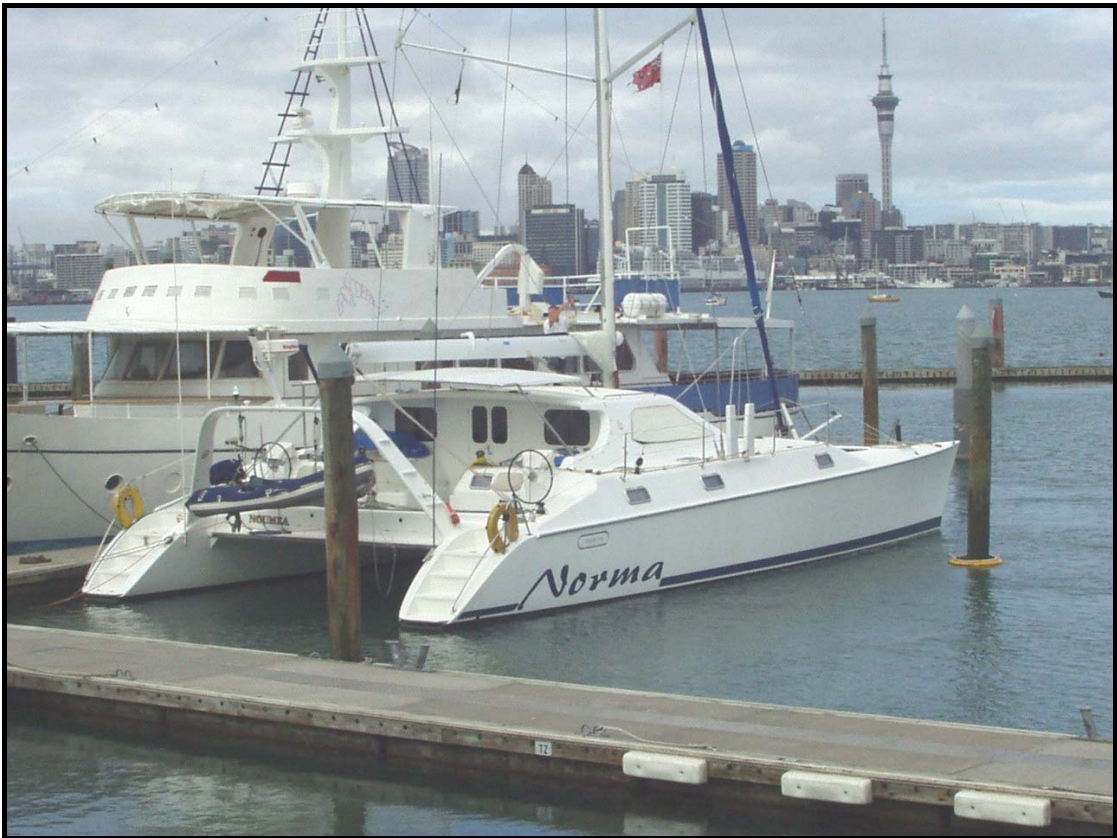
Tray Line suffered a 20 cm hole through her hull 30 cm above water level. **Norma** sustained damage to her bowsprit.
