Accident Report

# Trident

## Serious Injury

**REPORT NO. 96 293**

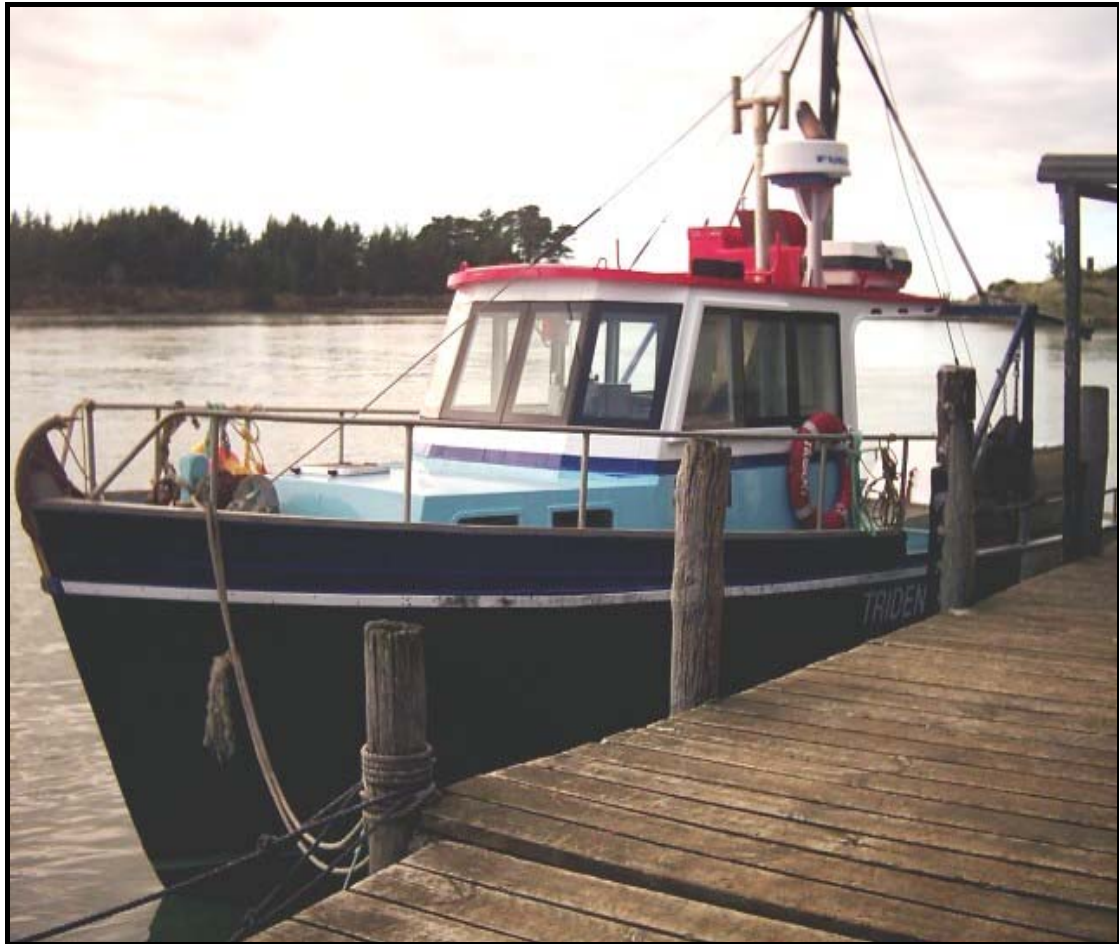
**APPENDIX 1**  
PHOTO OF *TRIDENT*

- 2.1 *Trident* (See Appendix 1 – Photograph) is a wooden hull fishing boat, built in 1978 by R D Scotts of Invercargill. She is used for trawling and cray fishing out of Riverton, Southland.

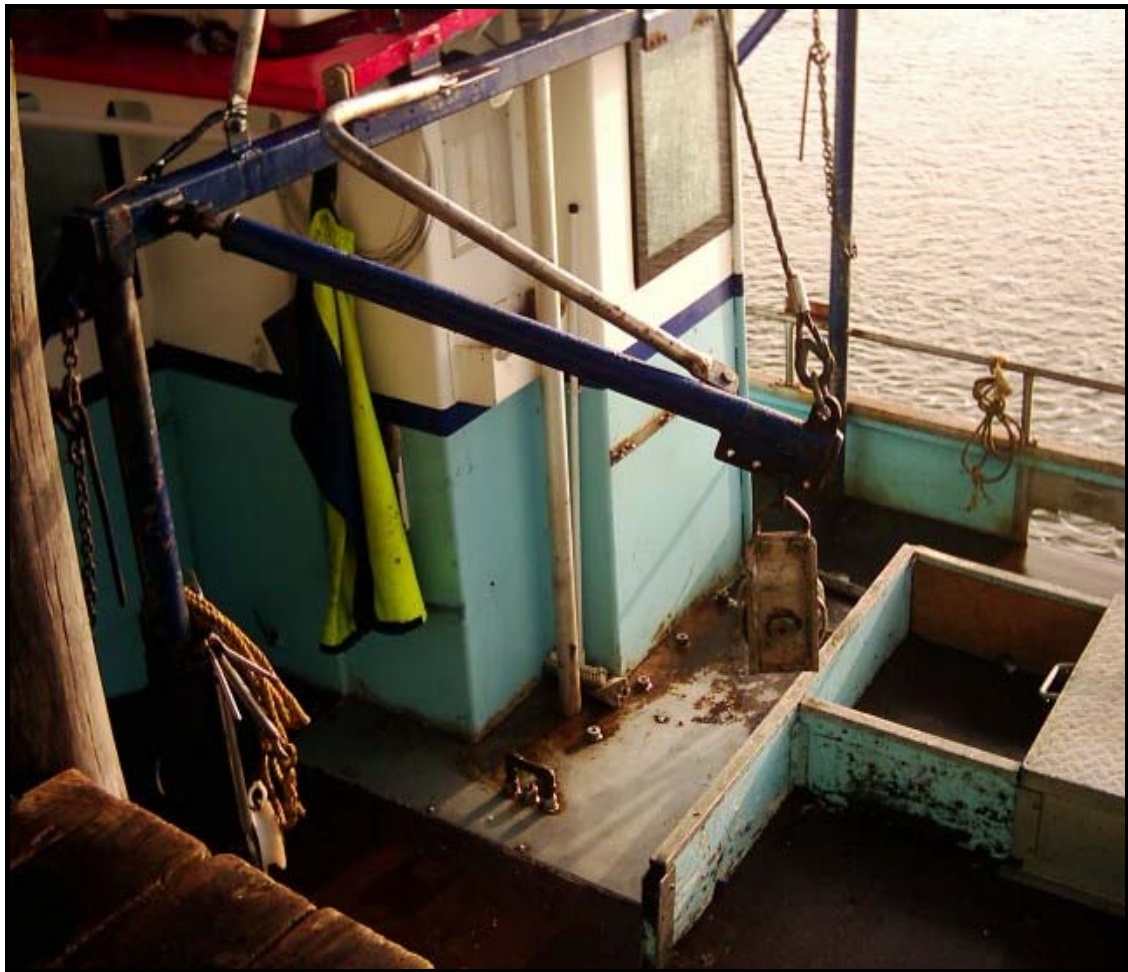
**APPENDIX 2**  
PHOTO

- 3.2** The support stay was of a smaller diameter to that which it had replaced and was not as strong (*See Appendix 2 – Photograph*). In commenting on the draft report, the owners stated that the support stay was replaced by one of the same diameter, but made of heavy walled stainless steel. The previous one was made of mild steel.

- 4.1** The cause would appear to be due to excessive weight coming from the boom and associated equipment onto the stay causing the stay to be overloaded and subsequently giving way.
- 4.2** The exact cause of the increase in weight cannot be determined exactly. However, it is reasonable to assume that it may have been caused by a combination of the pot being fouled on the seabed, the boat riding to the top of a wave and possibly falling back from her position (the pot hauling line was leading slightly forward at the time of the accident) while still on the top of a wave and the vessel taking a roll to port or starboard. This sudden increase in weight then transferred onto the stay, which bent before the relief valve on the hydraulic system could come into play.

- 5.4** It is recommended that the Owners ensure the replacement support stay is of the same or similar construction and strength as the boom. In commenting on the draft report, the owners advised that this recommendation has been carried out.
