Summary Report

Grounding

Twofold Bay

20 July 2006

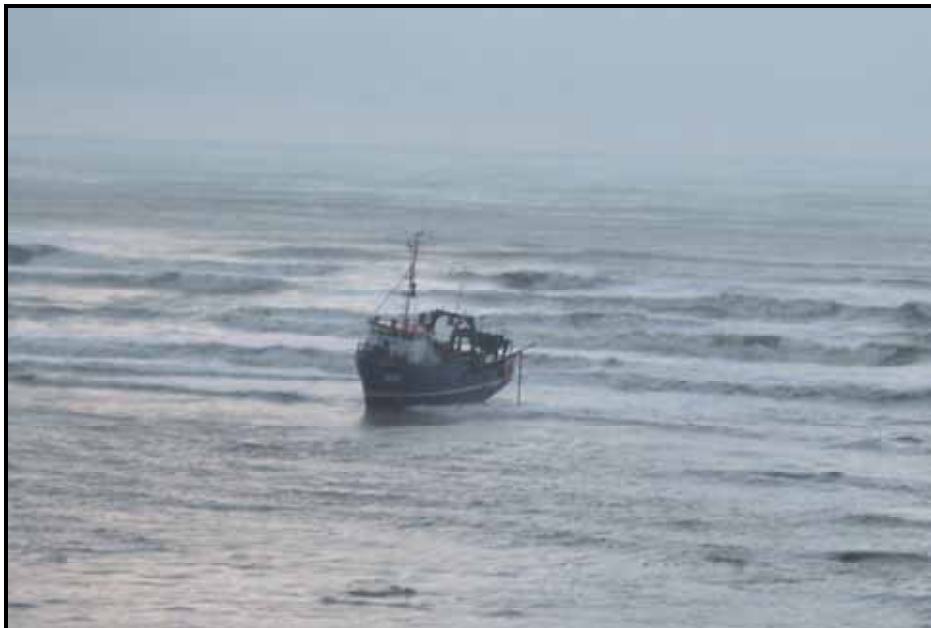
Photograph 1
Twofold Bay aground

The vessel suffered damage to a hull mounted transducer.

The accident occurred because an unsatisfactory anchor watch was being maintained by the Skipper. The Skipper spent too long in the engine room without returning to the wheelhouse to check the vessel was safe. The Skipper acknowledges that he was away from the wheelhouse for too long a period and will ensure that, in future, if he is required to leave the wheelhouse for extended periods, that a deckhand will be tasked with maintaining an anchor watch in the wheelhouse.

The Investigator suspects that the reason for dragging is that the anchor did not 'bed in' when dropped. The upper side of the anchor had scratches on it which could have occurred if the anchor had been dragged 'upside down' along the bottom.
