Accident Report
La Mer & Universal Spirit
Close Quarters Situation, 7 miles
north east of Napier on
20 November 2004
Class B

REPORT NO.: 04 3612

LA MER & UNIVERSAL SPIRIT – CLOSE QUARTERS

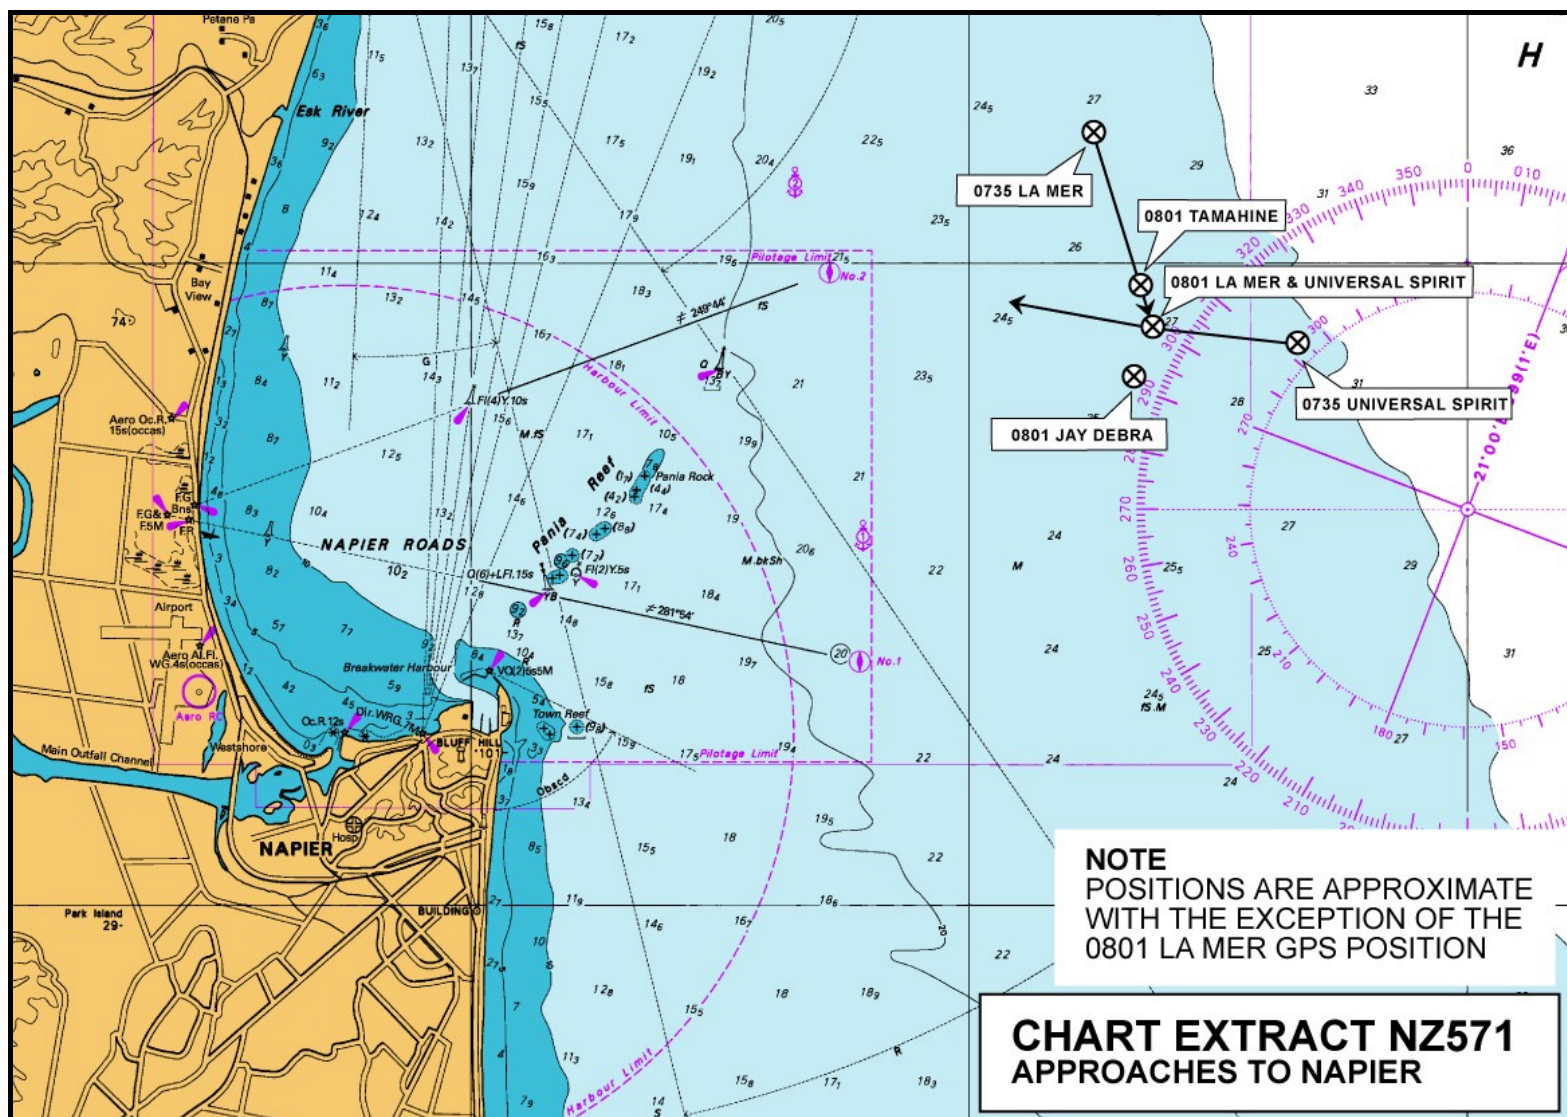
La Mer was trawling on a course of 140°(M), (161°(T)) about seven miles north east of Napier. At about 0730 hours the Skipper observed ***Universal Spirit*** to be lying stopped some 1½ - 2 miles distant on their port bow. ***La Mer*** was on the starboard quarter of ***Universal Spirit*** and she was showing the day shapes for a trawler.

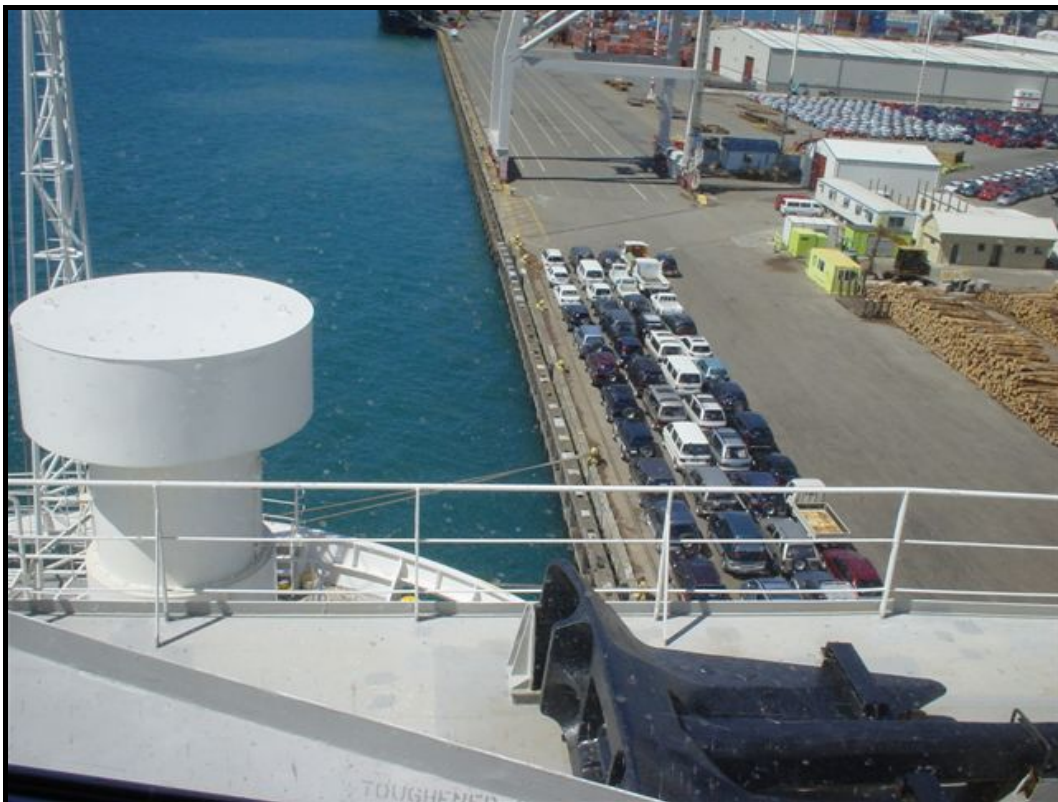
View from Starboard Wheelhouse Window of *Universal Spirit*

La Mer, which was on *Universal Spirit's* starboard quarter, whilst *Universal Spirit* was lying stopped, was now a little forward of her starboard beam, and quite close. Because of the height of *Universal Spirit's* bridge; the bridge wings extending to the ship's side well beyond the wheelhouse, and the deck below the wheelhouse extending well forward and out to the ship's side; a large area of sea on the starboard side of the vessel would not be visible from within the wheelhouse. Neither the Master nor either of the Officers went to the extremity of the starboard bridge wing to check for vessels close to the ship. Consequently, in the opinion of the Investigator, neither the Master nor either of the Officers saw *La Mer*.

Because of the height of the radar scanner, it is probable that *La Mer* was so close that she was beneath the radar transmissions, and consequently was not painting an echo on the radar screen monitored by the Third Officer.

1. The Management Company of *Universal Spirit* make this report available to the Masters and Officers of all vessels under their management.
2. The Management Company of *Universal Spirit* remind Masters and Officers of all vessels under their management of the importance of keeping an all round lookout. On high-sided vessels this requires searching the sea in the vessel's immediate vicinity from the extremity of the vessel's bridge wings. This is particularly important when manoeuvring in port approaches, where small vessels are to be expected.

3. The Maritime Safety Authority issue a Marine Notice (Ships) reminding mariners of the importance of keeping an all round lookout. On high-sided vessels this requires searching the sea in the vessel's immediate vicinity from the extremity of the vessel's bridge wings. This is particularly important when manoeuvring in port approaches, where small vessels are to be expected.
