Accident Report
Fatality
Unnamed Canadian Canoe
23 May 2008

Maritime New Zealand

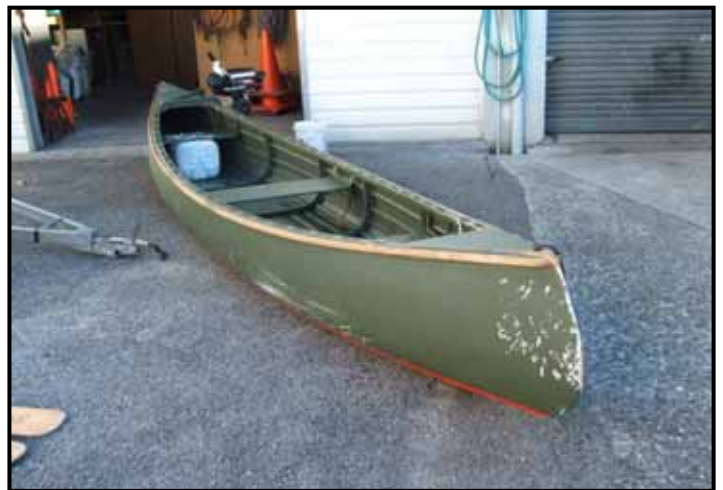
Figure 2
Canadian Canoe involved in this accident

- 1.7 The canoe itself was in good condition with no discovered faults or damage that may have contributed to this accident. Communications were poor in the region making standard equipment such as a cell phone or VHF radio redundant. If an Emergency Position-Indicating Radio Beacon (EPIRB) or personal locator beacon (PLB) had been carried and activated, Search and Rescue (SAR) may have been alerted sooner. If emergency flares had been carried and set off, they may have assisted an earlier response.

- 2.4 However, where the stern is not flat, mounting the engine on a bracket so that it sits to one side of the hull, as it was in this case, is also an acceptable method. The main consideration with this arrangement is that the load, usually comprising the passengers and their equipment, may have to be distributed to compensate for the off-set engine.

- 2.5 Another issue with mounting an engine on a canoe is that the extra weight may tend to lift the bow, presenting a greater surface area of hull to any cross winds, increasing the risk of capsizing. In this case the outboard motor only weighed 12kg and it does not appear to have been a contributing factor. That problem is normally offset in the same way as above – by repositioning the load so that the hull is correctly positioned in the water. Investigations conclude that the load was correctly positioned on this trip.

- 2.6 Canoes have inherent buoyancy that is directly proportional to the design and materials from which it is constructed. It is not uncommon for additional buoyancy devices to be fitted inside the hull and these are important in the event of a capsize. Without the fitted buoyancy, the canoe may sink if swamped, with the additional devices it will tend to float. Fitted buoyancy takes many forms, from purpose made inflatable devices, moulded polystyrene, and even expanding foam installed into voids under the gunnels.
- 2.7 In this case, the canoe had two 20 litre plastic containers fitted under the seats.

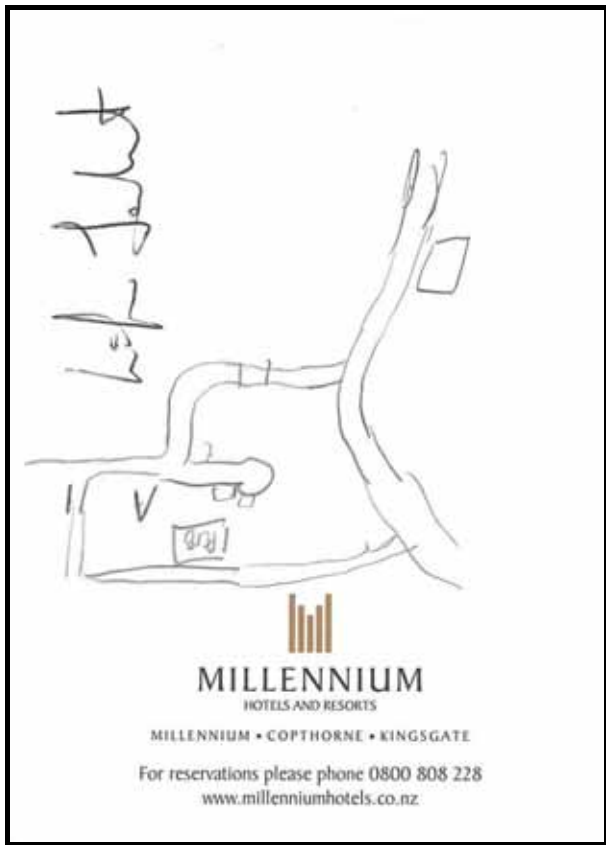
Figure 3
Diagram showing Mr Hill's "lifejacket" notation

- 3.4 The survivor then drew a map on a small pad so that Mr Hill could find his bach in Moana the next morning. After the survivor left, Mr Hill wrote the words "Life Jacket" on that map to remind him to bring the lifejackets the next day, then left that pad on his dining room table.

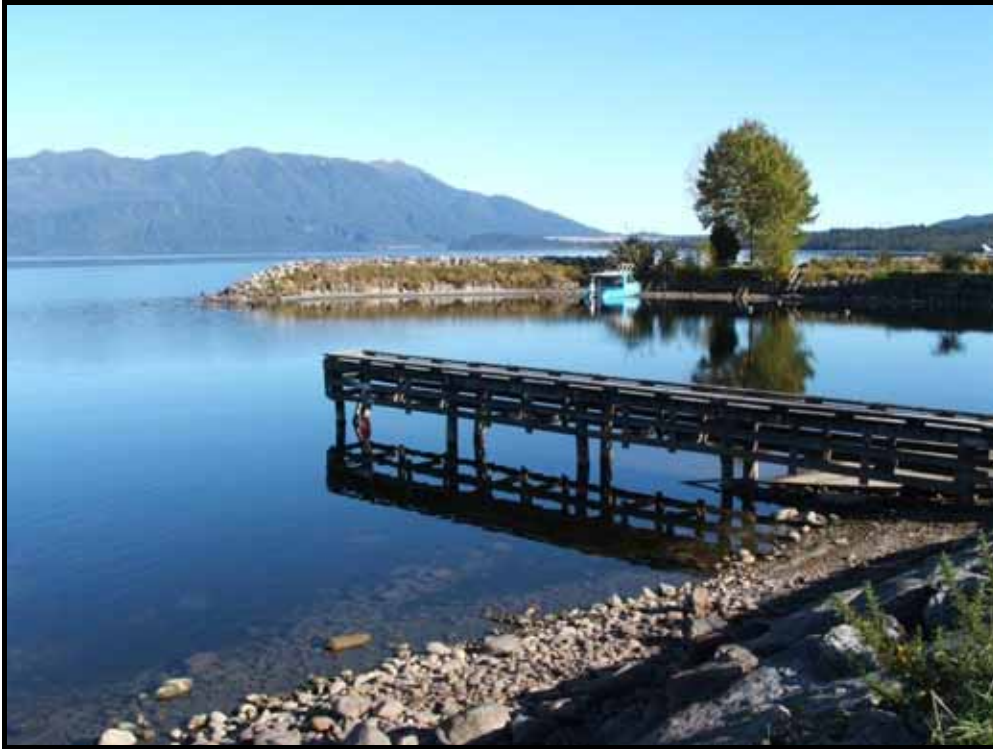
Figure 5

Lake Brunner was calm at the time Mr Hill left his vehicle there and a local resident who was a witness, stated that it was similar to the conditions shown in this photograph.

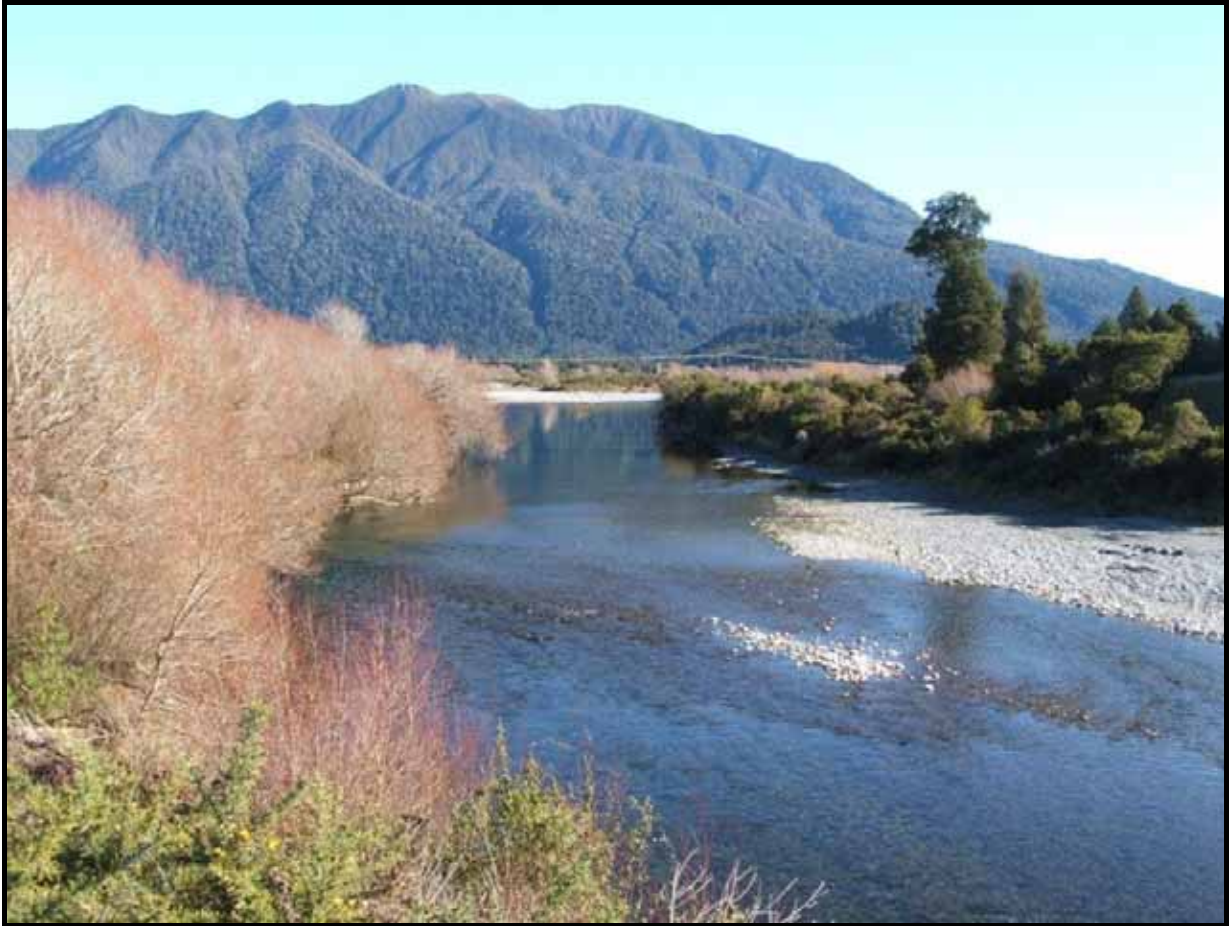
Figure 6

The Crooked River where the men originally intended to go duck shooting was very shallow at the time of the accident, so they decided to go to Lake Poerua instead.

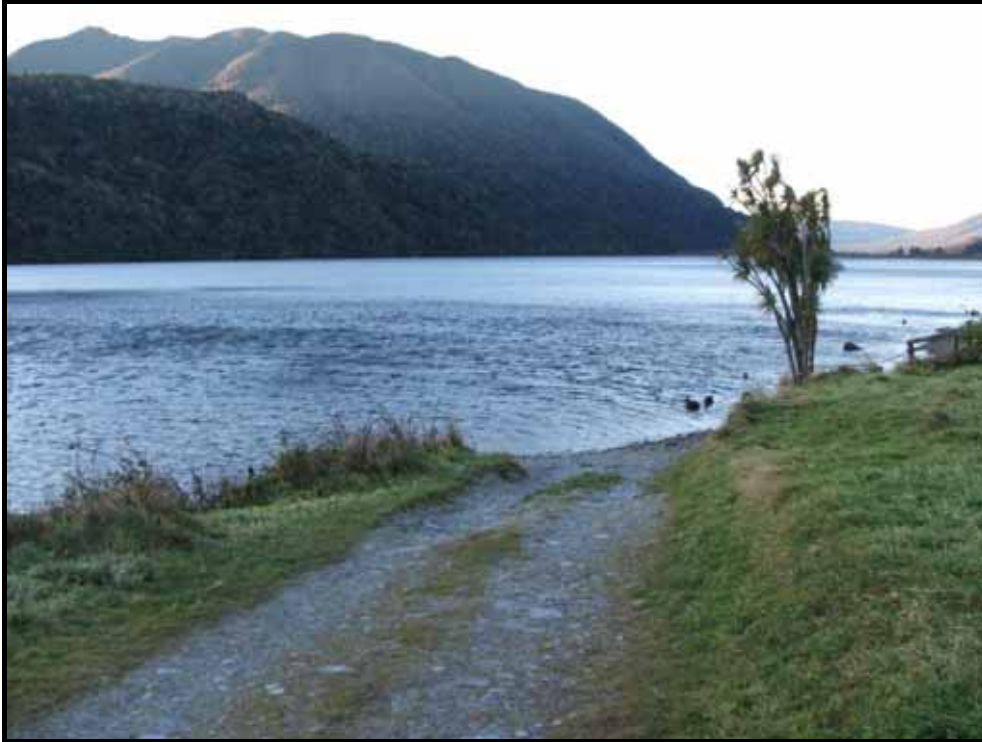
Figure 7

Lake Poerua looking north from the boat ramp where the canoe was launched. The men headed up the lake approximately in line with this track down to the lake's edge.

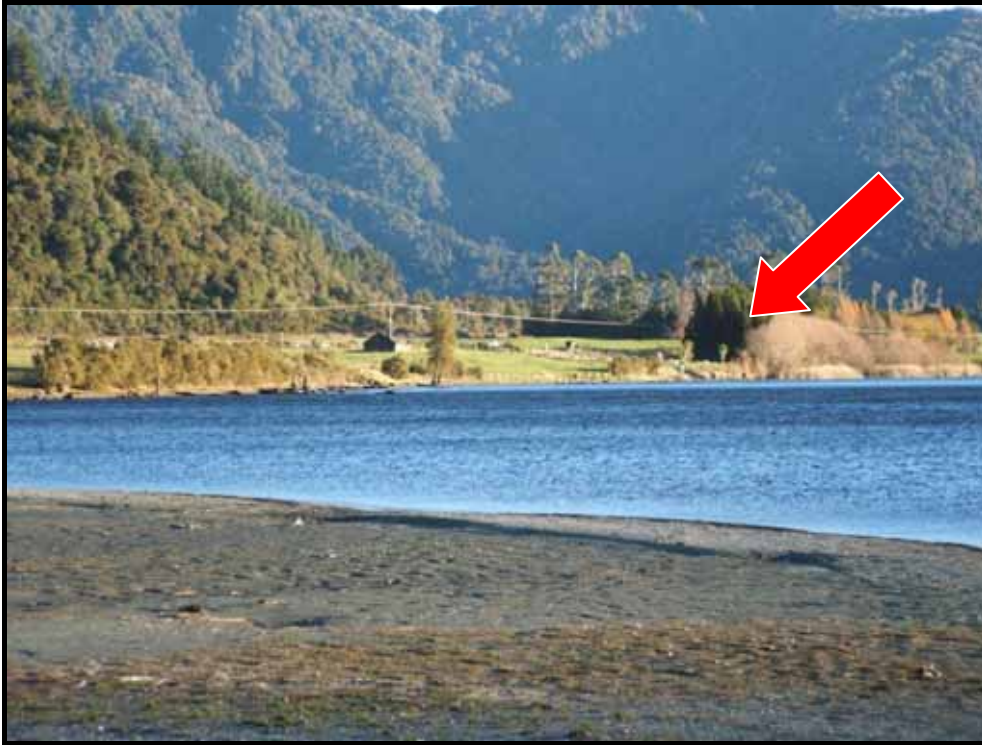
Figure 8

Lake Poerua looking south from the beach where the survivor eventually made it to shore. The red arrow indicates the boat ramp from where the canoe was launched, and it capsized to the right of this photograph.
