Class B Accident Report

Unnamed Dinghy

Swamping

At Lake Hood on 3 October 2004

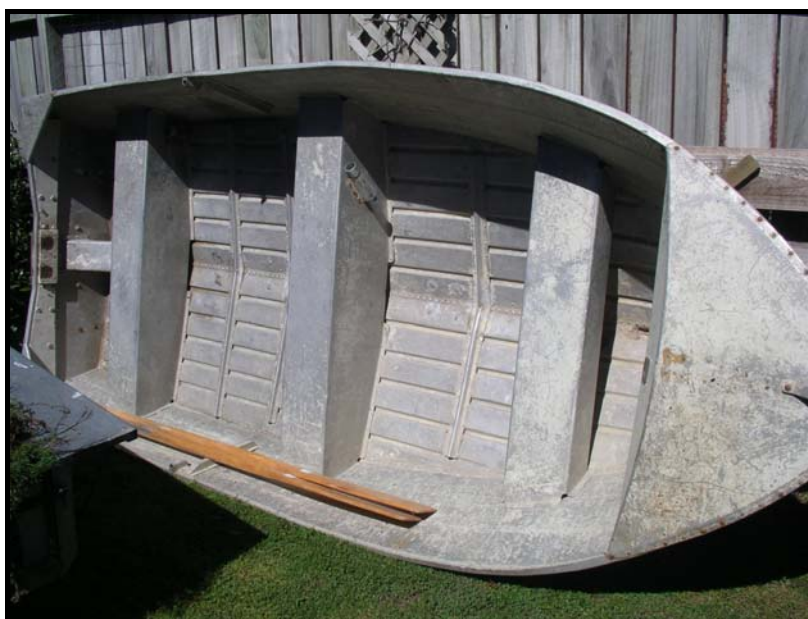
At about 1200 hours on 3 October 2004, it was decided to take the *Unnamed Dinghy* (See Photograph below) to Lake Hood to trial the recently repaired outboard engine. The Skipper ran the engine and found it to be working. After a couple of circuits around the upper lake, he asked if his friends wanted to go for a ride in it.

The dinghy was swamped after taking water over the bow, caused by the wake from its own propeller or other vessels in the vicinity. The dinghy rolled over and its buoyancy allowed it to float level bow up just under the surface. The dinghy was then towed by hand back to the beach.

With the dinghy loaded with six adults there was not enough freeboard to keep the vessel afloat as it took on water by the head. The freeboard was described as being approximately 30-50 centimetres.

It is recommended that the Skipper be censured for failing to look after the best interests of his passengers by overloading the vessel and not supplying them with lifejackets, and for failing to report the accident to the Maritime Safety Authority and the Regional Harbour Master.

It is recommended that the Skipper and the Owner sit the New Zealand Coastguard Day Skippers Course and provide a copy of the completion certificate to the Maritime Safety Authority by 30 July 2005.
