Accident Report
Machinery Failure
Unnamed Jetboat
23 March 2006

REPORT NO.: 06 1269

VESSEL NAME: *UNNAMED JETBOAT*

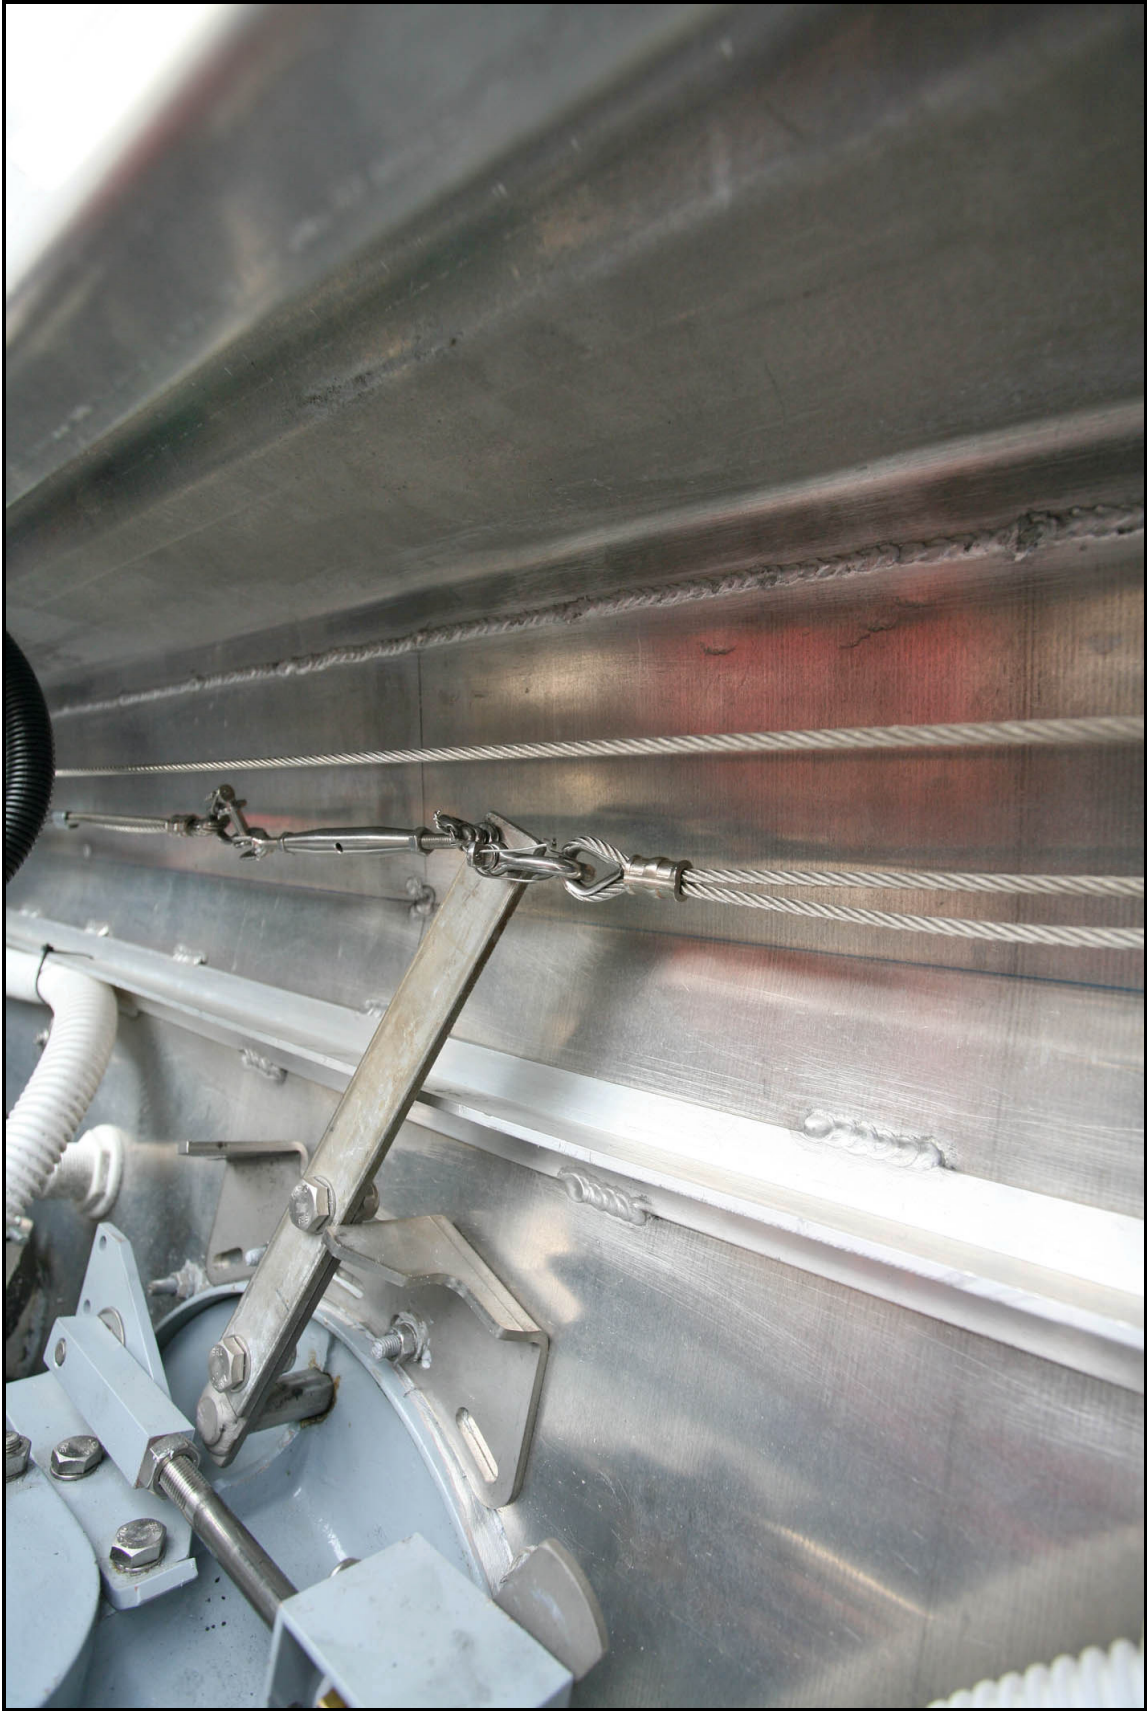
Photograph 1
Temporary repair to steering

They found the damaged boat out of the water and smashed into a rock wall. On inspection, the steering had failed due to a pin coming out from a shackle.

Shotover Jet's head mechanic made temporary repairs and the jetboat headed back down river and then back to Frankton Marina.
