Accident Report

Fatality

Unnamed Jetboat

11 August 2005

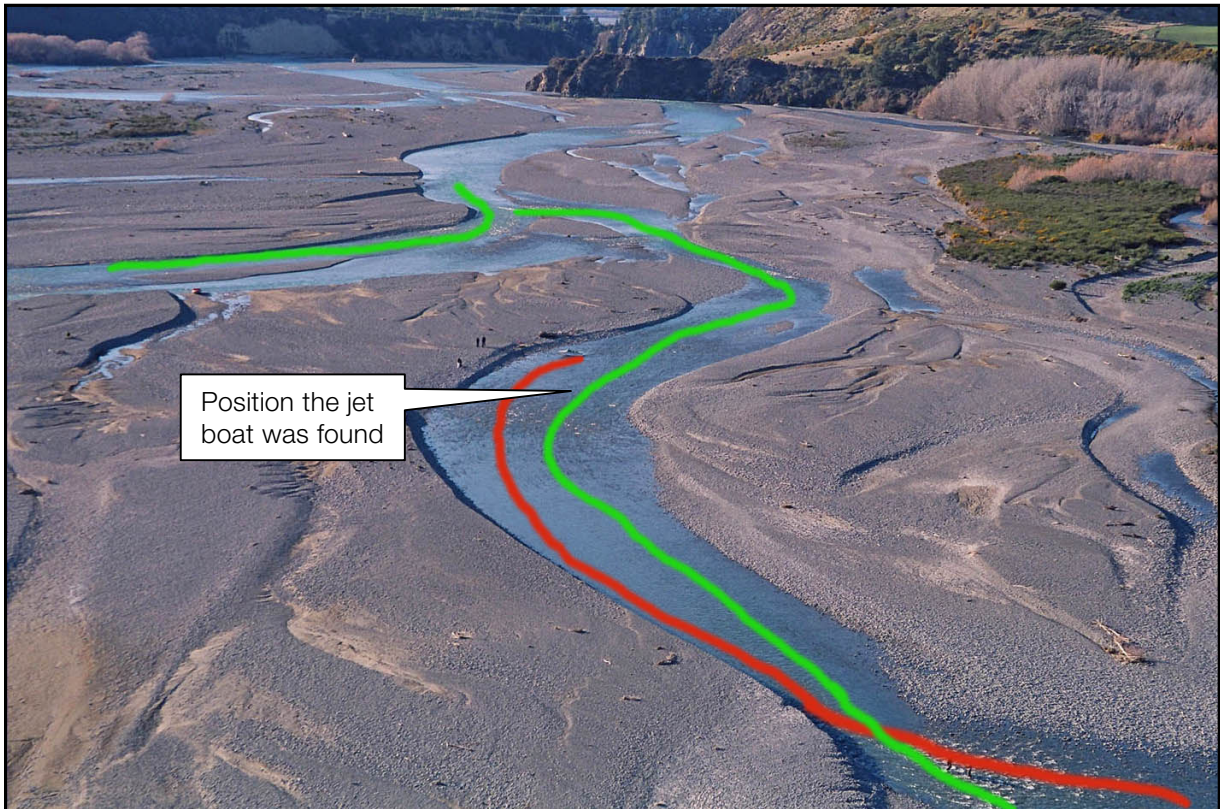
Figure 3

Mr Burrows then continued trying to get the vessel down the river leaving Friend Two behind. Later, Friend Two noticed the boat had stopped but there was no sign of Mr Burrows (See *Figure 3*). The vessel was estimated to be travelling at about 56-60 kph judging by the impact on the rocks.

Waimakariri River – Accident Scene. The green lines indicate the line Mr Burrows should have followed. The red line indicates the actual line that he took.

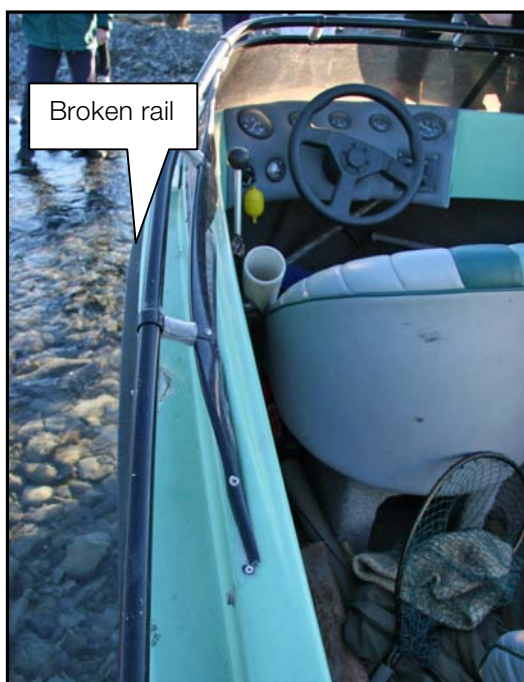
“The boat inspection at the scene showed high side impact with the windscreen and rail from inside the boat to the left side of the driving position (See Photograph 1), indicating Mr Burrows was driving in a standing position, the engine box and rear seat had been dislodged from their normal position and indicated a sudden forward motion stop.”

Photograph 1
Damaged side rail

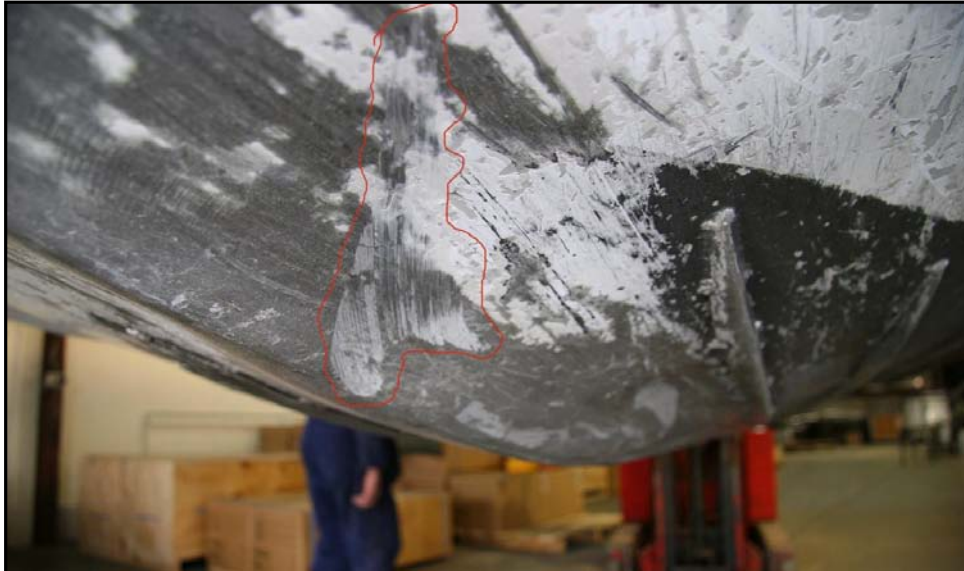
Photograph 2

“The marks on the hull are consistent with the markings on the rocks indicating to me that the boat had hit a rock hard and fast around the centre keel line approximately 1280mm from the bow (See Photograph 2), resulting in the boat being thrown into the air. This would have caused the forward motion damage to the engine box and rear seat. On landing, the marks on the rocks show the boat spun and this would have thrown Mr Burrows against the rail and most likely out of the boat (See Photographs 1 & 3). The last marks on the rocks indicate that the boat was not fast moving but bouncing and at this time the boat most likely ran over Mr Burrows who may have been thrown from the boat.”

The red circle indicates the damage to the centre keel line approximately 1280mm from the bow.

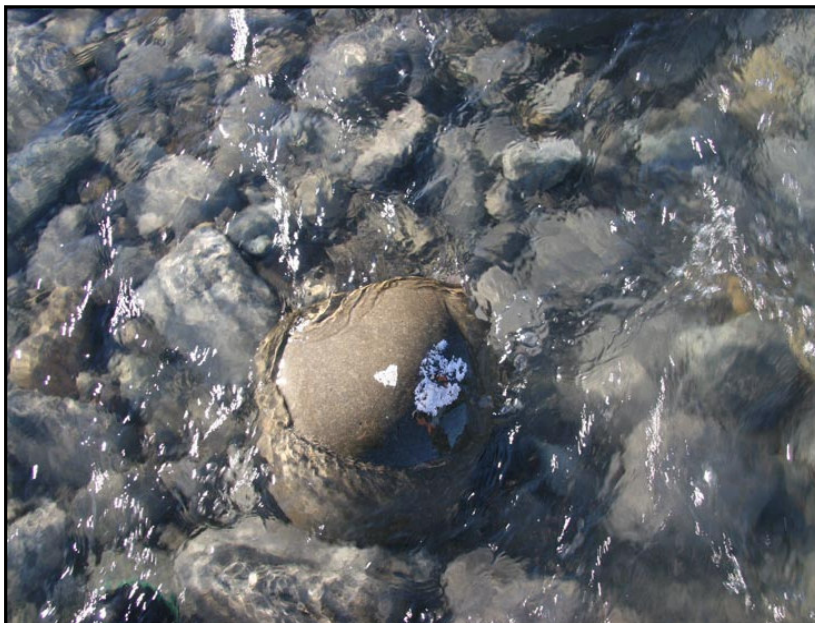
Photograph 3

A stone with white paint from the hull of the jet boat

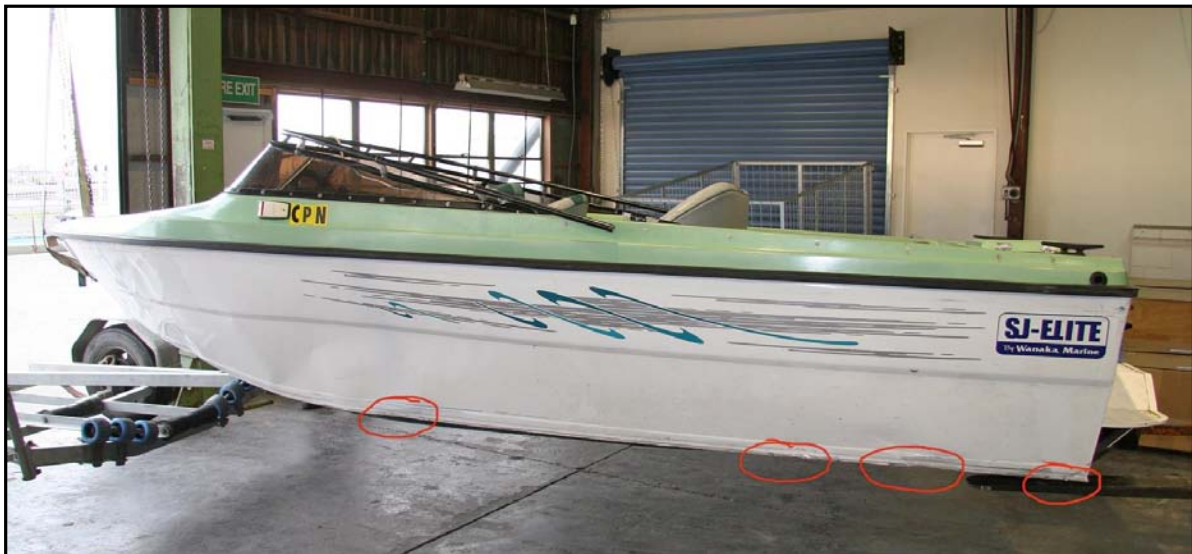
Photograph 4

- *None of the safety equipment on board had been used.*
- *The impacts had not affected the operation of the steering system.*
- *The accelerator cable and operation was checked at both ends. They were found to be operational.*
- *The fuel system including all lines, filters and taps were in good working condition.*
- *The battery isolator switch was still in the on position.*
- *The motor started and stopped normally.*
- *The boat was lifted and the hull and unit inspected.*
- *The hull had come into contact with many rocks over its life and had at least 9 fresh high-speed impact marks on I (See Photograph 4).*
- *The jet unit shaft and operation were correct.*

Red circles indicate areas of the hull which have sustained recent damage

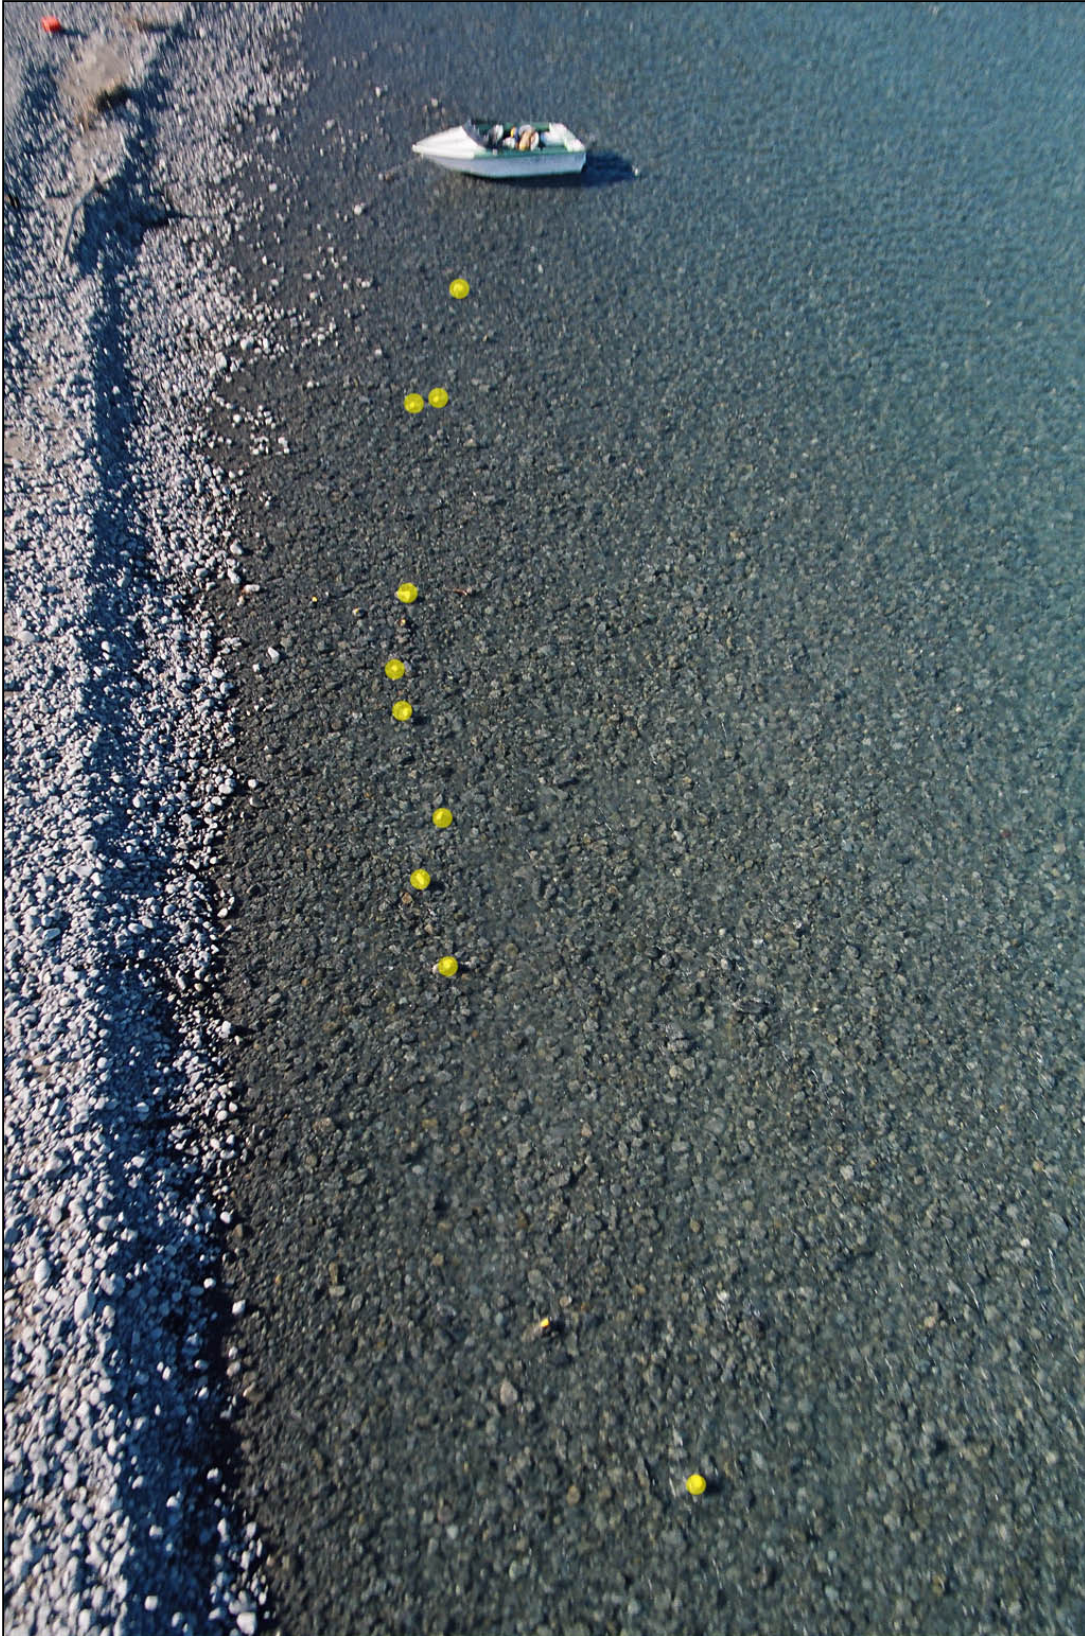
Photograph 5

The yellow dots indicate the path taken by the jet boat before the vessel finally stopped. They yellow dots mark the rocks where paint from the hull was found.
