Accident Report  
Entrapment Resulting in 1 Fatality  
**Kayak**  
19 August 2007  
Class A

# 1. SUMMARY

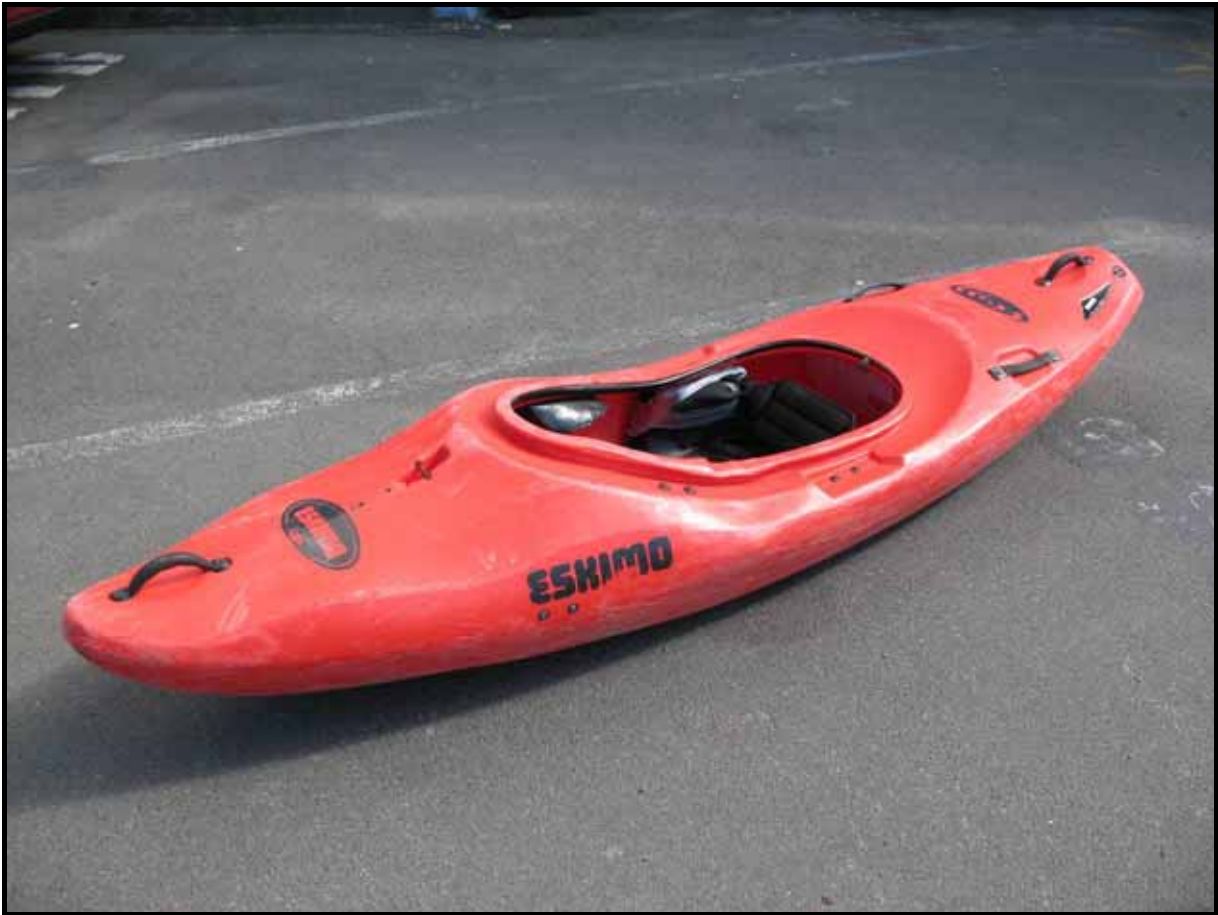
Photograph 1  
*Kayak*

2.2.1 The kayak was a 2.45 metre Eskimo, Salto model (*Photograph 1*). It was constructed of blow moulded polyethylene and manufactured in Germany. It was a dedicated “creeker” kayak designed for tight manoeuvring in creeks and going down waterfalls. It weighed 18 kilos and when new has a retail value of \$2100.00. It had flotation in the bow and stern (*Photographs 2 & 3*). Damage on the housing coaming was observed. This is likely to have been caused by the water pressure forcing it against the tree trunks (*Photograph 4*).

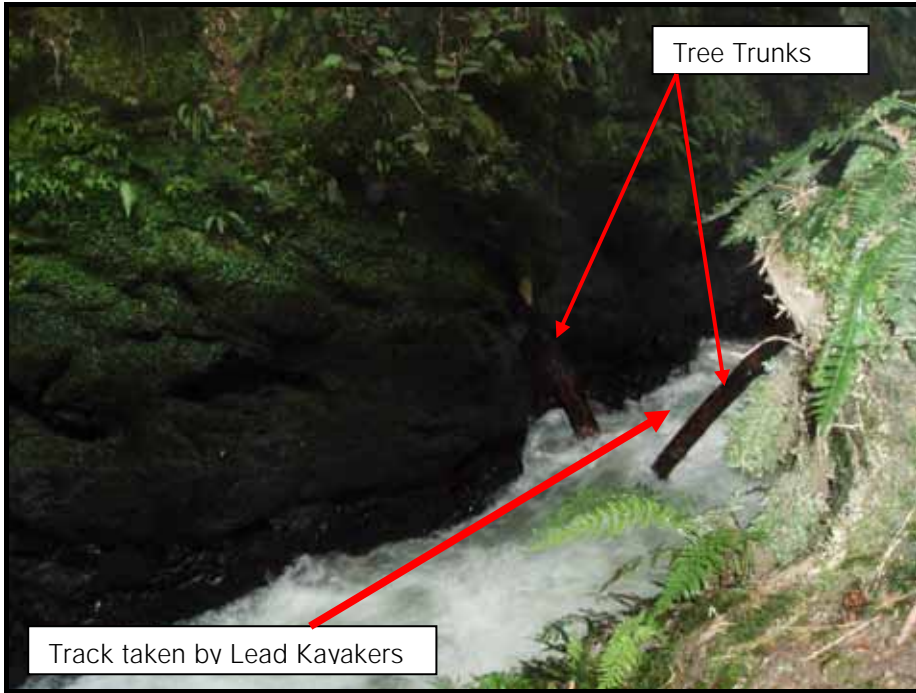
**Photograph 6**  
Accident Scene

- 2.1.4 As the group rounded a bend in the river they encountered a tree trunk from a tree that had fallen from the forest above (*Photograph 6*). The group used hand signals to warn the kayaker behind of the obstacles. The first two kayakers were able to navigate safely over the trunk to the next calm area of river 200 metres downstream. The third kayaker stopped in an eddy below but out of sight of the tree trunk. When last seen by the third kayaker Mr Stidham's kayak was pointed downstream towards the right side of the river and approaching the tree trunk as if he was trying to pass to the right of it. The current at that section was flowing to the left side of the river bank.

- 2.5.1 On 29 August a raft with Police, Maritime New Zealand and New Zealand Recreational Canoeing Association (NZRCA) members examined the accident scene. The river level was approximately 1 metre lower than at the time of the accident. *Photograph 6* shows the tree trunks in the same position as described by the three surviving kayakers. The tree trunk on the left side of the river had been in place for some time. The trunk on the right was recent. The underwater section of the right hand trunk was angled downstream and held the kayak under the surface. The other kayakers travelled through the 'V' section (*Photograph 6*).

- 3.1.1 The intersecting tree trunks were positioned in the river on angles that caused the kayak not only to become trapped but also forced below the surface by the hydraulic pressure exerted on the hull. The pressure against the hull would have been such that Mr Stidham would have been unable to escape from the cockpit as his body would have been trapped between one of the tree trunks and the kayak.

- 5.1 It is recommended that Environment Bay of Plenty review the safety signage at the Kaituna river and consider placing a sign at the entry point warning of dangers likely to be encountered and advising kayakers to seek out local knowledge.
- 5.2 It is recommended that a summary of this report be placed in the Maritime New Zealand publication Lookout! with reference to the NZRCA website that has a safety bulletin advising kayakers of hazards that may be encountered on many of the rivers kayaked in New Zealand.
