Accident Report  
Capsize Resulting in 1 Fatality  
*Kayak*  
11 March 2005  
Class A

REPORT NO.: 05 1185

Vessel Type:	Minnow Kayak
Construction Material:	Plastic
Accident Investigators:	Ian Logie & Andrew Hayton

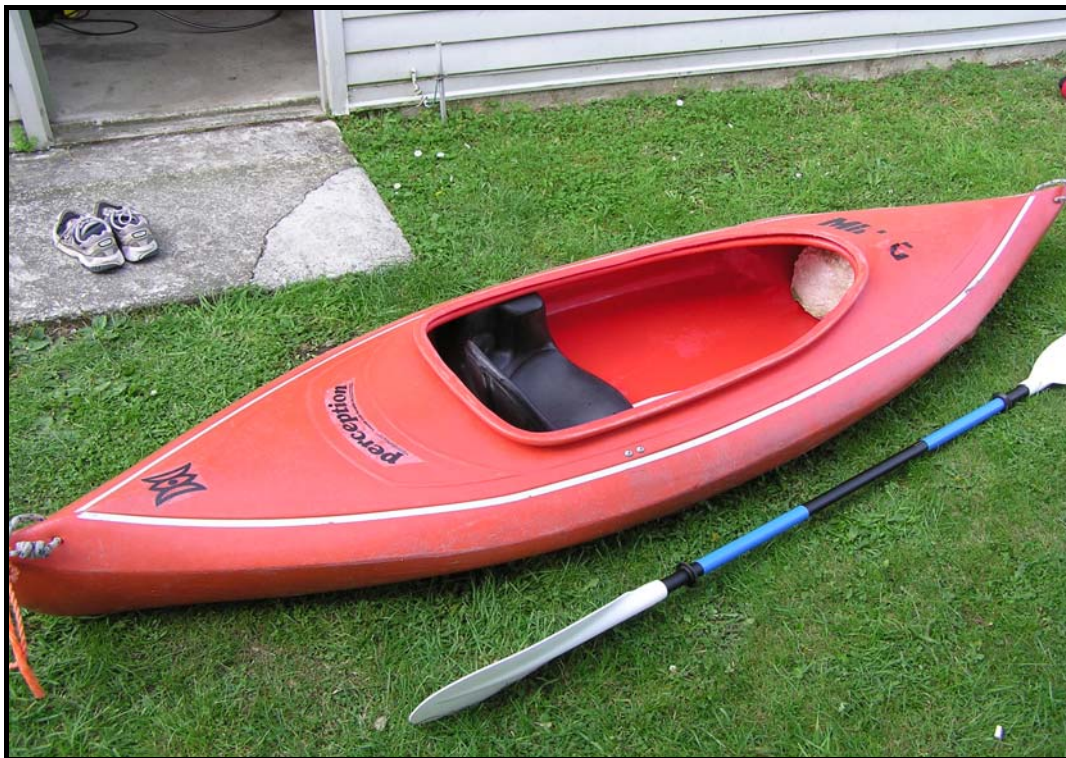
Photograph 1  
Kayak

The Minnow kayak is an open cockpit kayak with a wide flat hull most ideally suited for family fun on flat water. They are also popular amongst duck shooters and fishermen on sheltered waters (See *Photograph 1 - Kayak*).

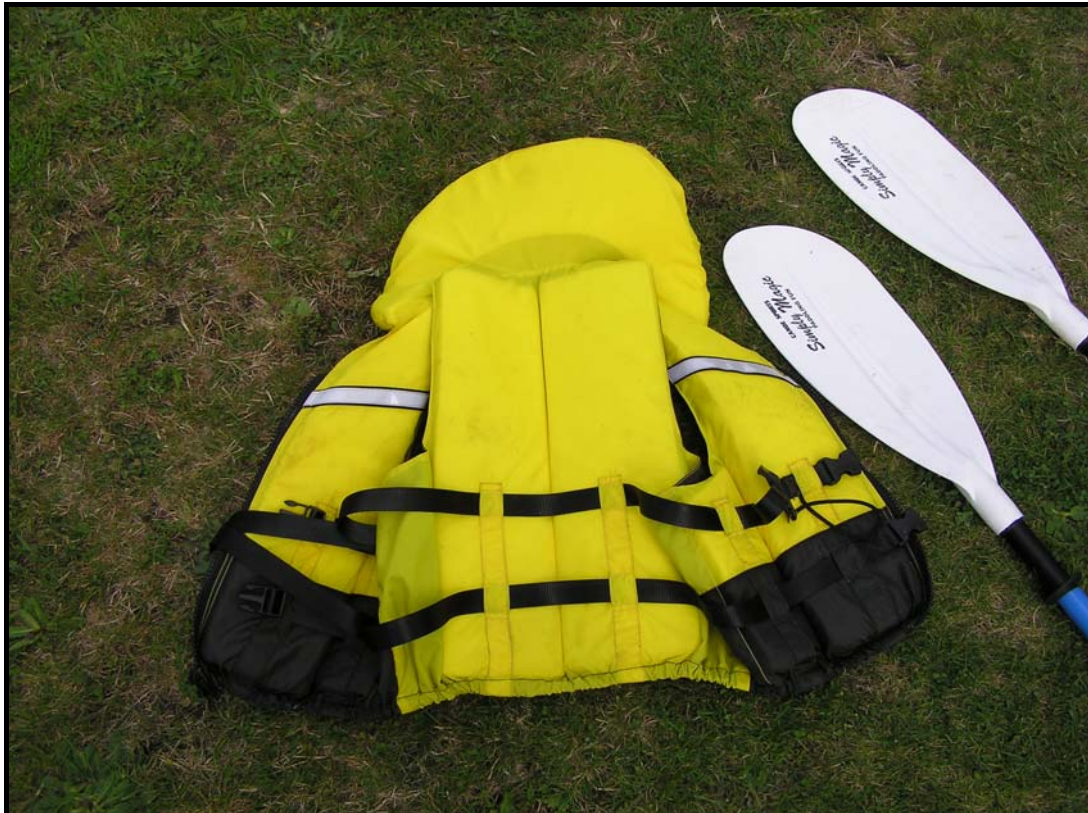
Photograph 2  
*Kayaker 2's PFD*

With the kayaks were two paddles and one personal floatation device (PFD) (See *Photograph 2 - PFD*). The two Kayakers also tied a plastic/vinyl blow-up buoy onto each kayak (See *Photograph 3 -* ). They joined each buoy to its respective kayak with approximately sixteen metres of orange plastic rope. The rationale for this was that if one of them capsized, the other person could throw their buoy to the swimmer in order to assist. The owner recommended that they paddle at the Lake Manapouri (Shallow Bay) end of the Waiiau – as the Waiiau is very swift. They were keen to paddle the Waiiau though and ran along the length of it (on the Kepler track) the day prior to attempting to paddle it. Unfortunately during this run they did not notice the lack of well-defined eddies suitable for a beginner. The owner told them that there was one rapid on it.

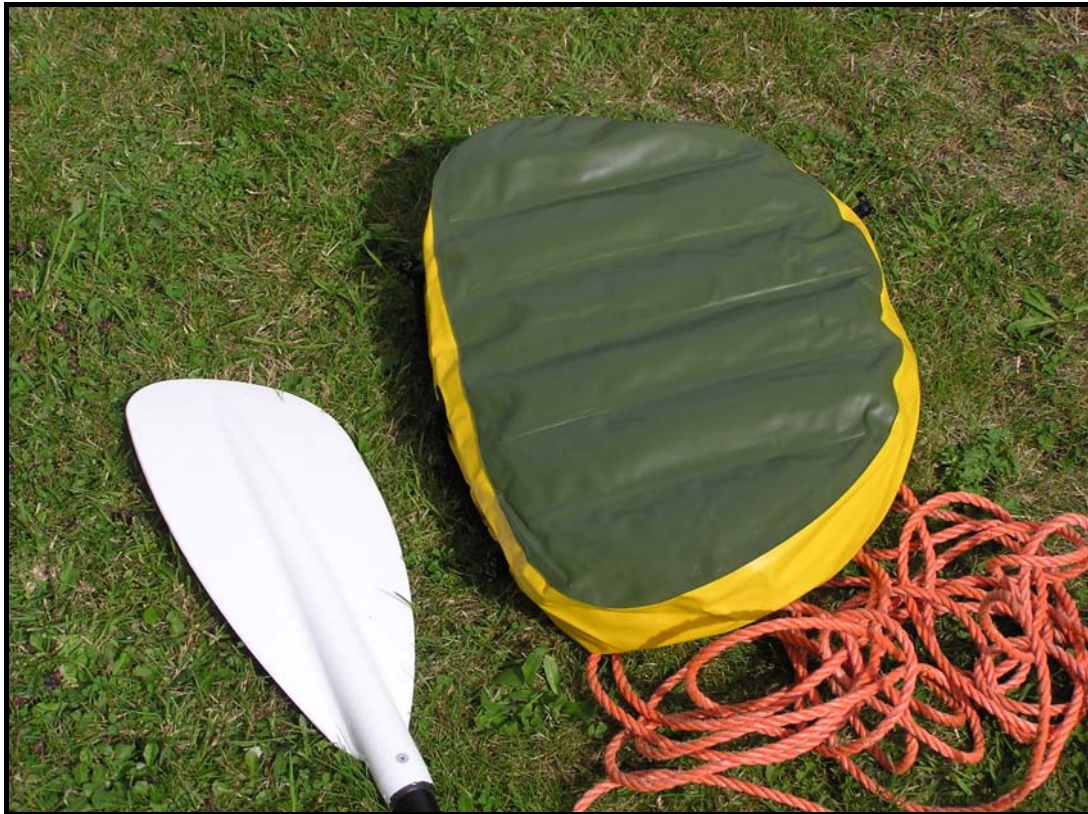
Photograph 3

Buoy attached to *Kayaker 1's* kayak

Rope and rivers are potentially a very dangerous mix. Although throwbags can be useful in rescuing people and equipment from a wide variety of situations on a river, they should not be carried without a knife. Any rope being carried on a river should be carried in such a way that it remains secure at all times – until a paddler goes to use it.

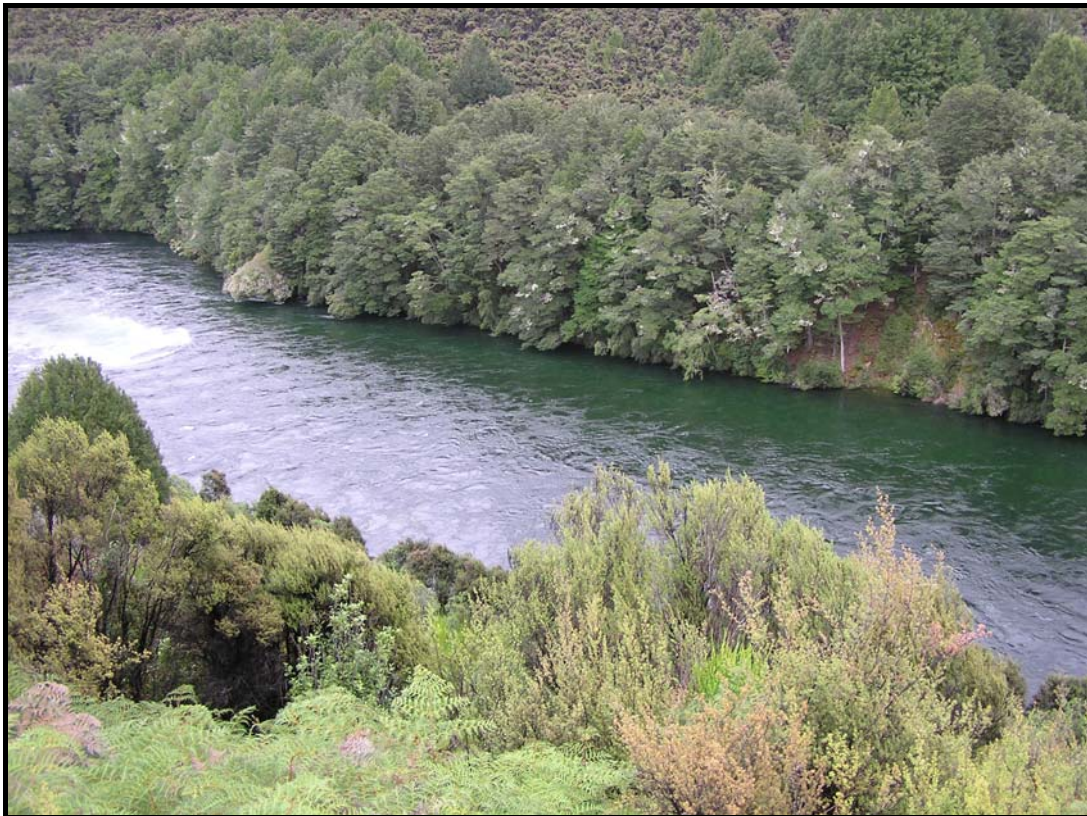
Photograph 6  
Overview of Accident Site

The next time Kayaker 1 eddied out, he was on the river right side and approximately 50 metres upstream of the accident site (See *Photograph 6 – Overview of Accident Site*, *Photograph 7 – Eddy which Kayaker 1 parked himself in* & *Figure 1*). It was upstream of “Black Rock” - the rock that the jet boat people had told them about, and they “wanted to scout it”. Kayaker 2 followed Kayaker 1 towards the bank. However, she was not in same small eddy – she was still in the moving water. She held onto branches from the trees on the side in order to steady her position. The current however continued taking her kayak downstream and Kayaker 2 capsized. When she came up she attempted to swim herself and her kayak to shore. The river was still moving swiftly and she realized that she was quickly approaching a strainer (See *Photograph 8 – Side on view of Strainer* *Photograph 9 – Strainer viewed from up river*). She attempted to put her kayak between herself and the strainer.

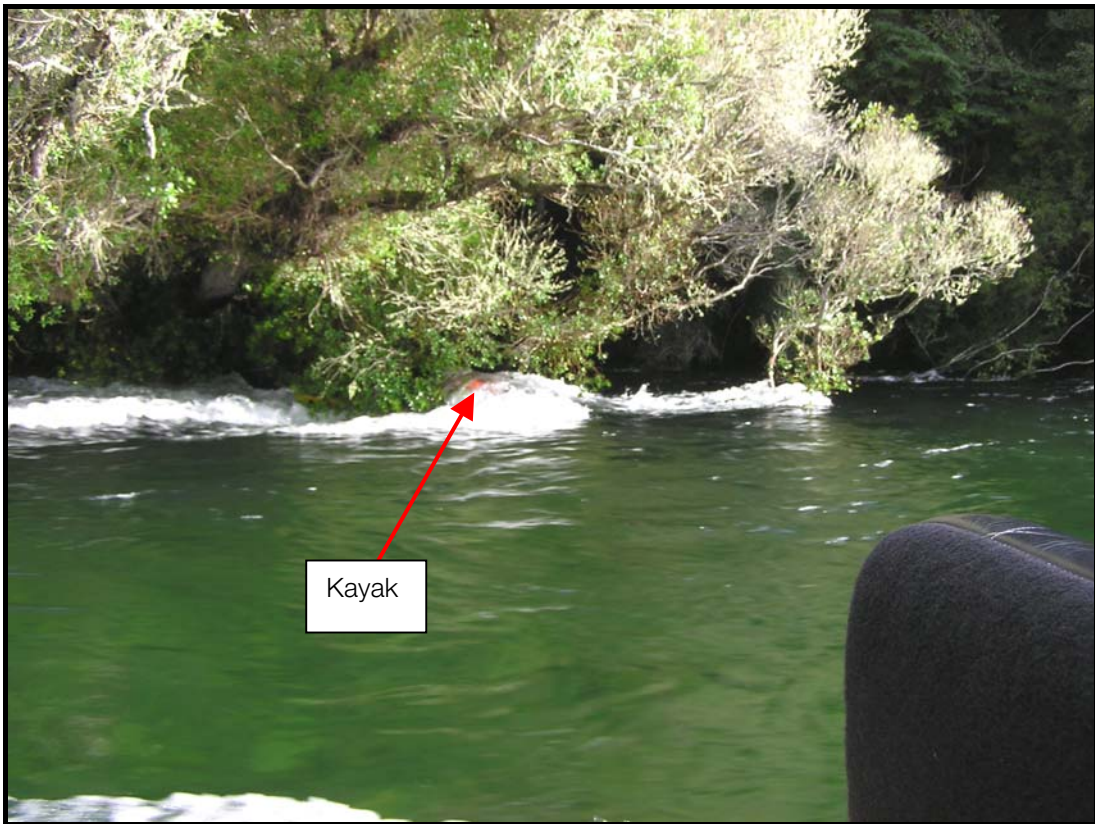
Photograph 8  
Side on view of Strainer (Note – Kayaker 2's kayak still pinned)

The strainer was a limb and branches of a Rata tree extending from the bank. The branch furthest from the bank was extending upstream from the limb. Kayaker 2 was sucked underneath and found that the rope attaching the buoy to her kayak was wrapped around her ankle and pulling her still further onto the strainer. She managed to free her ankle of the rope and with a Herculean effort managed to resurface and climb onto the limb of the tree.

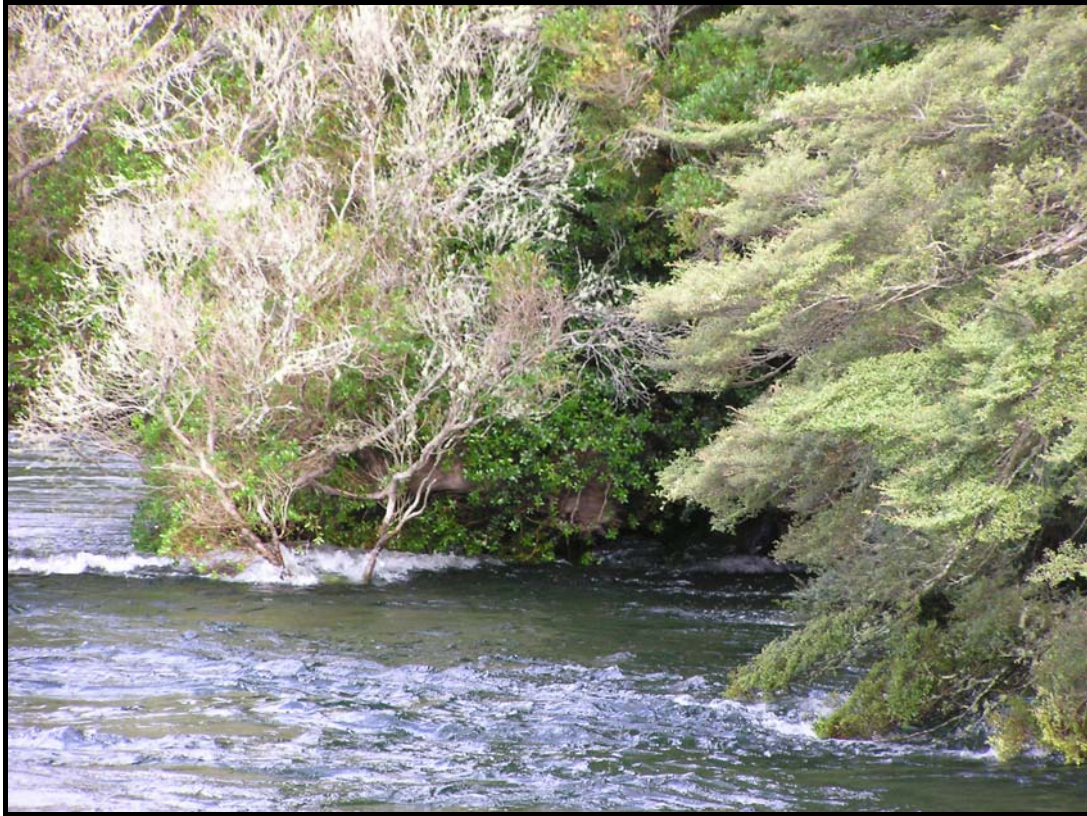
Photograph 9

Strainer viewed from up river

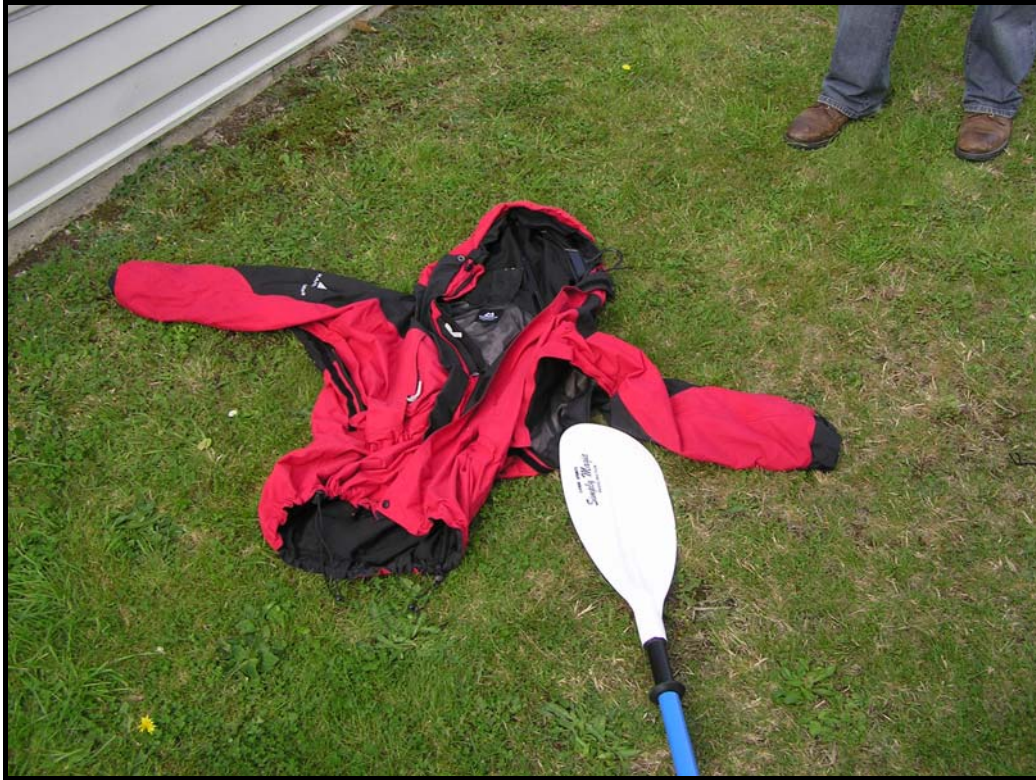
When Kayaker 2 looked around, it was quiet and she could not see Kayaker 1. Both of their kayaks were stuck on branches of the Rata tree and she could see Kayaker 1's red jacket (*See Photograph 10 – Jacket*) beneath the surface, stuck on the branch furthest out into the current. She assumed that he must have got out of his jacket and be drifting downstream.

Photograph 10  
Kayaker 1's Red Jacket

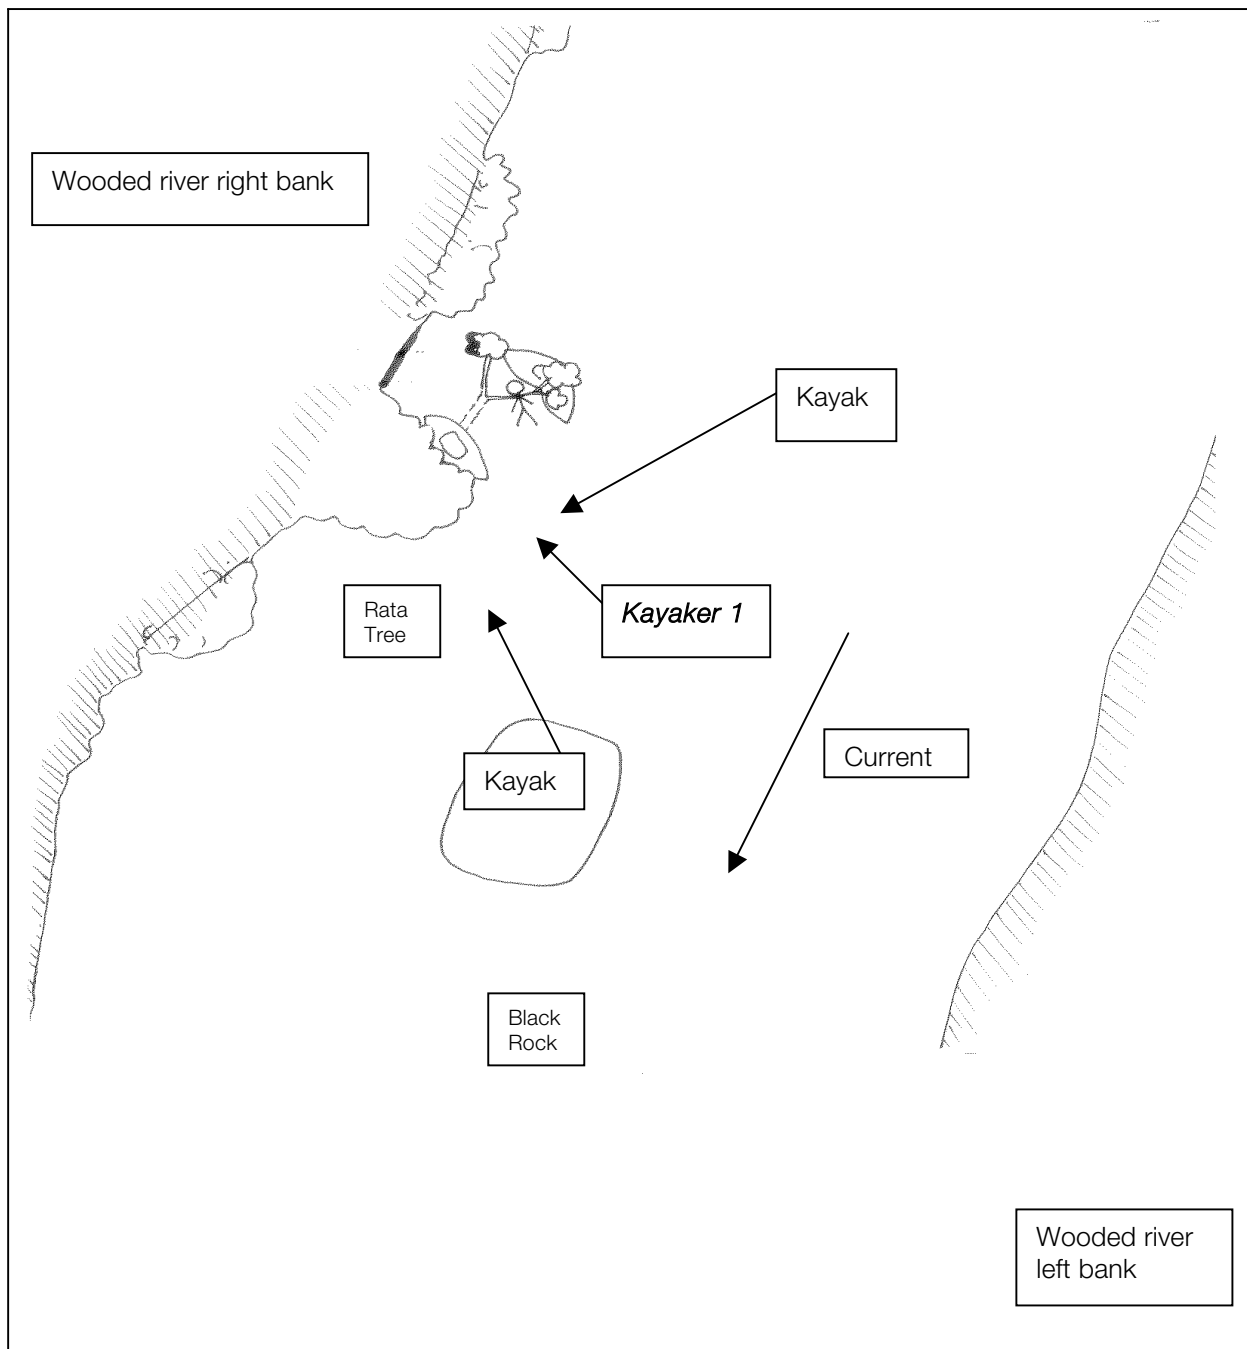
**Figure 2**

In order to find Kayaker 1, Kayaker 2 ran downstream. There was no sight of him. On her way back she met a German tourist who had heard her screaming and her whistles. He rang for help (111) at approximately 1722 hours and accompanied her back to the Rata tree to check if Kayaker 1 was still in his kayak. Kayaker 2 edged her way along the limb of tree and felt the submerged jacket with her foot. The jacket was between his kayak and the tree. She then realised that Kayaker 1 was still inside the jacket (See *Figure 2 - Sketch*).

Sketch of Accident Site

*Note – Kayak's & Kayaker 1 mostly submerged*

The hood of the jacket was bouncing to the surface at times with the current. There was a lot of current flowing over the branch that Kayaker 1 was stuck on and this made it far too dangerous to attempt to grab a hold of him. The current was too swift for Kayaker 2 to be able to see where Kayaker 1's jacket was attached to the tree.
