Accident Report

Fatality

Kayak

13 January 2007

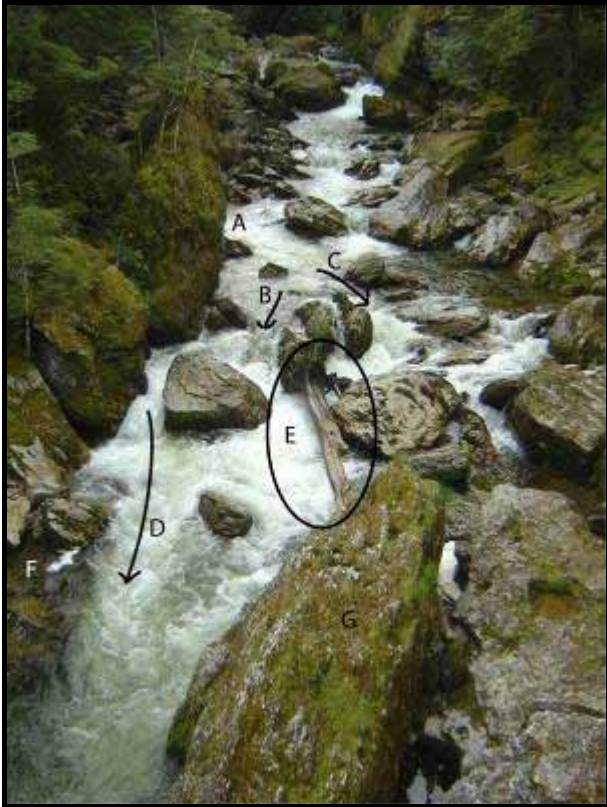
Plate 1
Accident Site Rapid

7. Dennis and his companion continued paddling down the river until they came to the rapid where the accident occurred at approximately 1500 hours. They both stopped in a small eddy on the true river right (*Plate 1, Accident site - point A*) from where they could boat scout and see the top of the rapid. The rapid was a Grade 4 rapid (*See Appendix 2*) characterised by numerous rocks with water flowing over and around them down a moderate gradient, and two obvious lines to either side of a pair of rocks (*Plate 1, Accident site - points B & C*).

8. Dennis's companion could see a clear line down the hard right of the rapid (*Plate 1, accident site - point B*). While he couldn't see all the detail of the rapid, he could see that the line he was looking at exited safely into a pool below the rapid (*Plate 1, Accident site - point D*). Based on the character of the river so far he felt confident that he could successfully negotiate any obstacles that came into view as he paddled the rapid.

The water level at the time of the accident was approximately 300mm higher.

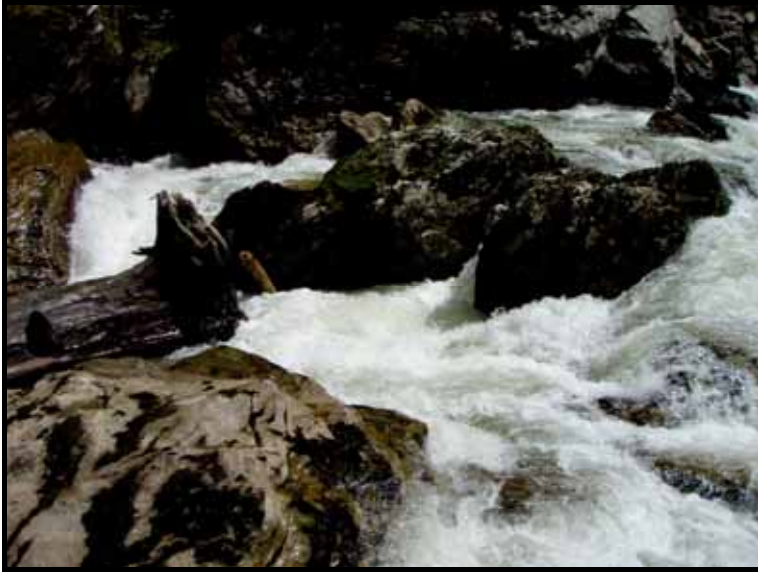
Plate 2
Accident Site (Point E)

The water level at the time of the accident was approximately 300mm higher.

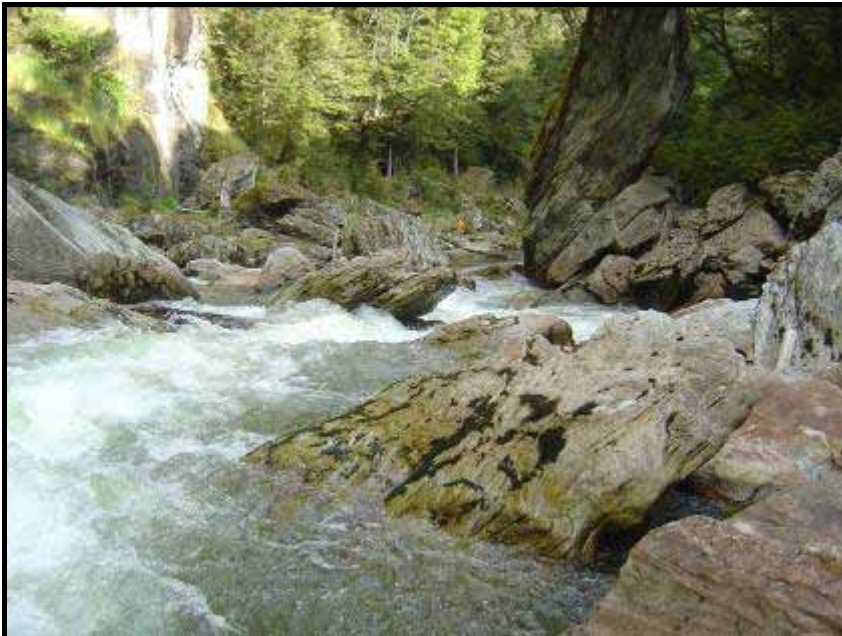
11. Dennis paddled out of the eddy and into the beginning of the rapid. As Dennis's companion watched, Dennis's kayak appeared to bounce off a rock (*Plate 3, point B: Point A the line Dennis's companion paddled*) and move quickly to the true left of the river, towards the line with the tree. At this point Dennis disappeared from his companions view behind rocks. His companion did not see Dennis again.

Plate 3
View of the rapid looking downstream from the eddy where Dennis and his companion began.

The water level at the time of the accident was approximately 300mm higher.

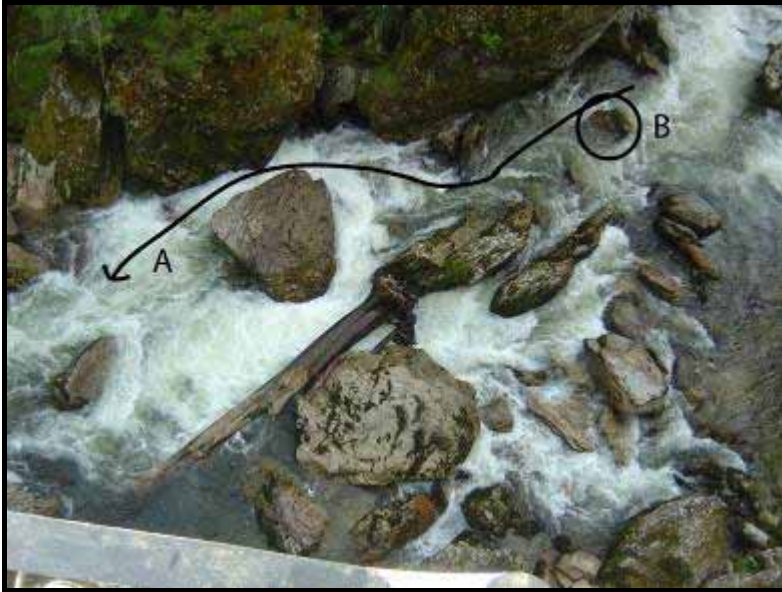
Plate 4

Accident Site showing rock (Point B) which Dennis bounced off and headed to centre left channel

The water level at the time of the accident was approximately 300mm higher.

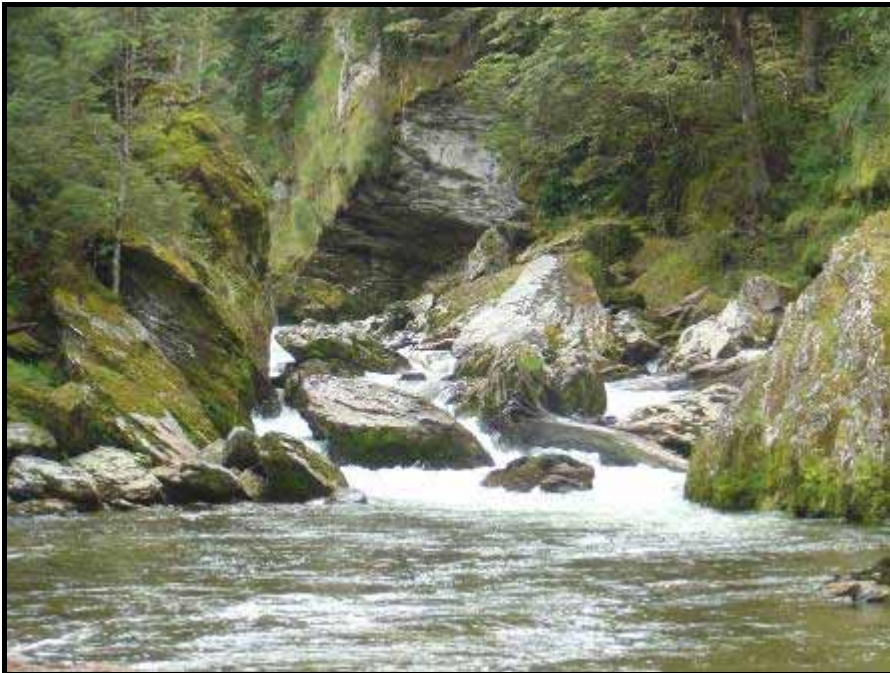
Plate 5

View of the rapid looking upstream from the true left.

The water level at the time of the accident was approximately 300mm higher.

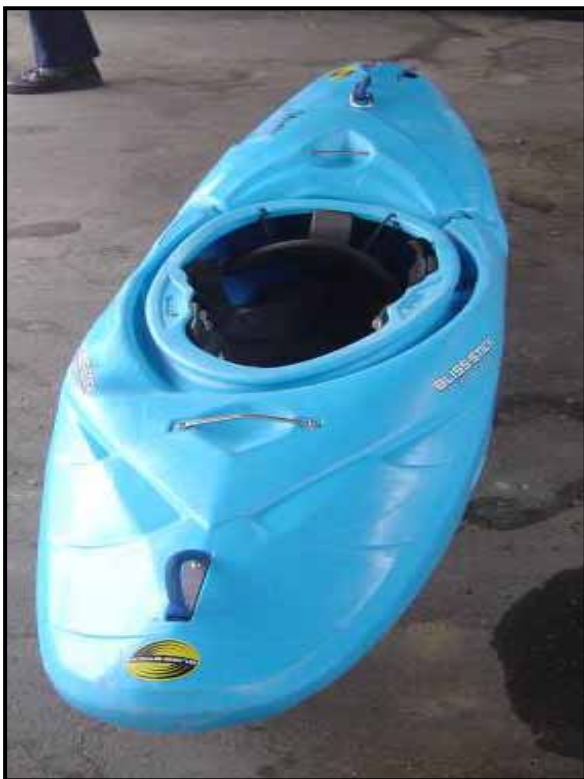
Plate 6

16. The kayak had sustained severe damage. There was a dent in the front of the kayak (*Plate 5*), a large dent in the rear underside of the kayak (*Plate 6*) and the kayak had folded and split behind the cockpit (*Plate 7*). Both of the foam structural pillars were displaced, particularly the rear one. The bottom of the rear pillar had slid out sideways and the top had popped free of its plastic bracket allowing the kayak to bend longitudinally. The seat had twisted and was out of place

Dent on right side in front of cockpit

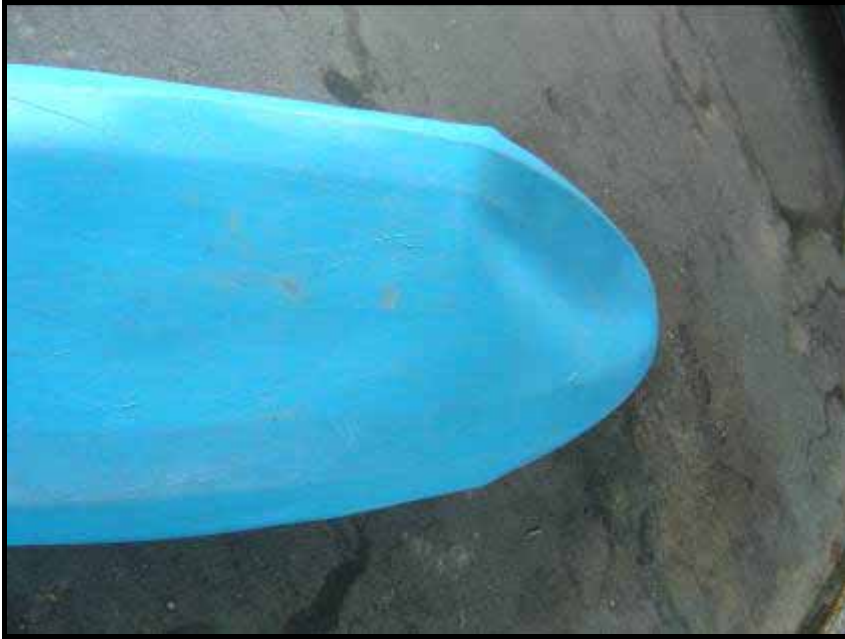
Plate 7
The dent in the rear underside of kayak

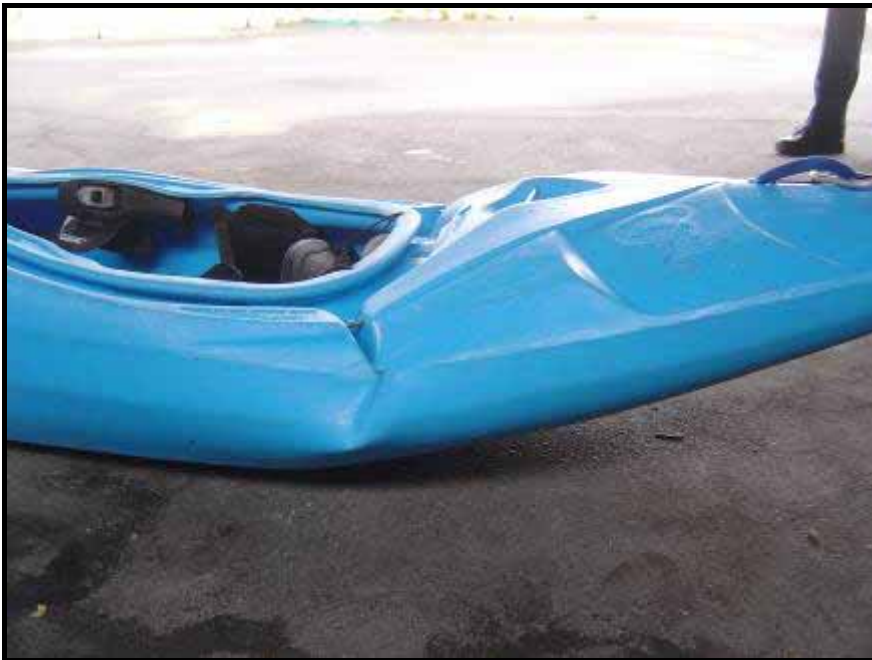
Plate 8
The fold behind the cockpit

10. It is probable that the prolonged exposure to the constant force of water against Dennis's body created a gradual lateral torque being transferred through to the kayak seat resulting in seat and pillar displacement. The displaced foam pillars and the constant pressure on the back deck of the kayak gradually resulted in the structural integrity of the kayak being compromised and the kayak being folded behind the cockpit. The manufacturer indicated that directly behind the cockpit is the weakest part of the top deck of the kayak. In the event of a severe pin the kayak is less likely to fold through the cockpit, or front deck therefore reducing the potential for entrapment in the kayak.

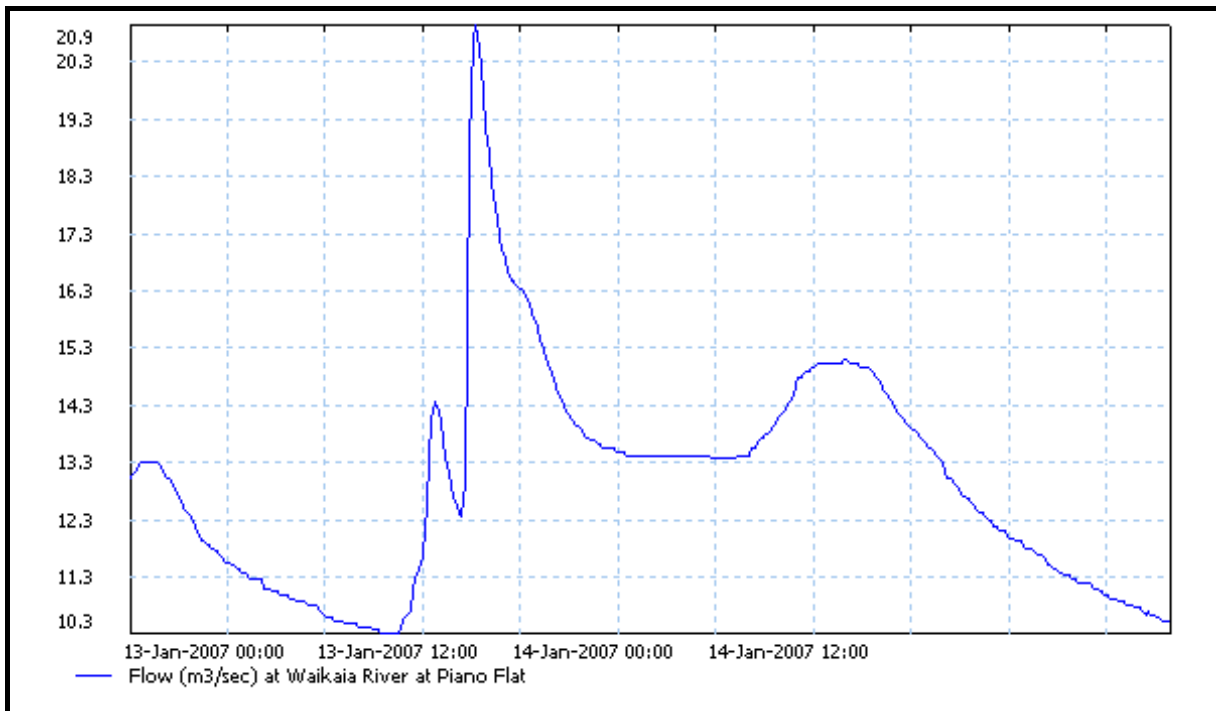
9. The Waikaia River was flowing at approximately 10.5 cumecs at the time of the accident (*see Appendix 4*). When Dennis and his companion put on, the river was at approximately 11 cumecs. It had been dropping steadily during the morning, but began to rise quickly later in the afternoon. Dennis and his companion had checked the river flow gauge the evening before the trip. It was 14 cumecs; towards the low end of the paddleable range of 10 – 50 cumecs according to the guide book they carried - *New Zealand Whitewater – 120 Great Kayaking Runs*, Graham Charles, 1999 (see Appendix 5). They were also aware that fine weather was expected for the next few days and they expected the river would continue to drop below a paddleable level. From the time of the accident until Dennis's body was recovered the river rose to approximately 20 cumecs and then dropped back down to below 10 cumecs.

River Flows recorded at Piano Flat on the Waikaia River on 13 and 14 January 2007.
