Accident Report

# Unnamed Raft

“Toilet Rapid”, Shotover River on 7  
March 2004

**REPORT NO: 04 3477**

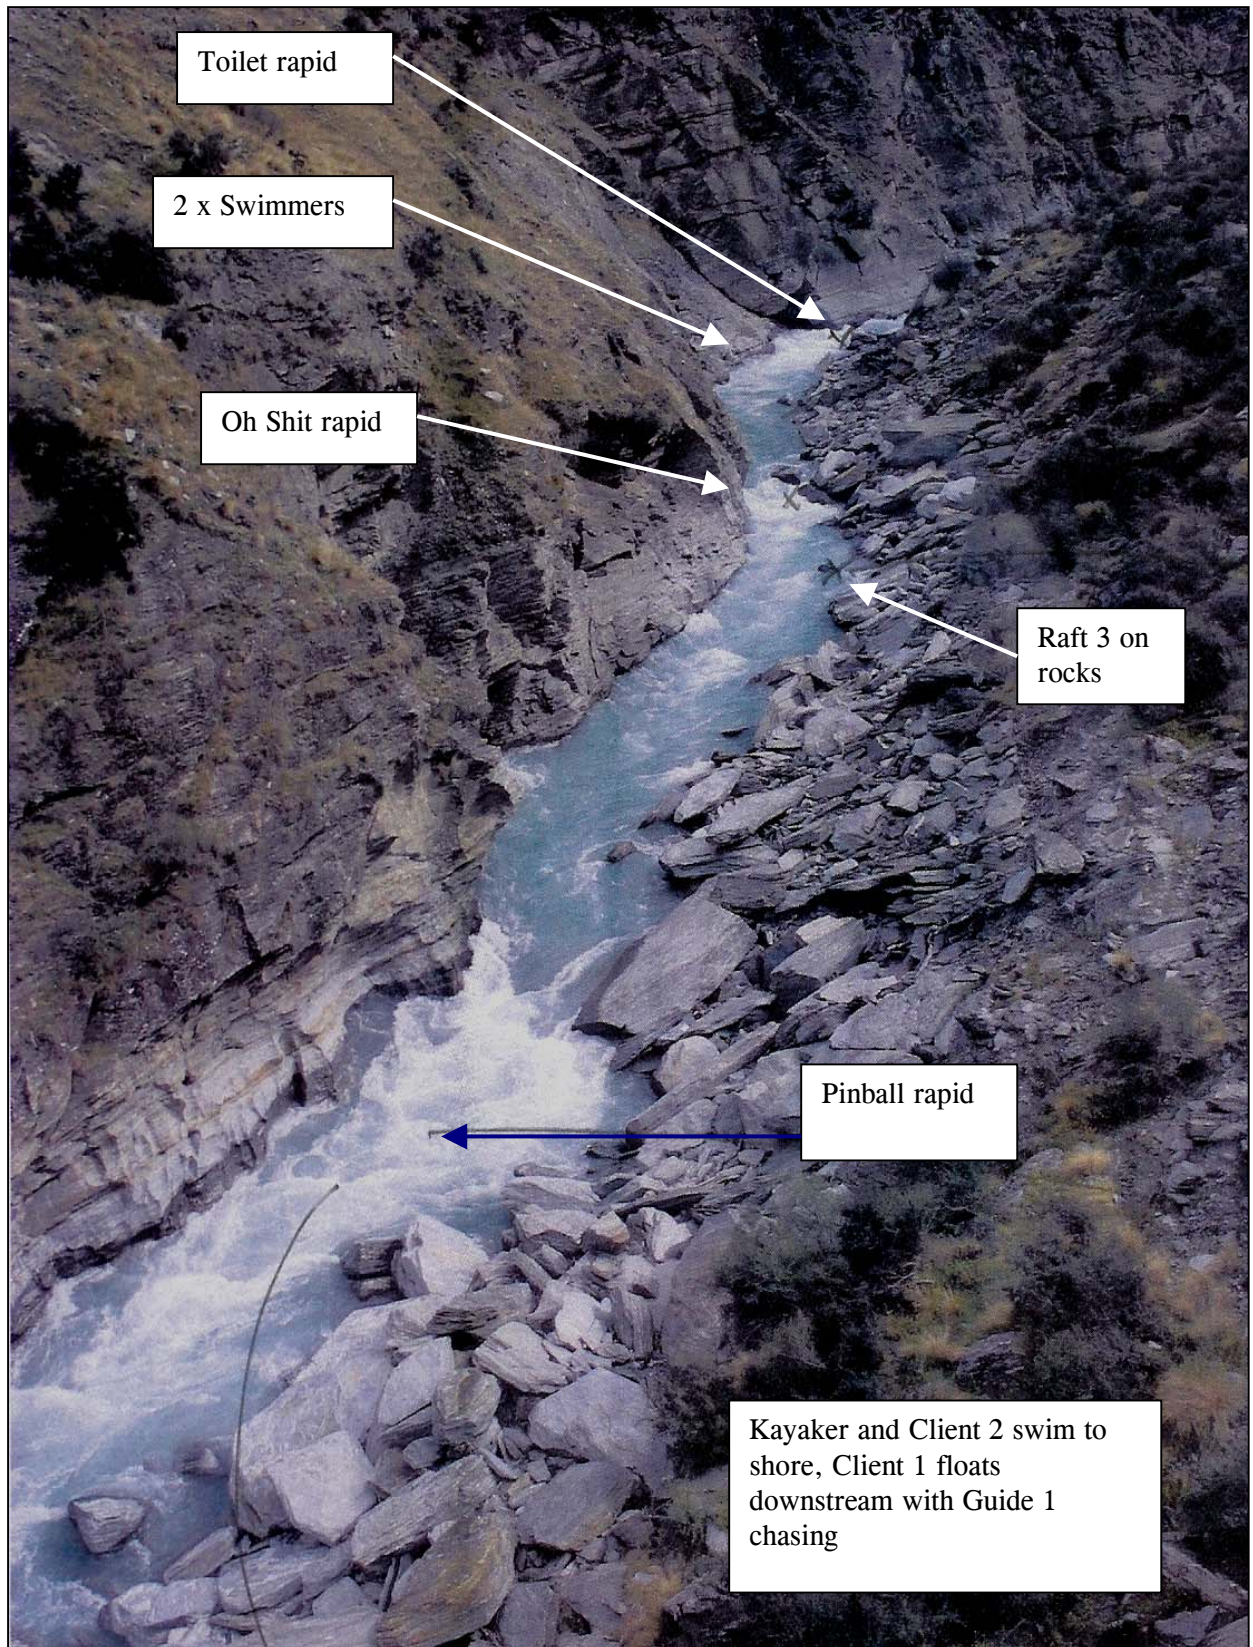
**Appendix 2** Photograph 2

- 1.24 **Raft 1** then hit and became stuck on “Oh Shit” rock (*See Appendix 2 – Photograph 2*). The Safety Kayaker’s kayak hit the side of **Raft 1** and he saw Clients One and Two go under the raft momentarily. They then surfaced and floated downriver. The Safety Kayaker paddled after Clients One and Two, who had cleared “Oh Shit” rapid, and were now in a ‘calm’ stretch of water, about 40 metres in length.

- 1.27 During this time, Guide Two had beached his raft and was running on foot down the left bank of the river to ensure no one ended up in the sieves down the left side of the next rapid which was “Pinball” rapid (*See Appendix 2 – Photograph 2*).

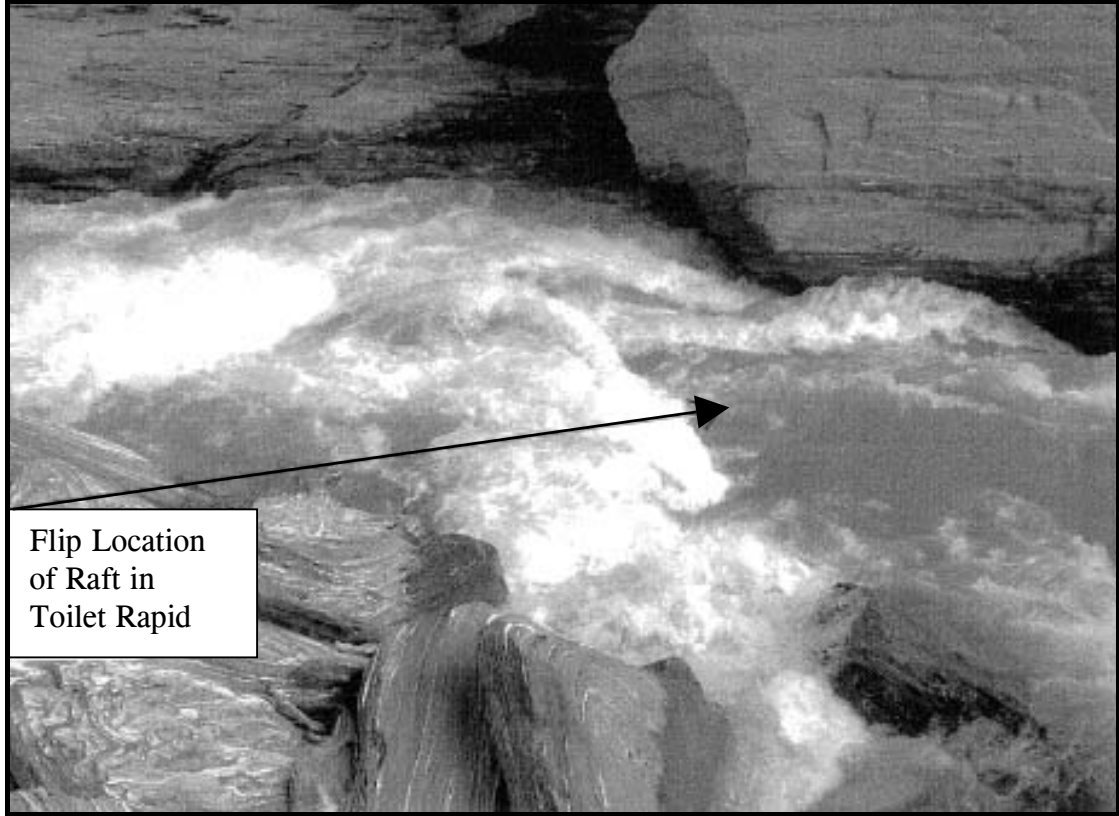
**Appendix 2** Photograph 3

- 1.19 At 1110 hours, **Raft 1** reached the top of the “Mother” section. Client One was positioned at the front left of the raft.
- 1.20 About three quarters of the way down the “Mother” section of rapids, is a rapid called “Toilet” (*See Appendix 2 – Photograph 2*). Guide One stated they were not on the right line for entering Toilet rapid, which is located on the true river right when looking downstream. They entered the rapid on the true river left and Guide One realised they might have some difficulty negotiating this rapid. In the event, the nose of **Raft 1** caught on a rock at the top of the rapid and turned it side on to the river flow and into the hydraulic action of the rapid. The hydraulic action of the “Toilet” flipped **Raft 1** over and everyone, including Client One, fell out. This was at approximately 1118 hours (*See Appendix 2 – Photograph 3*).
