Accident Report

Fatality

23 October 2005

REPORT NO.: 05 1220

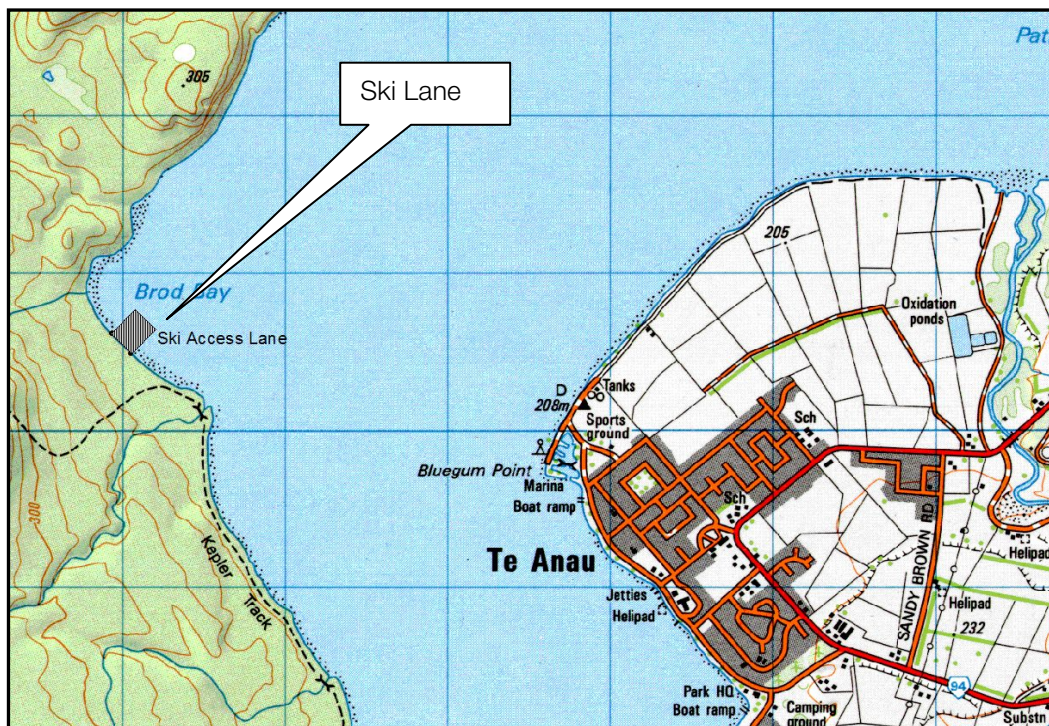
Figure 1
Topographic Map of Te Anau and Brod Bay showing ski lane

Initially, the witnesses could not confirm whether they were operating inside or outside the water ski lane but later stated that it did occur outside this area (See Figure 1 – Topographical Map of Te Anau & Brod Bay showing ski lane). There was only one other vessel on the water in the Bay and this had no influence on the outcome of the accident.

A pair of orange poles situated on the beach mark the ski lane. When the poles are aligned, they indicate the limits of the ski lane. There is also a small black plastic container in the water, which marks the outer extremity of the ski lane. This was very difficult to see. Initially, witnesses were unable to say whether or not the accident had occurred inside or outside the ski lane but later stated that it had been outside this area (See *Figure 1 – Topographical Map showing Ski Lane*).

- (b) Mark out the ski lanes in a manner that is readily apparent to all those on the water in the area.
2. It is recommended that Maritime New Zealand, in conjunction with the National Pleasure Boating Forum, investigate the possibility of implementing the following in a Maritime Rule:

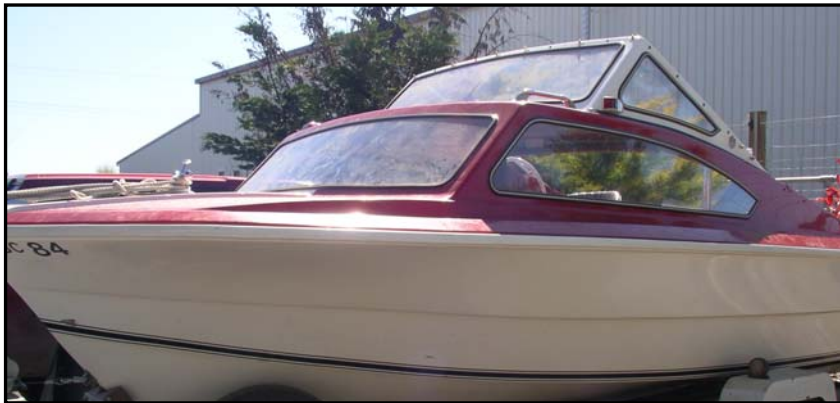
Photograph 2
Towing Vessel

The Driver and Owner of the towing vessel (See *Photograph 2 – Towing Vessel*) was the father of Kirsten. His vessel was a 4.9 metre fibreglass Sea Nymph with an 86kW Evinrude outboard motor. The Driver was an experienced Skipper and recreational boater. He had owned and crewed recreational boats for over 30 years.

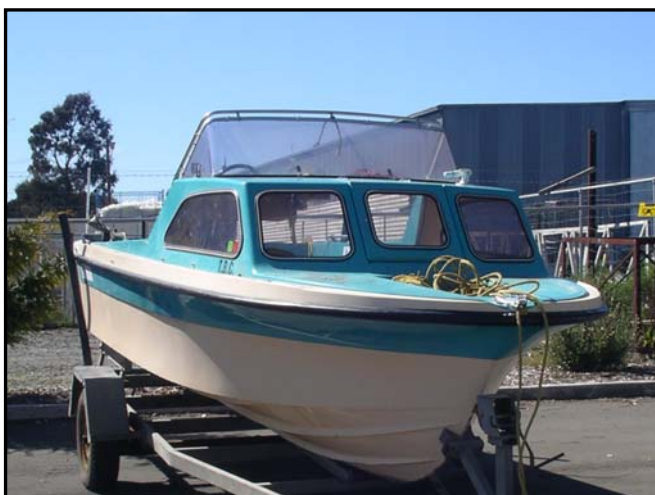
Photograph 3
Marlborough Rapier

The Skipper and Owner of *Marlborough Rapier* (See *Photograph 3 – Marlborough Rapier*) was a male aged 40. *Marlborough Rapier*, a 4.9 metre fibreglass vessel, is powered by a 86 kW Mercury outboard motor. The vessel had been in the Skipper's family since it was bought in the mid 1970's. The Skipper of *Marlborough Rapier* was also an experienced Skipper and recreational boater who had approximately 28 years of both lake and sea experience and would go out on an average of once or twice a month. He held a Marine VHF Radio Licence. He did not hold a Boatmaster's Certificate. Witnesses described him as being a very competent Skipper.

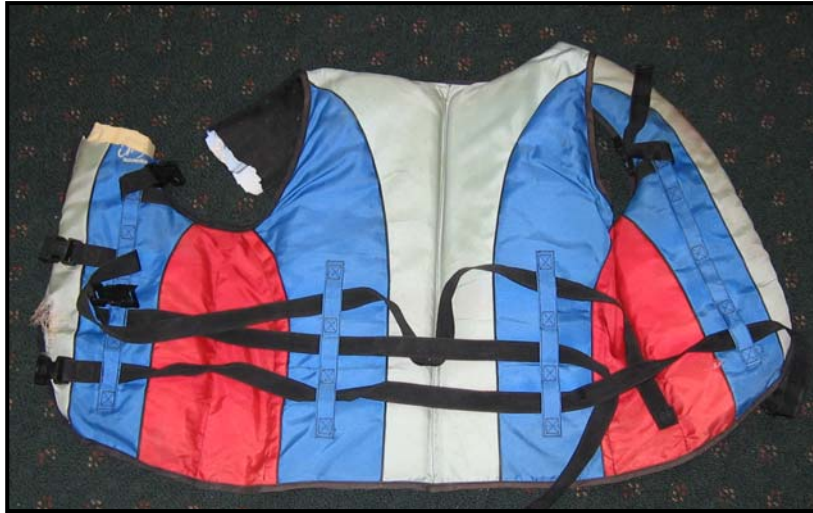
Photograph 4
Kirsten Flynn’s Buoyancy garment

At the time of the accident she was wearing a swimsuit, a dark coloured wetsuit and a blue, red and white Hutchwilco Type 405 buoyancy garment (See Photograph 4 – Kirsten’s buoyancy garment).

The Driver of the towing vessel and some of the witnesses on the beach stated they could clearly see Kirsten while she was in the water and swimming towards the biscuit and that the two red segments of the lifejacket she was wearing were particularly noticeable. Kirsten's parents maintain that the environmental conditions would not have obscured her from anyone who was keeping a proper lookout.

4. It is recommended that Maritime New Zealand liaise with the manufacturers of lifejackets and life vests in New Zealand with a view to their critically reviewing the colour of these garments and/or ensure the provision of fluorescent tape/stripes on or about the shoulders and around the top of the back/neck line of the wearer to ensure their maximum visibility to others on the water.

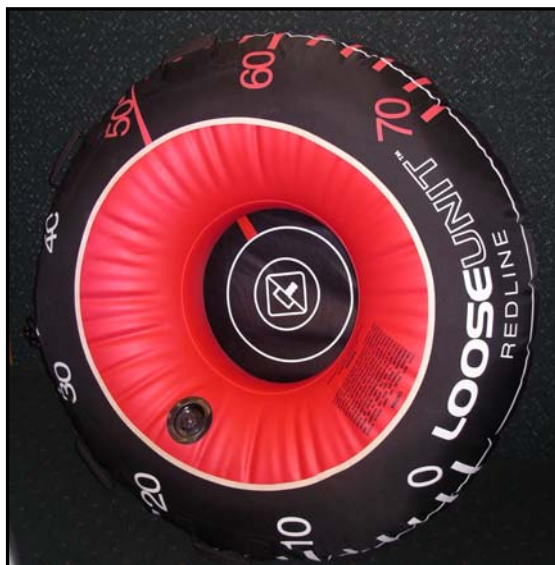
Photograph 5
Single Chamber Ski Biscuit

The children had been having fun in two ski biscuits (See Photographs 5 & 6 – Single & Double ski biscuits). There was a single chamber and a double chamber biscuit.

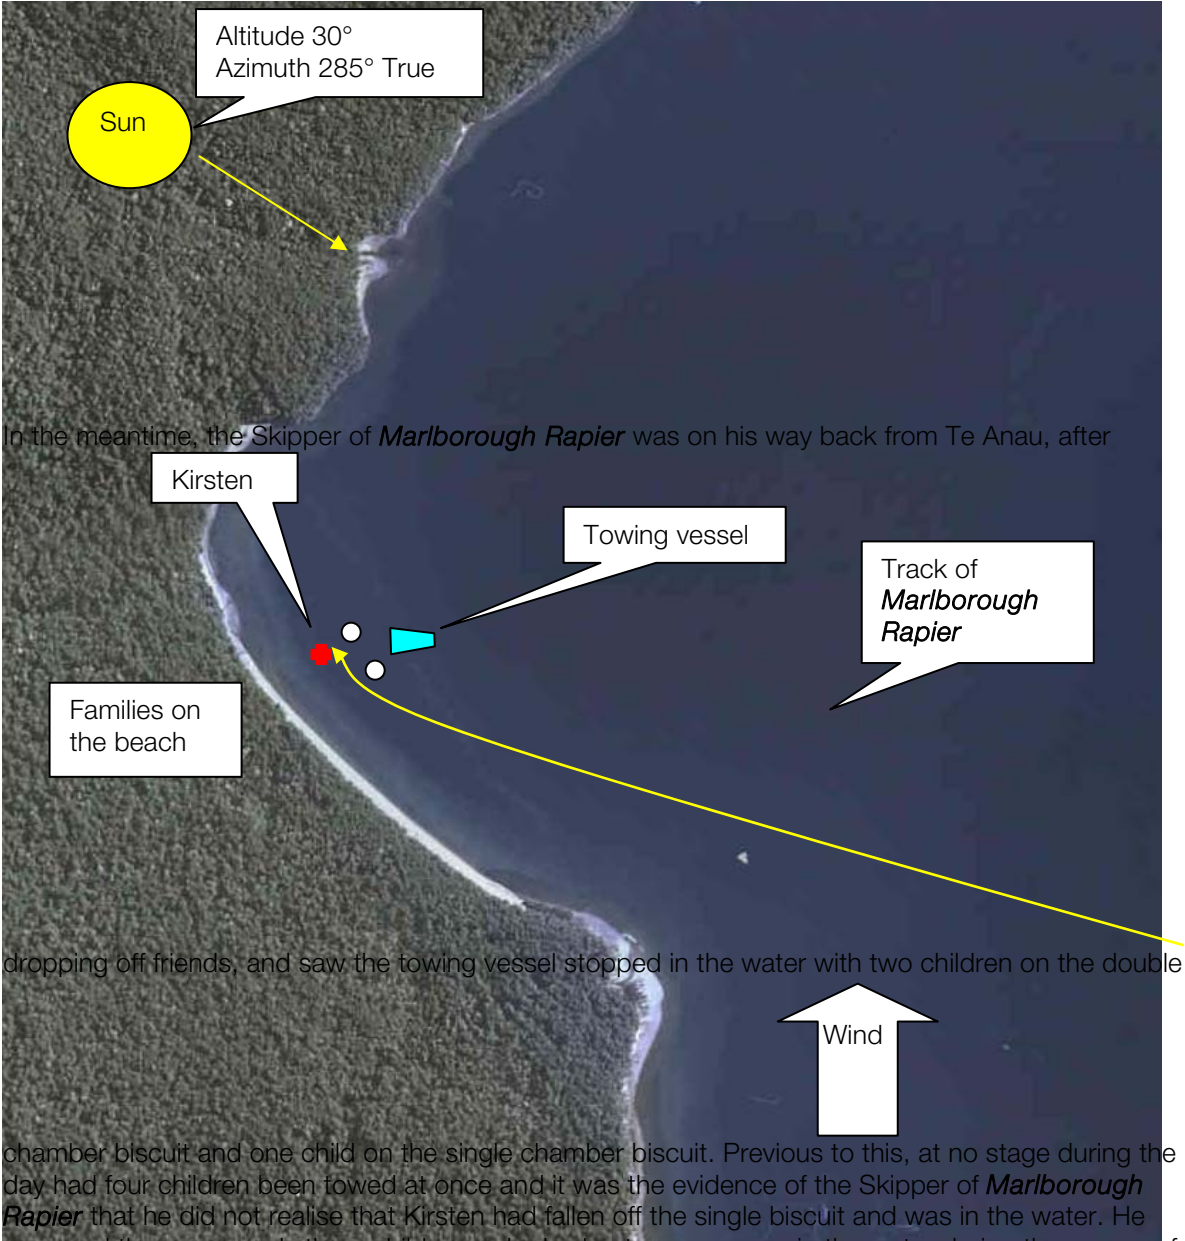
The southerly breeze meant that the wake of the towing vessel was blowing in the children's faces, so they (the Driver and Observer) decided to pull them back to the beach. They started an anti-clockwise circuit. The towing vessel motored parallel to the beach, about 100 metres off at the edge where the water becomes deeper and the colour of the water darker. When they were level with the families who were positioned on the beach, the Driver of the towing vessel turned to port and out towards the centre of the Lake. He gave the vessel a touch of throttle and then eased off to let the two ski biscuits slide out. Kirsten and another girl were on the outside of the turn (See Figure 3 – Aerial Photograph showing approximate positions of towing vessel and ski biscuits).

Figure 3 Aerial photograph of Brod Bay showing the approximate track of *Marlborough Rapier*, and the approximate positions of the towing vessel and the location of the two sea biscuits and Kirsten on the beach. It then turned to the left and stopped. He estimated that he was approximately 1.5 to 2

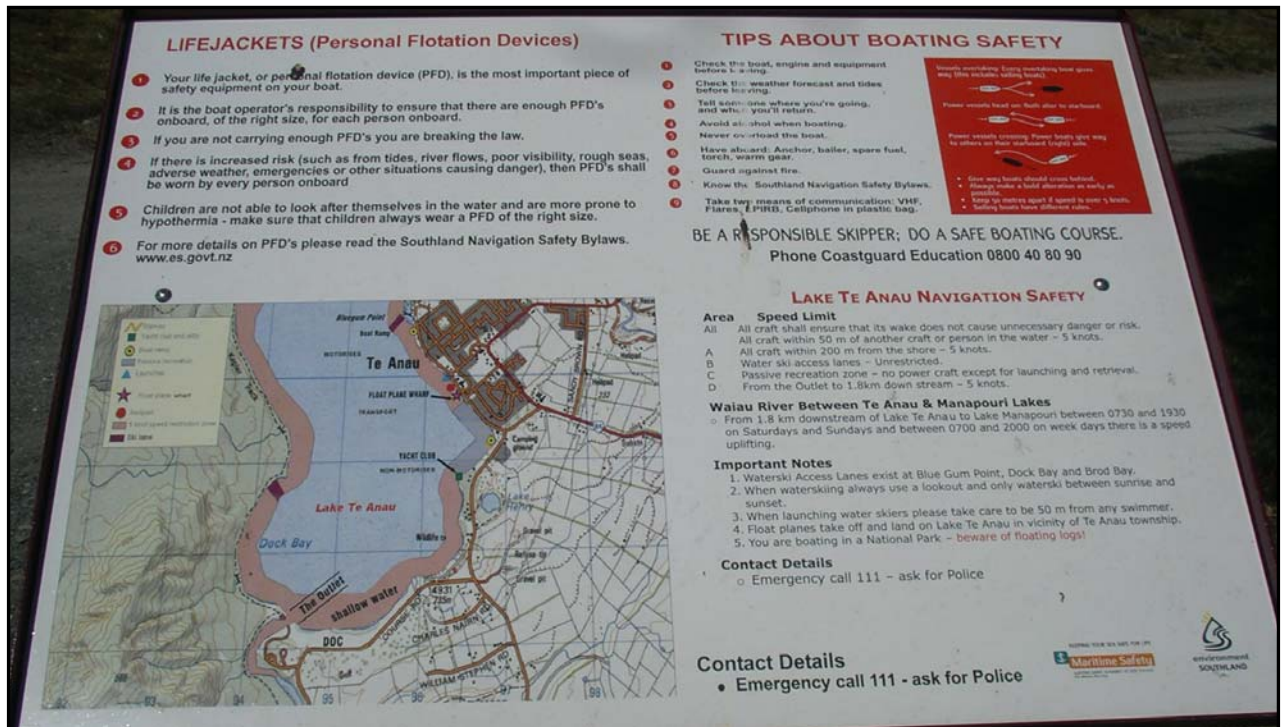
Figure 4
Safety Notice at the Boat Ramp, Issued by Southland Regional Council.

Lake Te Anau is under the Southland Bylaws. The Regional Council has erected signs at the two boat ramps stating the local rules (See *Figures 4 and 5 – Photographs of Safety Notices posted by Southland Regional Council*).

1. It is recommended that Southland Regional Council undertake the following actions:
 - (a) Investigate replacing the signs at the boat ramps with larger signs so as to capture the attention of users of the boat ramps.
