Accident Report

Grounding

Venture

18 April 2006

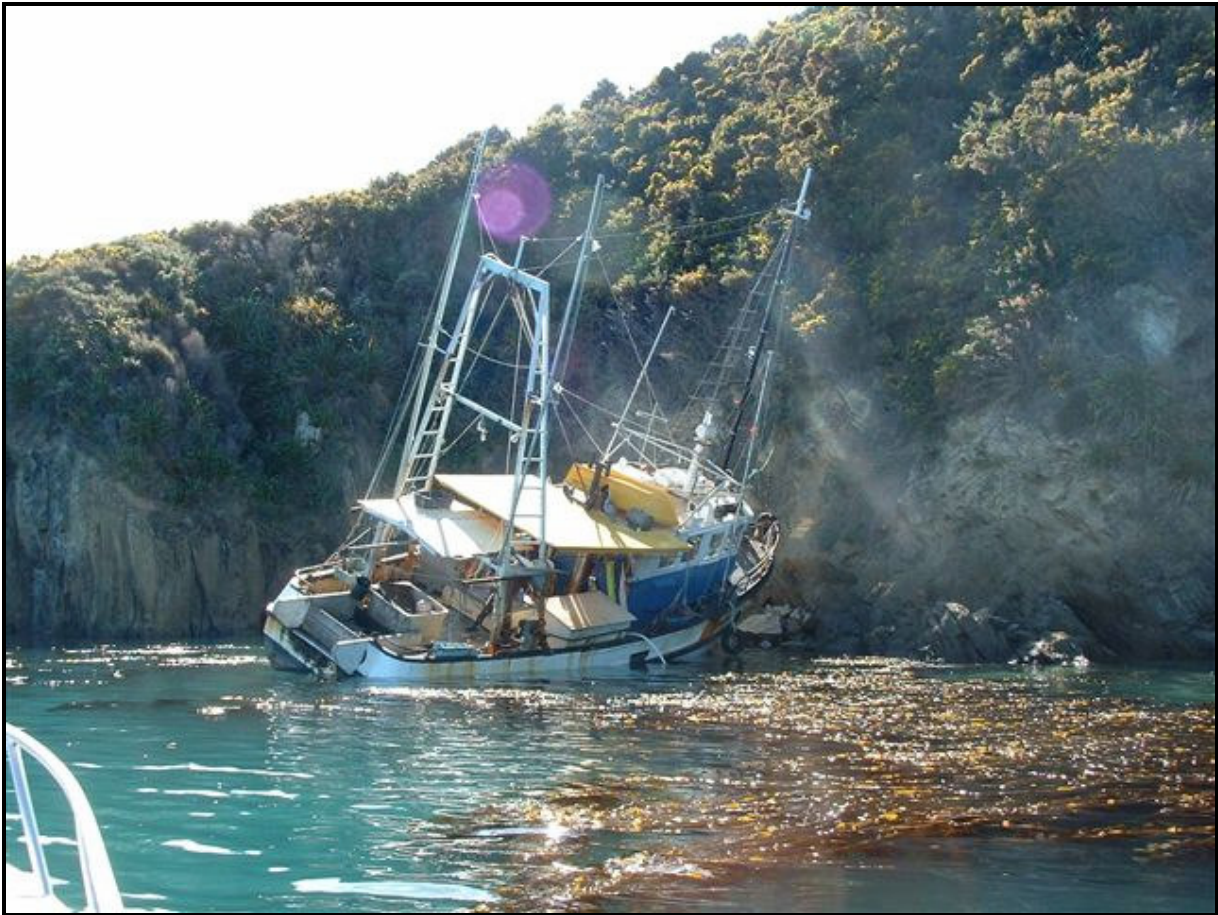
Photograph 1
Venture aground

The vessel grounded on sand and the force of the grounding was such that neither the Deckhand nor the Skipper's nephew woke up.

As the vessel lay over on the falling tide some water entered the after hatch. The space was pumped out several times to keep it dry. The hull remained watertight. The bow was caught on a sandbank but the stern was in deep water.

1. The Skipper of **Venture** be censured for failing to observe **Marlborough District Council Navigation Bylaws 2002 3.3 (iii)**.
2. The Skipper of **Venture** establish procedures for managing fatigue on board his vessel as required by **Maritime Rules Part 31C.15**. These procedures should be presented to the Safe Ship Management Company for approval within 2 months of the release of this report.
