Accident Report
Foundering resulting in 2 fatalities
Viper 1
16 March 2009

Maritime New Zealand

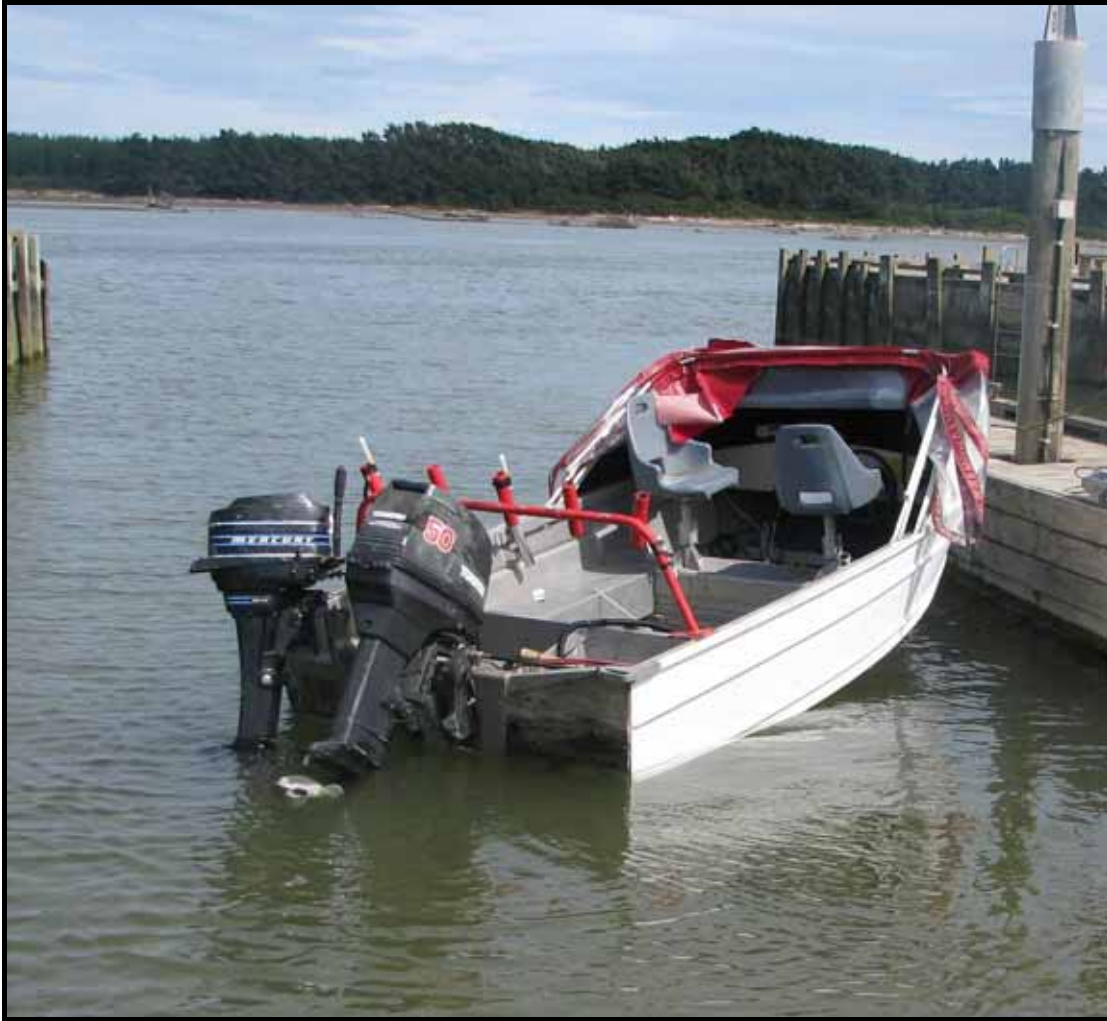
Photograph 2

The rod holder, pedestal seats, canopy, and plywood stern strengthening added to the vessel.

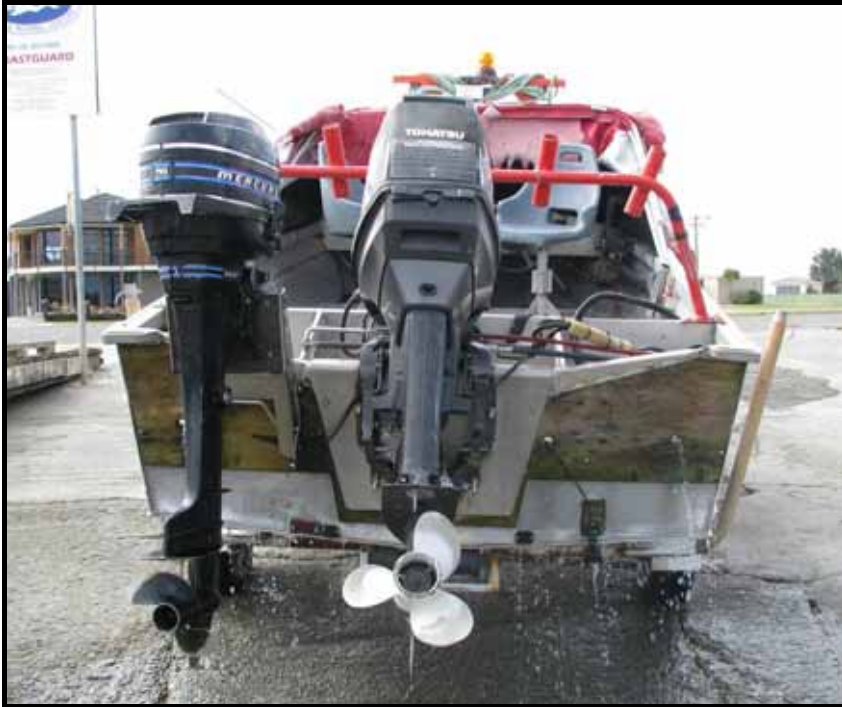
3.19 A piece of marine plywood had been attached to the transom to offer further support. The investigation could not determine when this was attached or by whom. The plywood showed signs of weathering and had begun to deteriorate, with rot showing in some areas giving the appearance of having been on the vessel for several years. The plywood had also come away from the stern by as much as 15 mm around the transom-well drainage holes. This allowed water to freely ingress behind the plywood, placing additional weight and pressure on the stern.

Photograph 8
The marine plywood attached to the stern.

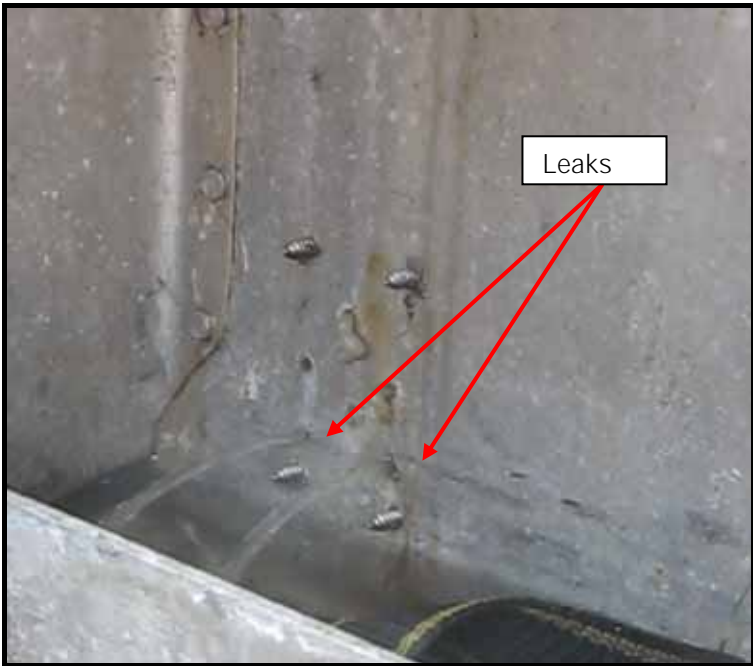
- 3.21 Photograph 10 shows water flowing freely through the two old transducer screw holes. These holes are situated behind the battery box on the starboard side of the vessel. Two other old holes had been repaired with silicone sealant, and it is unknown if all of the holes were repaired in this way and the silicone failed, or if these holes were never filled.
- 3.22 At some stage silicone sealant had been added to the transom-well. This was most likely done to fill gaps that caused water to run from the transom-well into the floor space. The sealant had deteriorated with age and come away from the gaps it was intended to fill. With the freeboard reduced, water that drained into the transom-well soon found its way through these gaps and into the floor space.

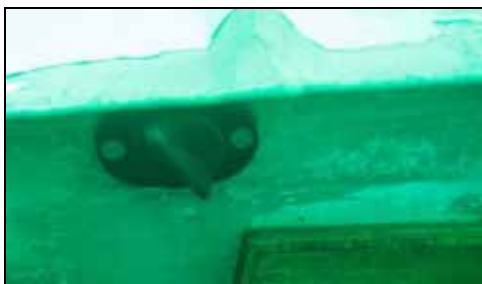
3.27 Both of the bungs were secure when recovered from the seabed. The bungs were well fitted and did not leak.

Photograph 15
The bungs were secure.

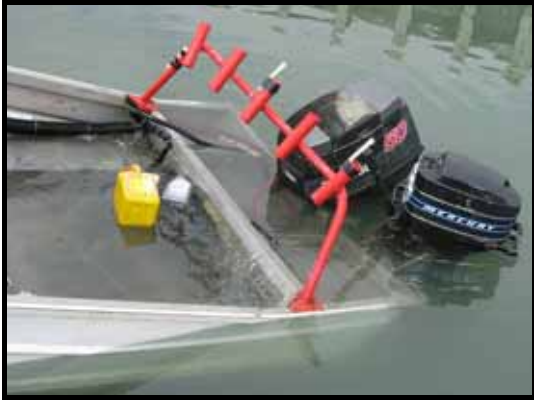
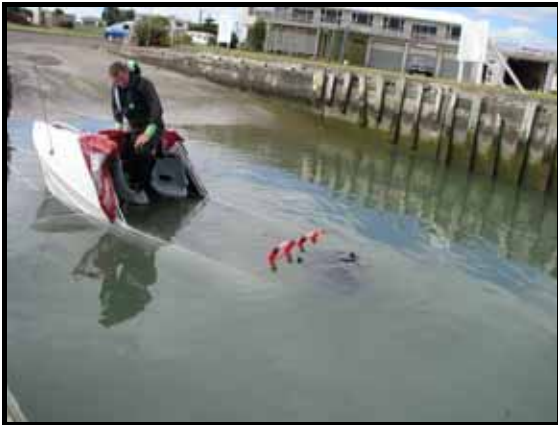
Photograph 17
Viper 1 in the stability test at 26 minutes.

Photograph 18
Viper 1 in the stability test at 26 minutes, 30 seconds.

Photograph 19
Viper 1 in the stability test at 29 minutes.

Photograph 20
Viper 1 in the stability test at 32 minutes.

Photograph 21
Viper 1 in the stability test at 33 minutes.

Photograph 22
Viper 1 in the stability test at 34 minutes.

- 3.39 After 34 minutes in the test environment *Viper 1* had completely sunk. Note that in Photograph 22 the bow has come to rest on the trailer.
- 3.40 With the leaks situated in the transom area it is considered unlikely that the vessel would take on water while underway.

- 3.43 Any small waves or chop would cause the bow to lift even higher, and subsequently drive the stern lower into the water. As shown in the photographs taken at 32 and 33 minutes in the test, once the corner of the vessel is submerged water pours in rapidly and *Viper 1* sinks.
