Accident Report
Wakanui
Head Injury - Buller River on
2 February 2005
Class B Non Serious Harm

REPORT NO.: 96 364

WAKANUI – HEAD INJURY

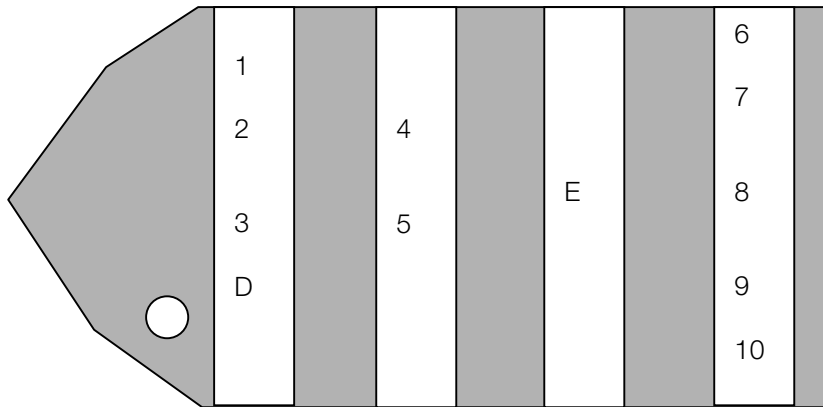
D – Driver

E – Empty

4 – Injured passenger

5 – Partner

- Three male passengers from a Kiwi Experience tour seating 1, 2 and 3. These passengers chose to sit at the front.
- The injured passenger and his partner were seated in 4 and 5. They also chose their seats.
- Seats 6-10. A family of five consisting of husband and wife with their two children and grandmother (age 78). The driver recommended they sit at the back, as it was the least turbulent part of the boat.

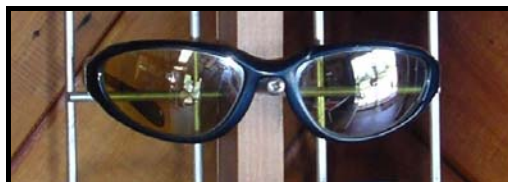
Sunglasses

The lacerations appeared to be caused by contact with the broken sunglasses.

The plastic sunglasses were UV rated. However, they were not safety glasses. The company has since purchased safety glasses for passengers on their jet boats.

Injuries caused by banging a head on the seat/rail or person ahead had not been identified as a hazard and no account was taken on how injuries could be exacerbated by wearing non-safety sunglasses.

- Update the hazard identification sheets to include the handrail as a potential hazard
- Review and update the Safe Operational Plan on a six monthly basis or as required in the event of change
- All drivers to sign the SOP
- Purchase new flares
- Replace glasses with safety glasses
- Update training records in accordance with the new training sheets in the SOP
- Hold a copy of all employees' first aid and medical certificates
