Class B Accident Report

**West Bay Water Taxi
and Kontiki
Collision**

Picton Harbour on 14 November 2004

REPORT No: 04 3602

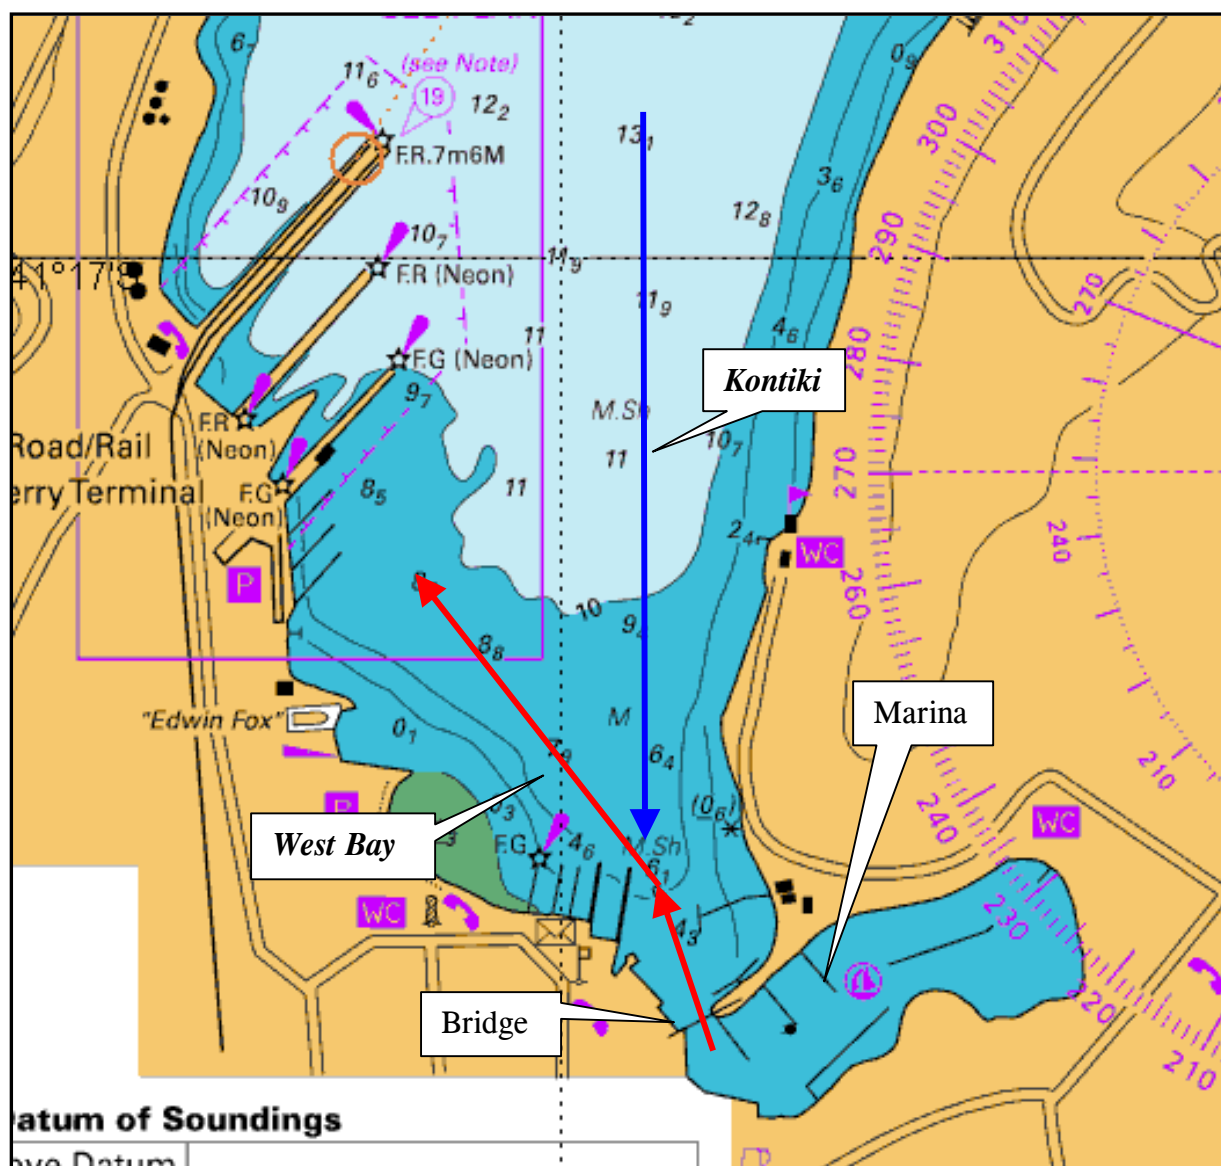
APPROXIMATE COURSES AND POSITIONS OF *WEST BAY* AND *KONTIKI*

West Bay exited the marina at three knots. When the Skipper reached the end of the town wharf, he altered course to port towards his berth at the ferry terminal. He was looking at his passenger whilst answering a question when he suddenly looked up and saw *Kontiki* for the first time, about five metres off his starboard beam.

Kontiki observed *West Bay* exiting the marina. *West Bay* was the give way vessel. The Skipper was expecting her to alter course to starboard around their stern. The Skipper of *Kontiki* started to veer to starboard, as he was unsure whether *West Bay* would give way. At this stage *Kontiki* was about 40 metres off the marina breakwater.

Kontiki hit *West Bay* head on at about one knot and then rode up her starboard side midships pontoon.
