Accident Report

Crane Failure

Sea Harvest

22 August 2005

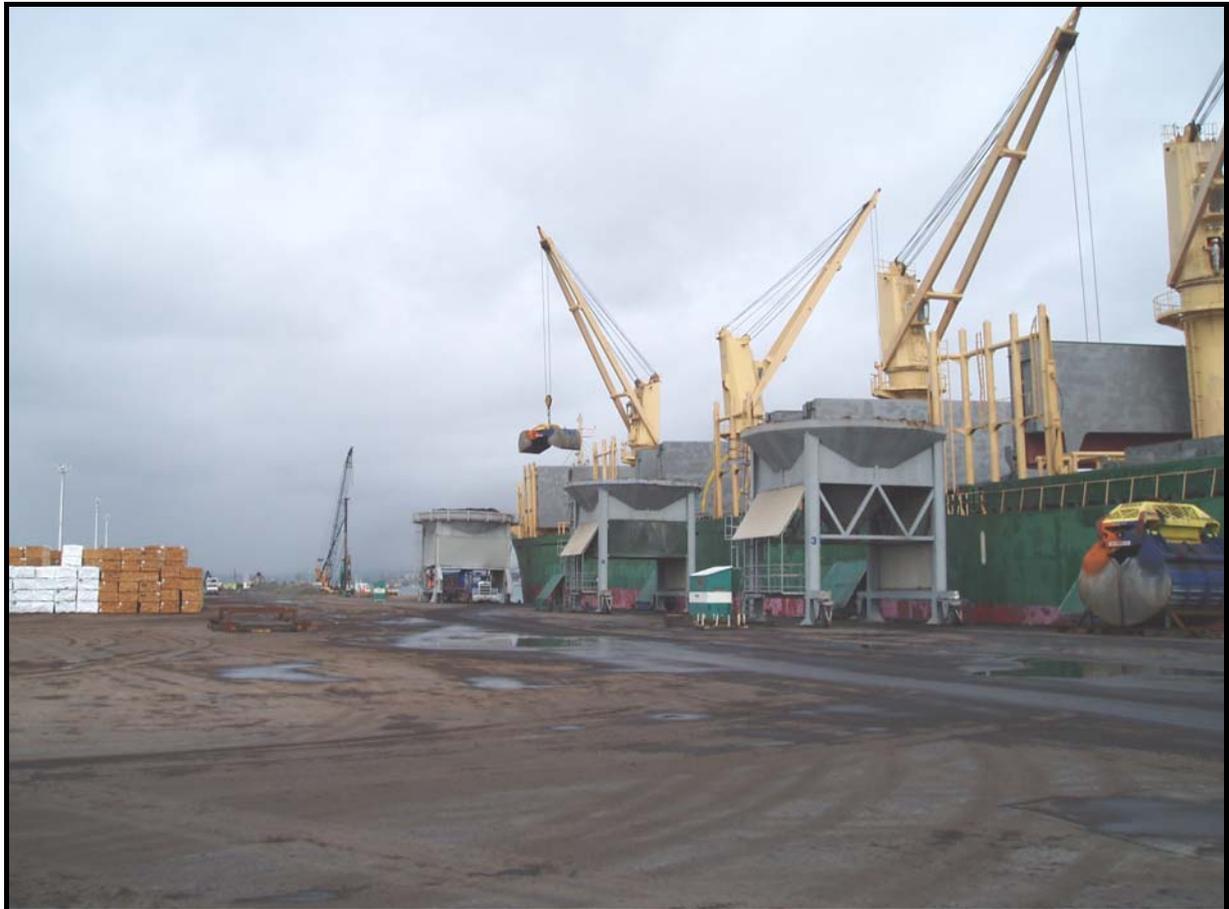
Photograph 1

On 21 August 2005, **Sea Harvest** arrived at the Port of Tauranga and berthed port side to at No. 9 berth, Mount Maunganui. At 2330 hours New Zealand Standard Time (NZST) the vessel commenced discharging coal into hoppers for loading into road vehicles (See *Photograph 1*). Work proceeded through the night.

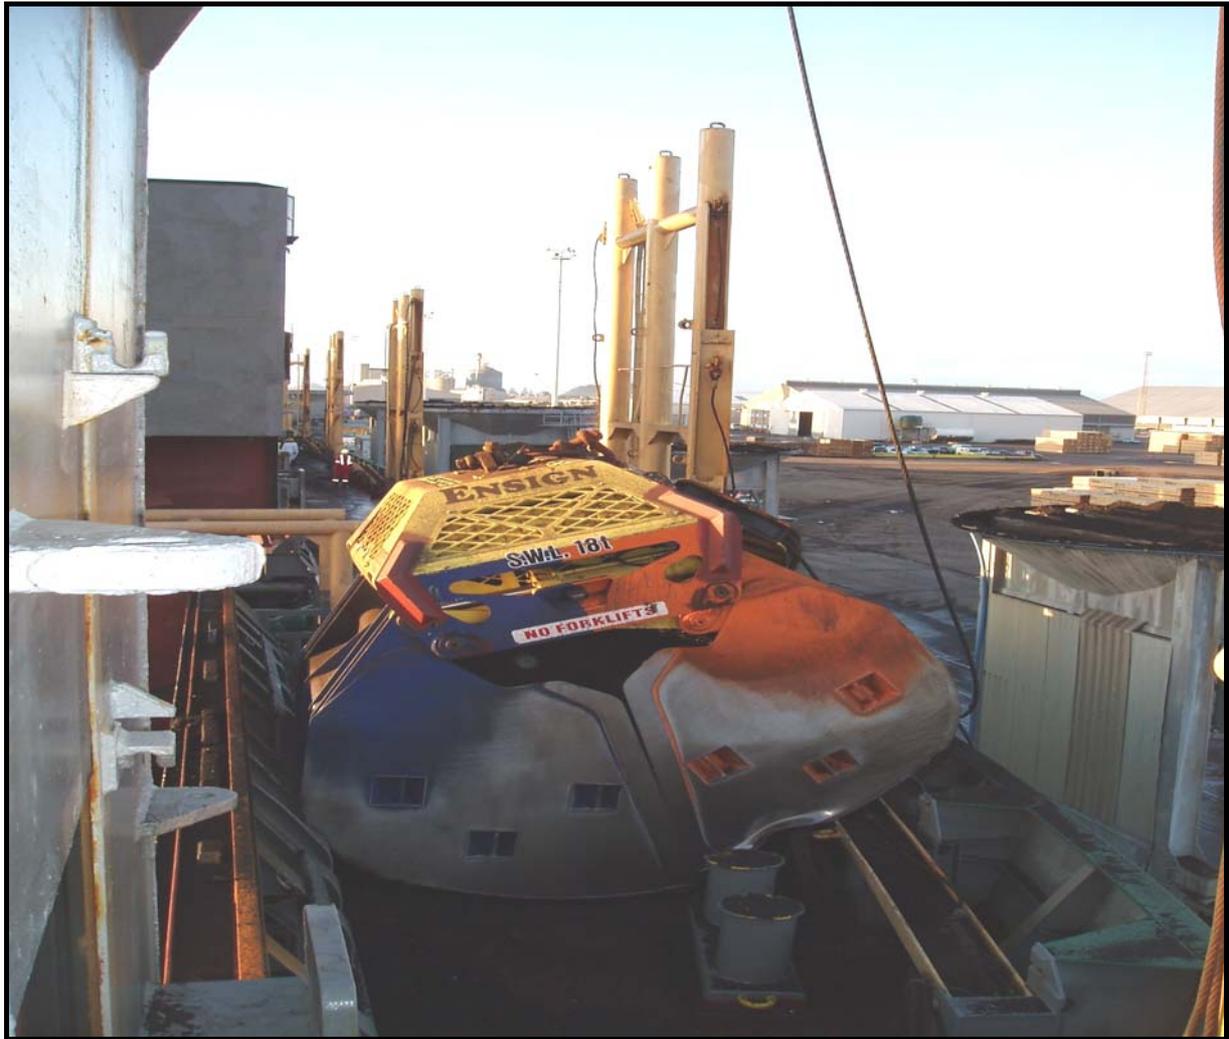
Photograph 2

On 22 August at 1550 hours, No. 1 crane lifted a grab filled with cargo from No. 1 hold and slewed it towards the hopper. When the grab was over the deck on the port side, the crane hoist wire parted, dropping the grab and its contents onto the narrow deck between the bulwark and hatch coaming (See *Photograph 2*).

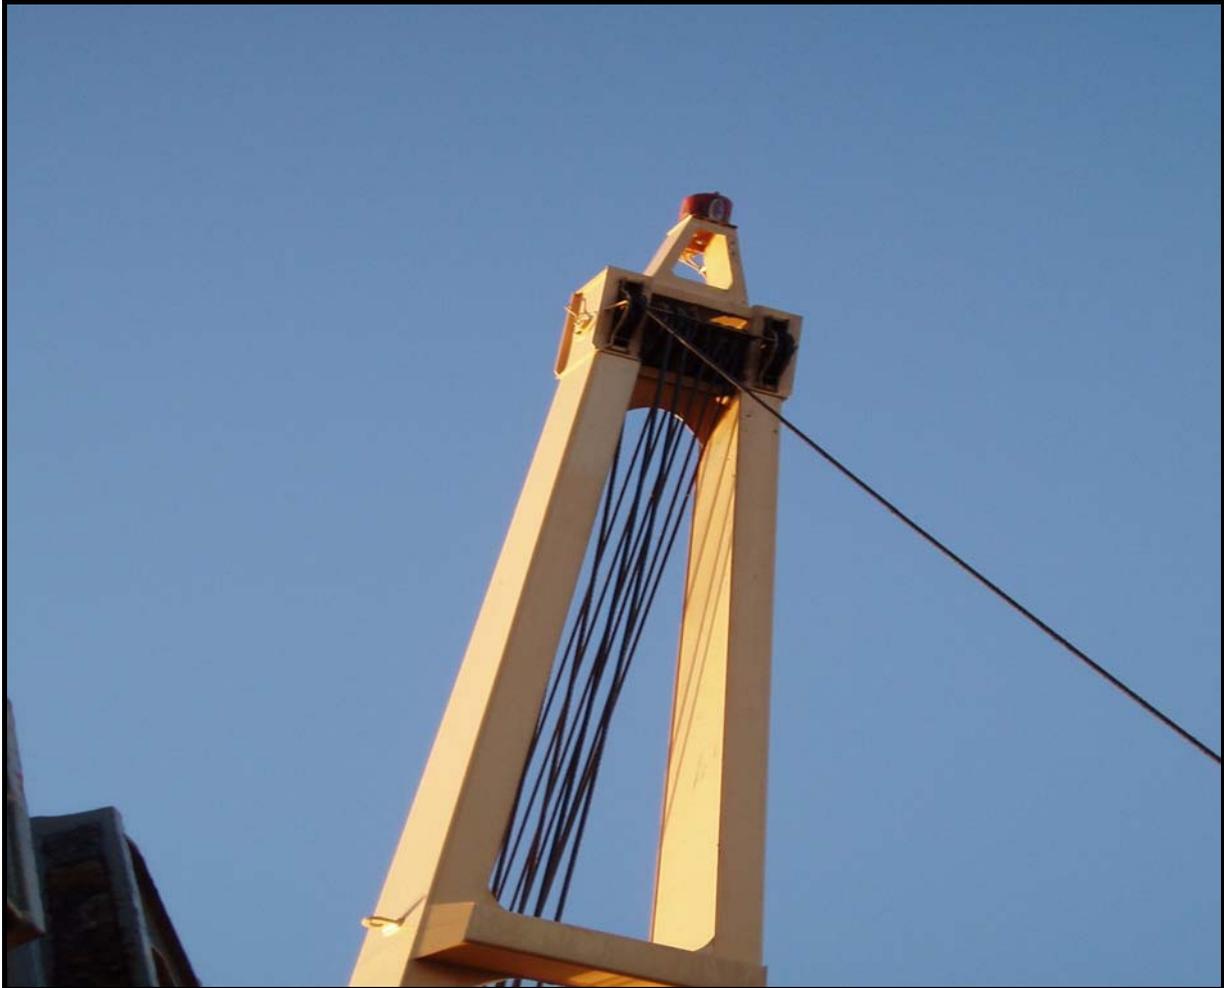
Photograph 3

There were no injuries. The deck plating was dented to a depth of about 25 mm but was not pierced. Two steel log stanchions stowed next to the bulwarks and the stiffeners alongside the hatch coaming were bent.

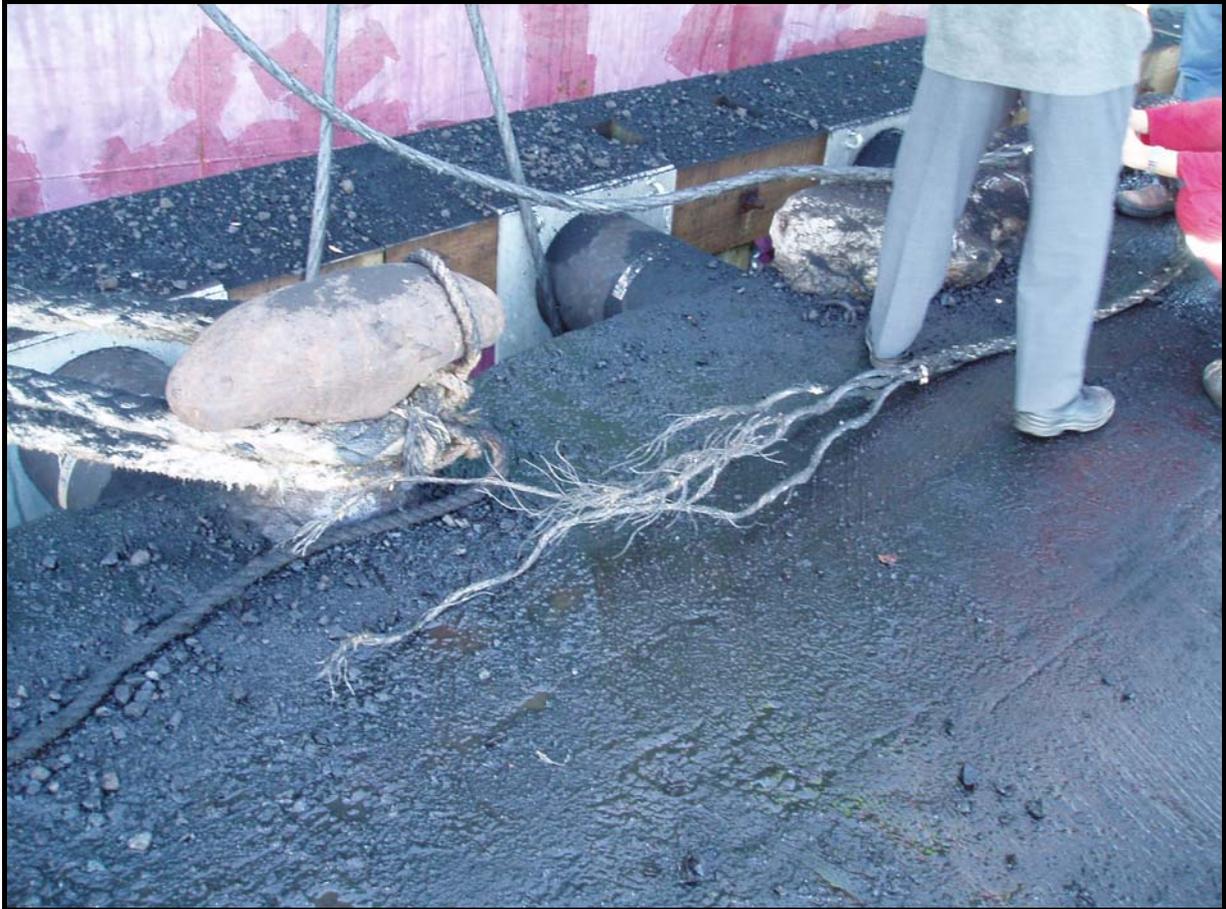
Photograph 4

The hoist wires fitted in 2003 were described as 4 x SeS(39), ie. 4 stranded wire rope with 39 wires per strand with a specified breaking load of 79.3 tonnes. Having 39 wires per strand, the replacement wire rope would be less flexible than wire rope of 48 wires per strand and therefore prone to suffer metal fatigue when passing through sheaves.

On the basis that the hoist wires fitted to the cranes in 2003 did not meet the manufacturer's specifications and that two hoist wire ropes had failed within a few hours of each other, the Master was advised that the cranes were not to be used to work cargo until the hoist wires had been replaced. Since there were only three replacement hoist wires on board, only three cranes were permitted to discharge or load cargo. The new wire rope fitted to No. 1 crane met the manufacturer's specification, but the other two wire ropes did not. They were 4 stranded ropes with 39 wires per strand and Class NK permitted their use for a maximum of one year.
