Accident Report  
Fatality  
*Unnamed Canadian Canoe*  
23 May 2008

## **Maritime New Zealand**

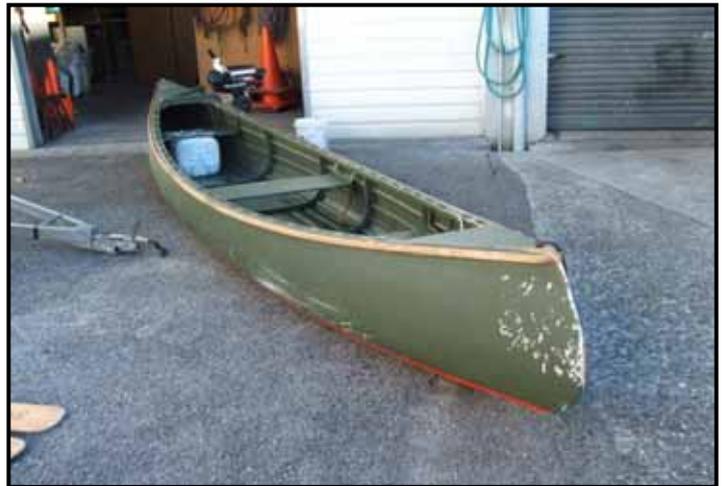
**Figure 2**  
Canadian Canoe involved in this accident

- 1.7 The canoe itself was in good condition with no discovered faults or damage that may have contributed to this accident. Communications were poor in the region making standard equipment such as a cell phone or VHF radio redundant. If an Emergency Position-Indicating Radio Beacon (EPIRB) or personal locator beacon (PLB) had been carried and activated, Search and Rescue (SAR) may have been alerted sooner. If emergency flares had been carried and set off, they may have assisted an earlier response.

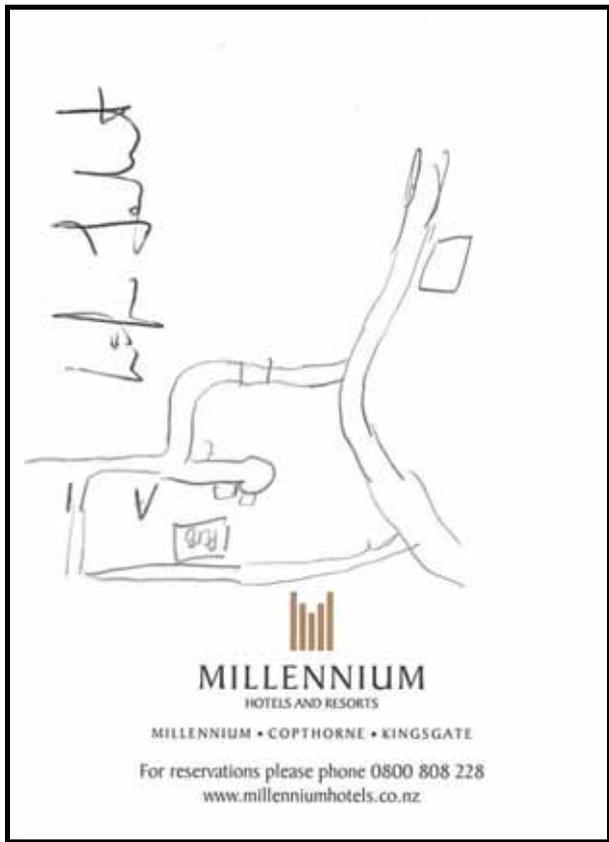
Figure 3  
Diagram showing Mr Hill's "lifejacket" notation

- 3.4 The survivor then drew a map on a small pad so that Mr Hill could find his bach in Moana the next morning. After the survivor left, Mr Hill wrote the words "Life Jacket" on that map to remind him to bring the lifejackets the next day, then left that pad on his dining room table.

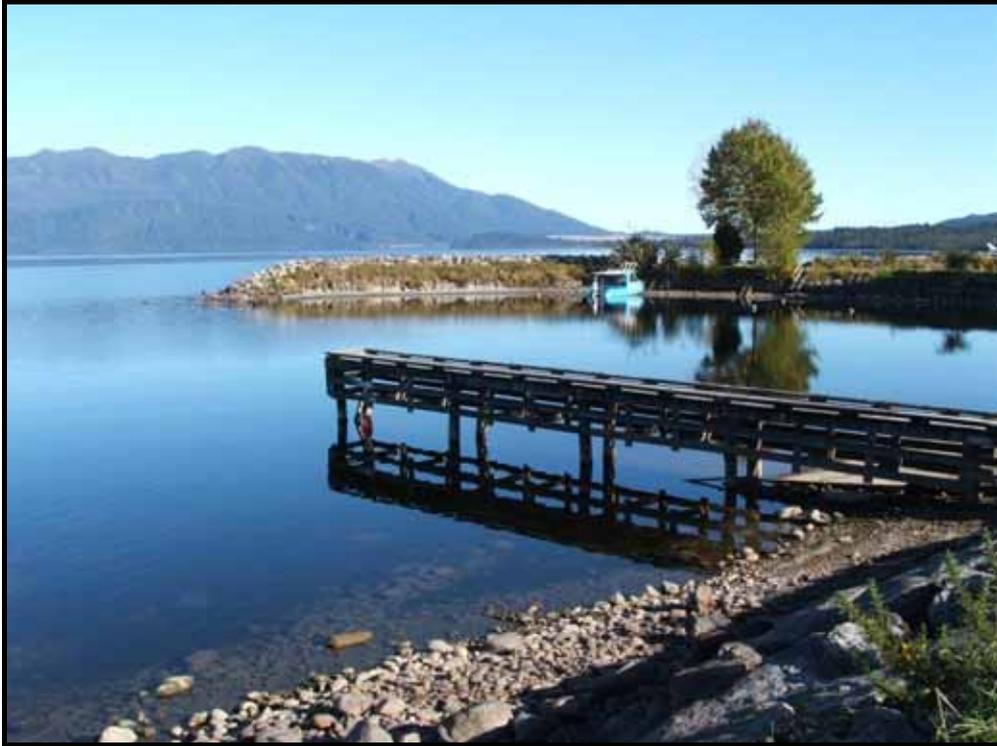
**Figure 5**

Lake Brunner was calm at the time Mr Hill left his vehicle there and a local resident who was a witness, stated that it was similar to the conditions shown in this photograph.

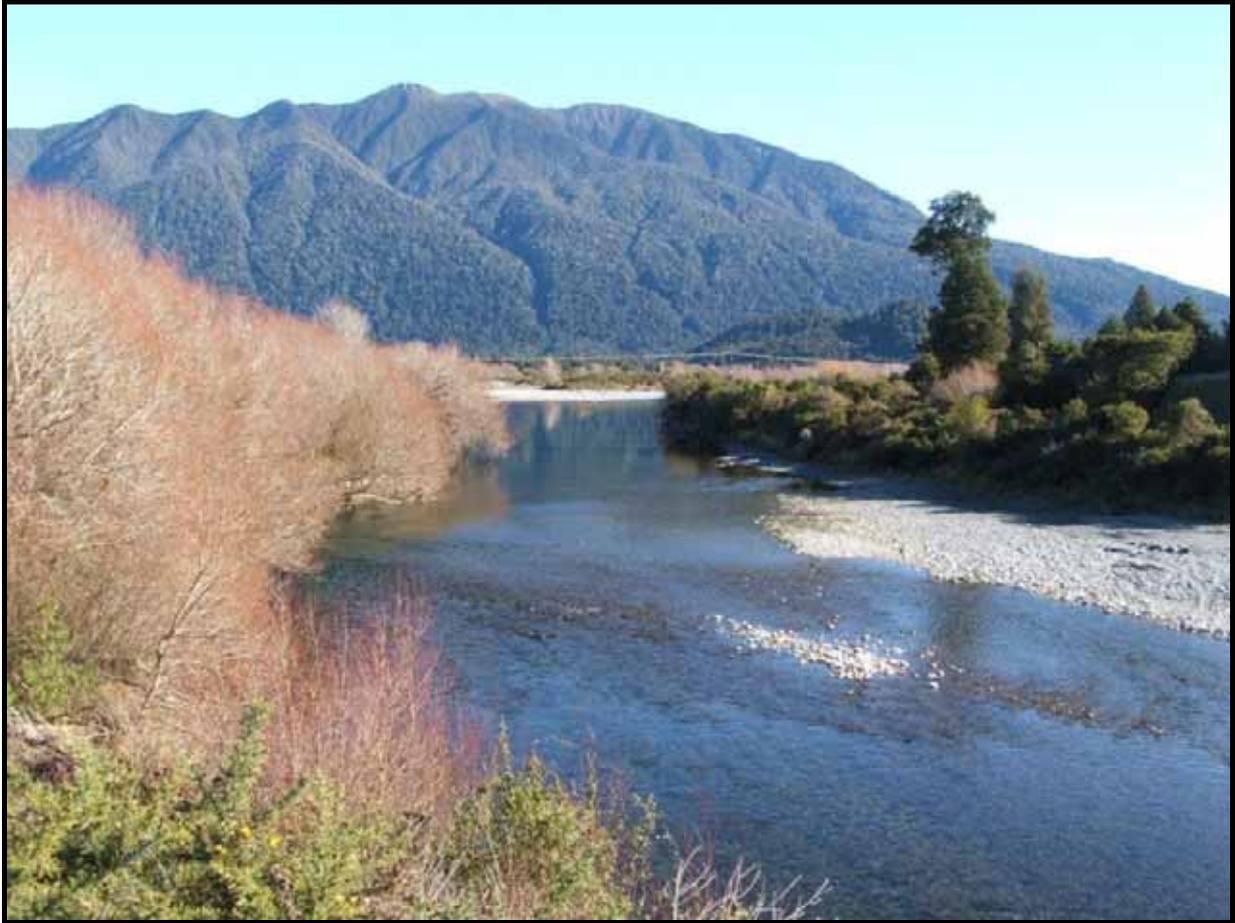
**Figure 6**

The Crooked River where the men originally intended to go duck shooting was very shallow at the time of the accident, so they decided to go to Lake Poerua instead.

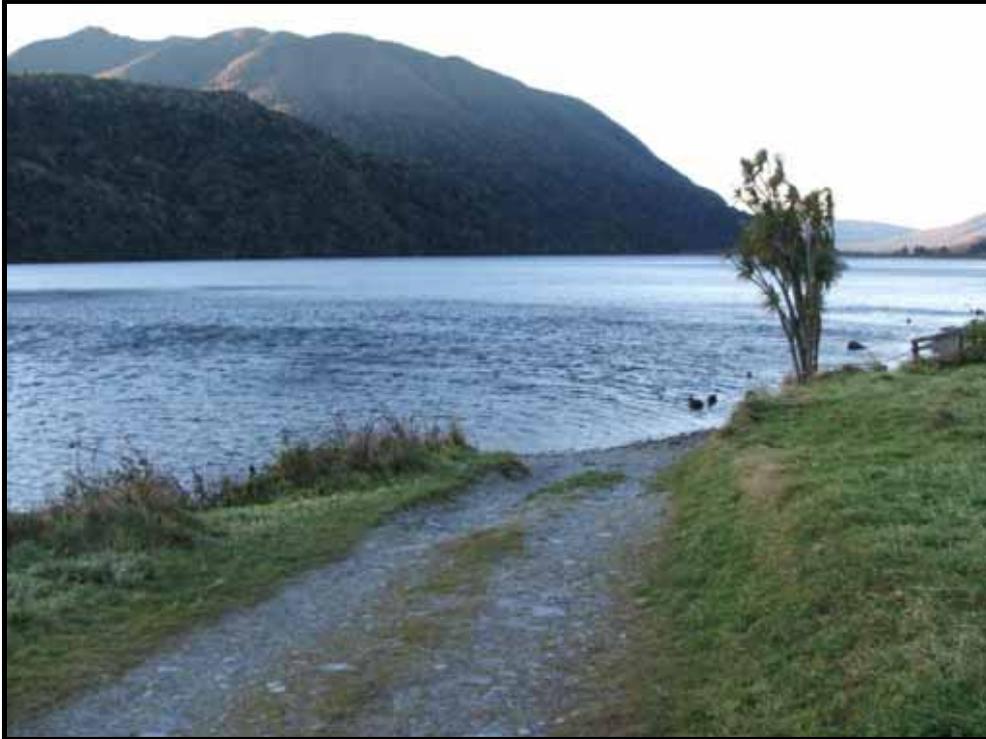
**Figure 7**

Lake Poerua looking north from the boat ramp where the canoe was launched. The men headed up the lake approximately in line with this track down to the lake's edge.

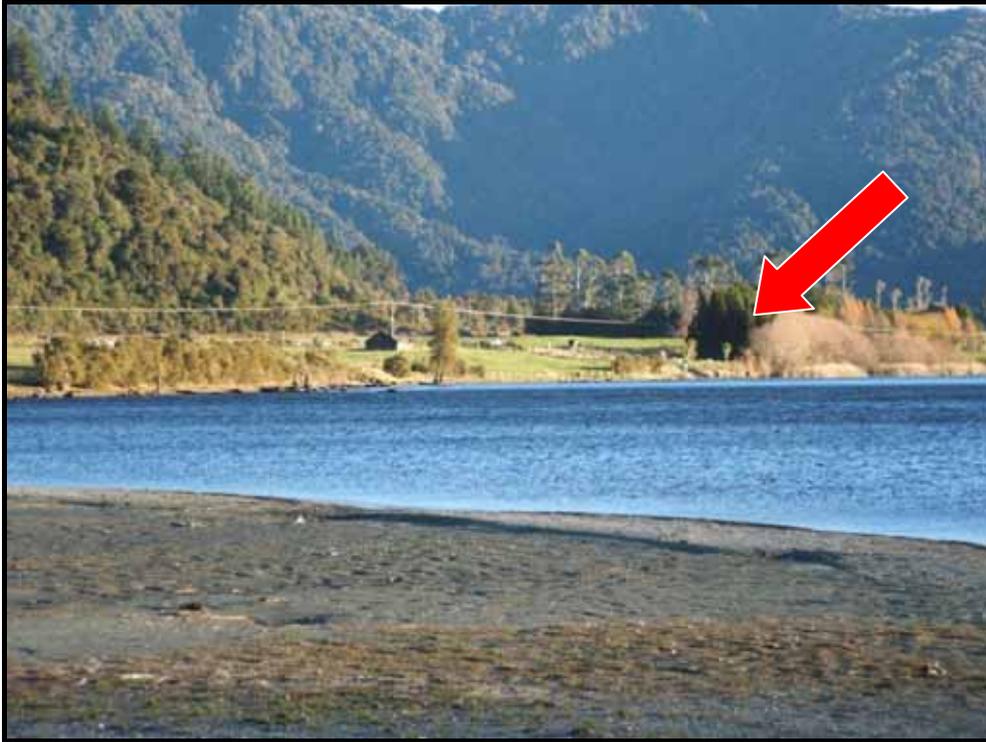
**Figure 8**

Lake Poerua looking south from the beach where the survivor eventually made it to shore. The red arrow indicates the boat ramp from where the canoe was launched, and it capsized to the right of this photograph.
