Accident Report
ANL Progress
Person Overboard at Port of
Lyttelton on 4 July 2004

ANL PROGRESS

CASUALTY DETAILS:

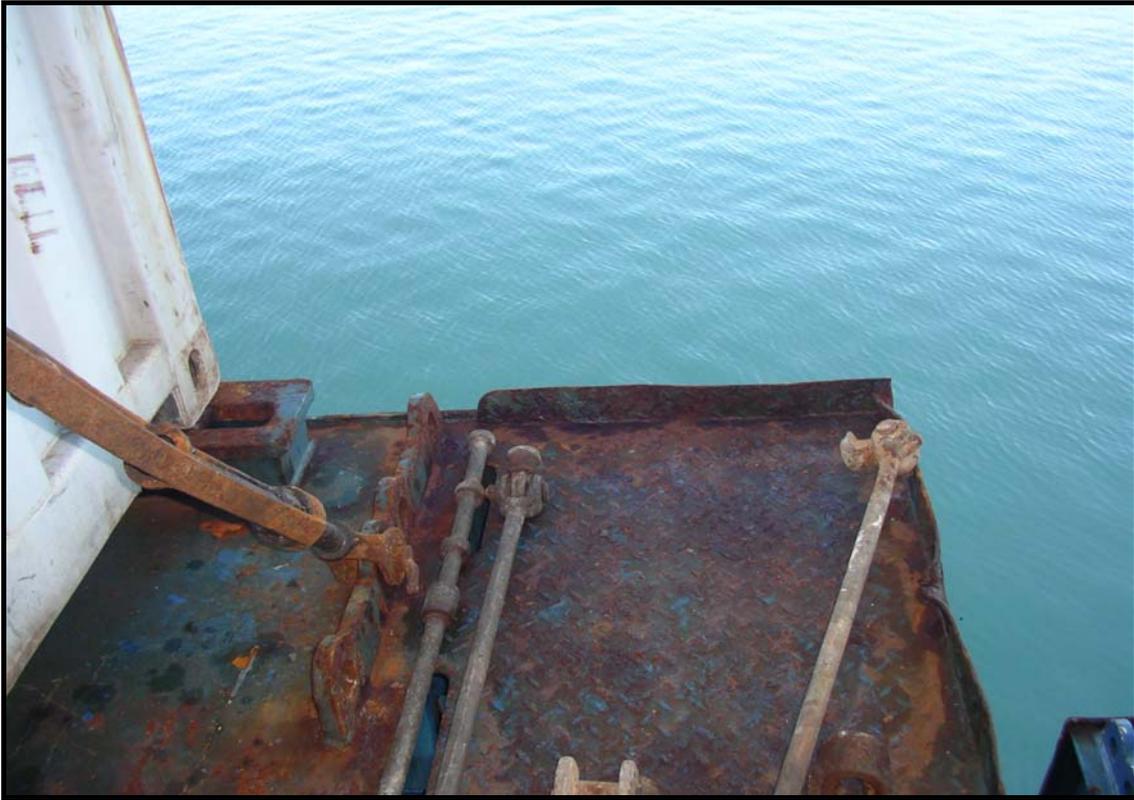
- 1.5 At approximately 0105 hours, Stevedore 1 undid the lashings on the outboard container. To do this he was standing on the lashing platform on the outboard side of the ship (See *Appendix 1 – Photos 1 & 2*). He undid the one and two high lashing bars and placed them on the deck. He then undid the first three high lashing bar (the lashing bar that is attached from the base of the first container to the base of the third container), (See *Appendix 1 - Photos 3 & 4*) and put it on the deck. He had just taken off the last three high lashing bar and was holding it upright when he lost his balance due to the vessel's movement (caused by the easterly swell coming up the harbour).

- 3.1 The weight and length of the three high lashing bar.
- 3.2 The restricted space in which the stevedore had to work.
- 3.3 Stevedore 1 was handling the bar alone.
- 3.4 The easterly swell conditions caused the vessel to range alongside the berth.
- 3.5 The lashing platform did not have a guardrail.
- 3.6 Stevedore 1 was not equipped with a fall arrest system.

Photo 1 – Lashing Platform From Which Stevedore 1 Fell

- 5.7 It is recommended that all stevedoring companies require the use of fall protection on platforms over three metres.
- 5.8 It is recommended that the Maritime Operations Division of the Maritime Safety Authority in conjunction with Occupational Safety and Health look further in to the issue of lashing safety onboard container vessels with special reference to the feasibility of fall protection.

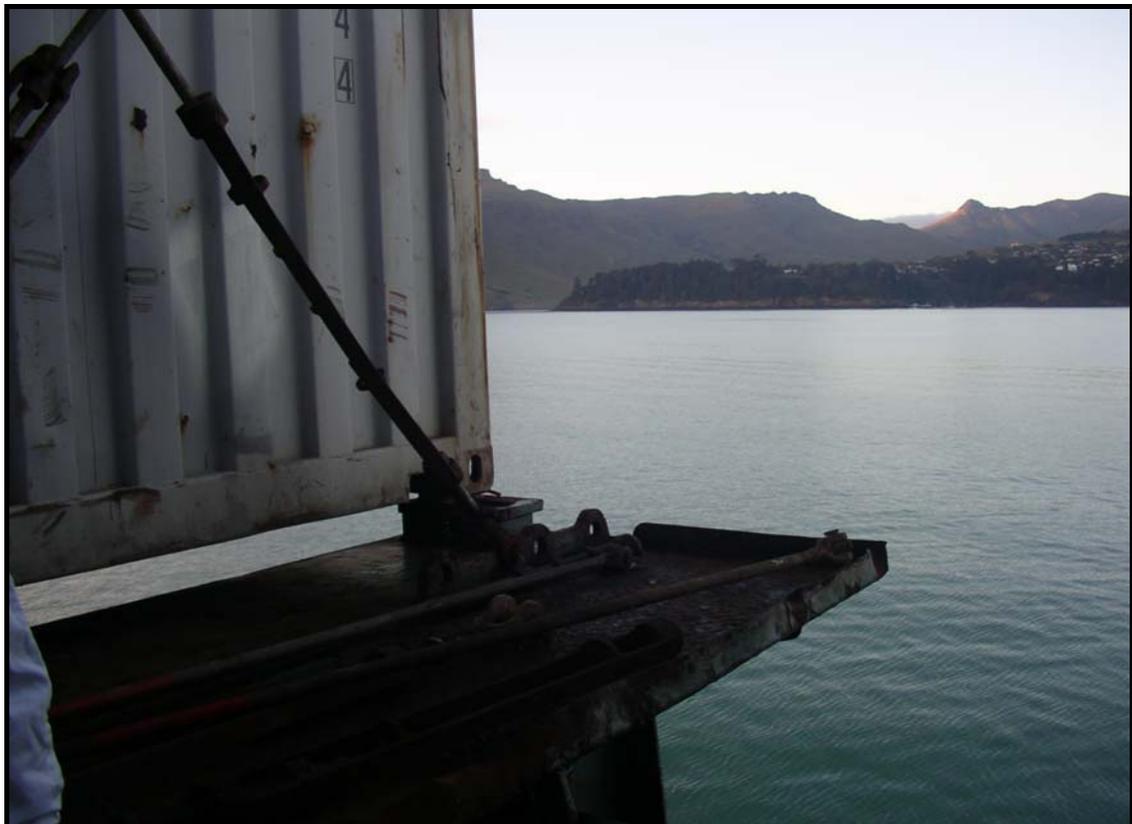
Photo 2 – Lashing Platform From Which Stevedore 1 Fell

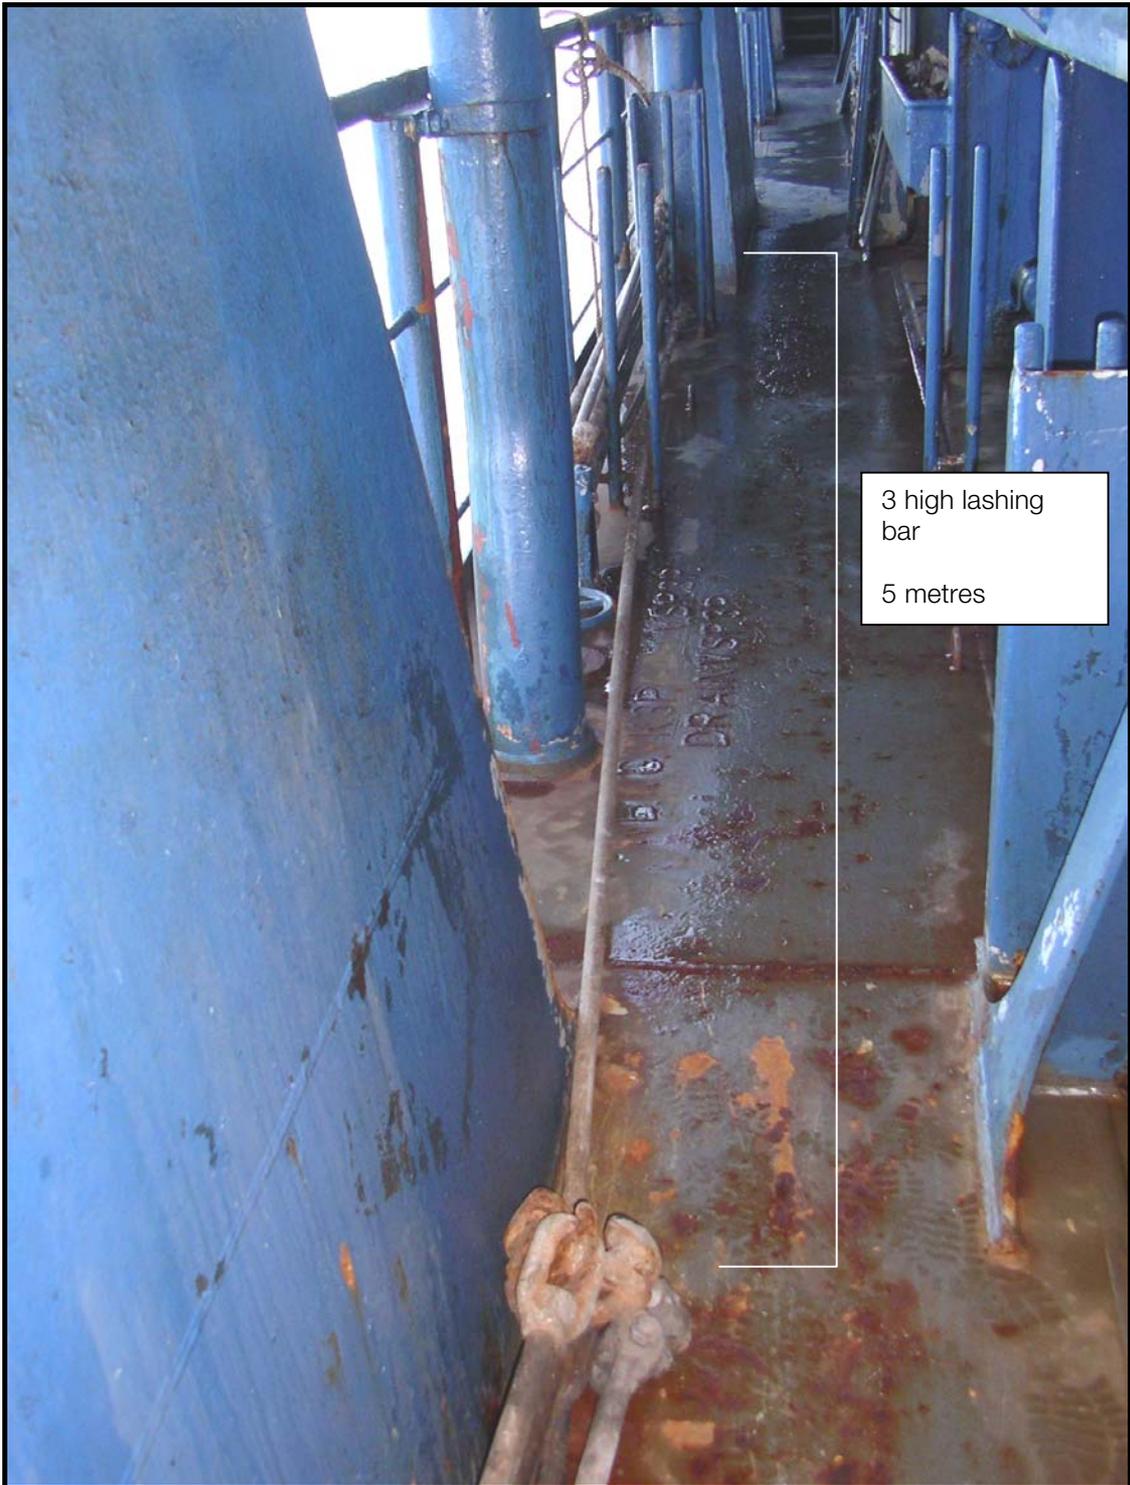
Photo 3

2.4.1 The three high lashing bars measure up to five metres in length and weigh up to a maximum of 24kgs.

3 high lashing
bar
5 metres
