Class B Accident Report

Amaltal Columbia Injury

Port Nelson, on 18 December 2004

***AMALTAL COLUMBIA – INJURY TO SHORE
CONTRACTOR***

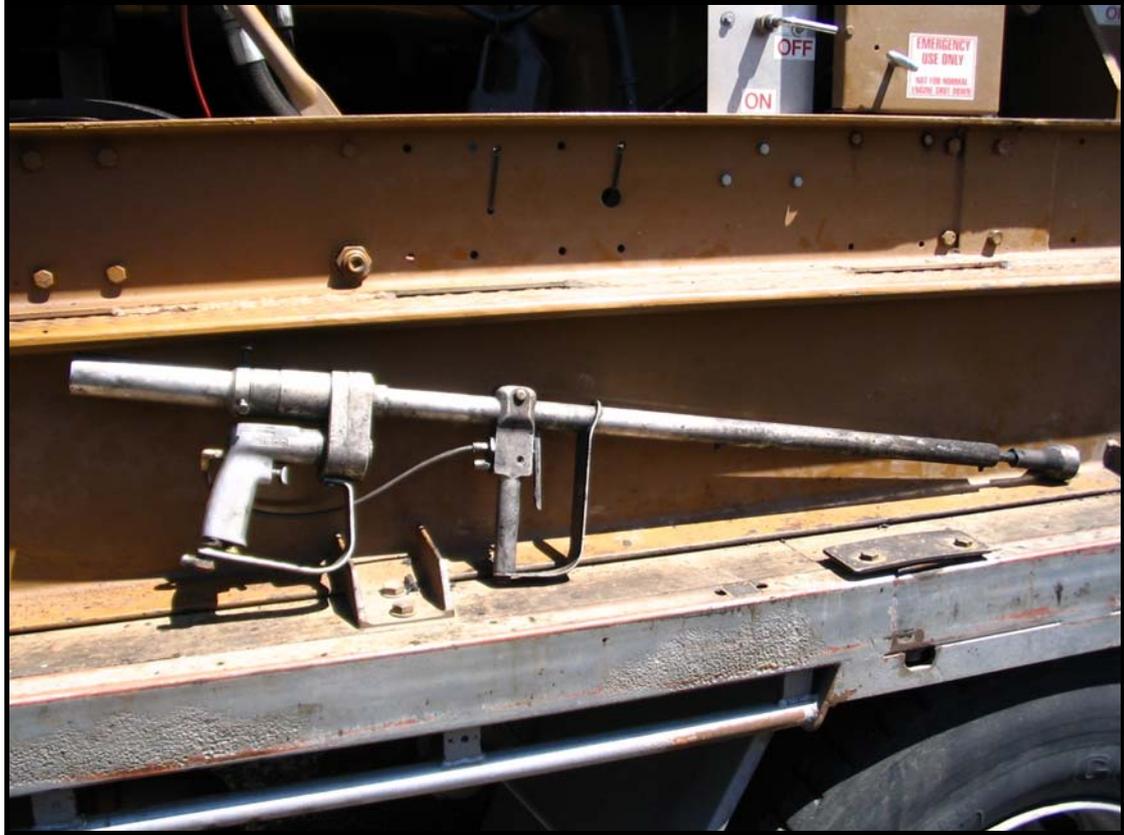
The gun used was a Vulcan stripper rotary gun and air operated multi mode flow control valve (tumble box) (*See Photograph 1*).

With both triggers depressed and only the primary let go, the gun stopped rotating and the water pressure from the tumble box to the gun was stopped. With both triggers depressed and the secondary trigger let go, the gun continued to rotate but the water pressure from the tumble box to the gun stopped.

The Onyx engineer concluded that he could not get the gun or tumble box assemblies to fail.

PHOTOGRAPH 1 - THE GUN USED AT THE TIME OF THE ACCIDENT

The wounds were consistent with the discharge of the gun with the rotating compressed air nozzle stopped, and the water pressure decreasing as the gun passed over his right leg at full pressure and onto his left leg at almost no pressure.
