# Accident Report

*Aquilo*

Person Overboard/Fatality

REPORT NO.: 04 1155

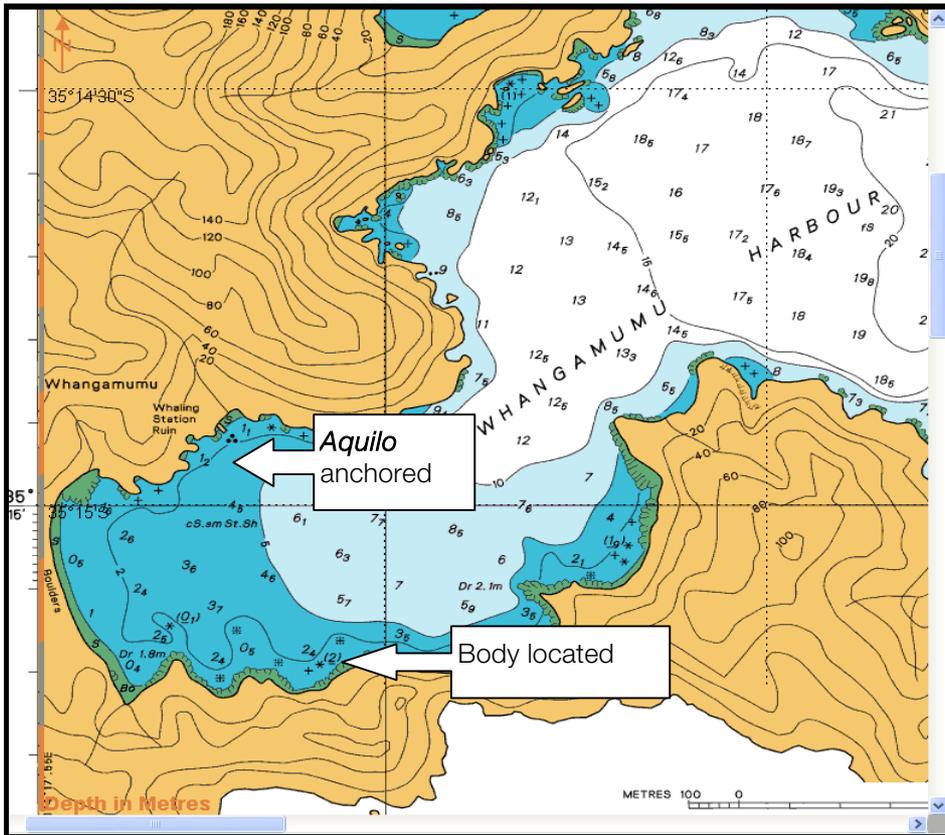
Figure 1

At about 1700 hours **Aquilo** moved further into the bay and anchored in the area with about 10 other vessels, including the yachts **Redeeder** and **Entourage** (See Figure 1). There was a light northwest wind.

At about 0730 hours they located the body of the Skipper's father on the rocks at about the high water level to the south of where **Aquilo** was anchored (See Figure 1). He was dressed in underpants and a singlet, which was his normal sleep attire and had minor cuts and grazes from being washed onto the rocks. He showed no signs of life.
