Accident Report  
*Arahura*  
Mechanical Failure in Tory  
Channel on 14 December 2004  
Class B

## REPORT NO.: 04 3626

# ARAHURA – MECHANICAL FAILURE

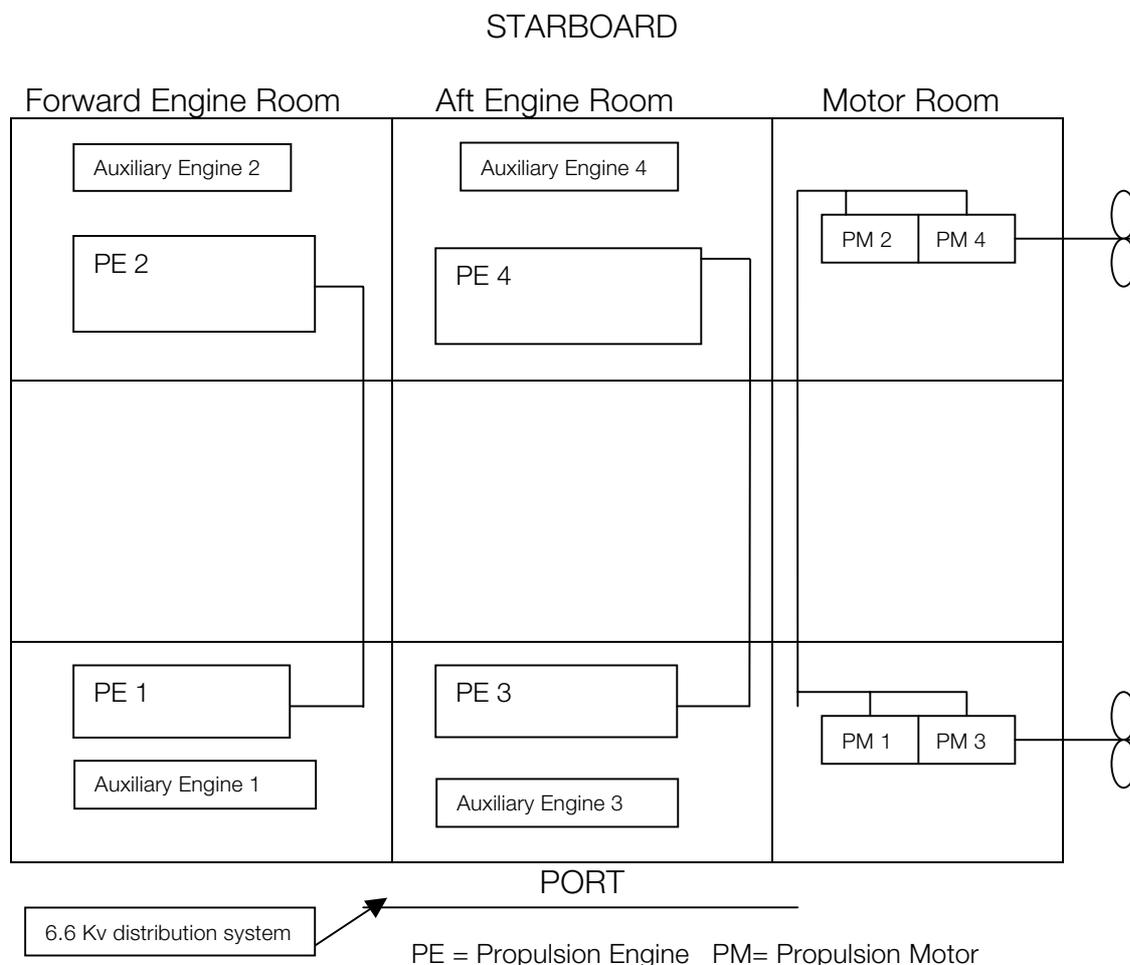
**Figure 2 – Machinery Layout onboard Arahura**

Whilst *Arahura* was transiting Tory Channel (Figure 1), a shore based Electrical Contractor was tracing/eliminating earth faults in the vessel's main engine room. These faults had been the cause of previous spurious alarms on the CSI alarm and monitoring system. The function of the system was to monitor the sensor outputs from the four diesel driven alternators (PE's – Figure 2 ). The PE's provided electrical power to four electric propulsion motors (PM's – Figure 2 ).

The Contractor mistakenly removed two wires from the CSI alarm system that were monitoring unit PE 4. This caused PE's 1 and 3 to shut down.

The above action caused a loss of electrical power to the starboard propulsion motor, which then stopped. *Arahura* still had power to the port propulsion motor (PM1).

- The Electrical Contractor was working on the CSI alarm system to PE 2. When the EO informed the contractor that an over speed alarm had sounded for PE4 the Contractor realised he had mistakenly removed the RPM monitoring wires for PE 4.

- PE's 1 and 3 shut down after the wires were removed from PE 4. As the Contractor had ascertained that earth faults existed in the RPM sensors, it is probable that the removal of these wires caused an electrical spike. This then caused the voltage to rise high enough to trigger an over speed shut down of the three operating propulsion engines. This was the conclusion reached by the contractor.

1. Interislander responded to the incident by putting out a fleet memorandum; prohibiting work on any system, when the vessel was on passage in enclosed waters, which affected or could affect the propulsion of the ship, no matter how remote. This included any alarms and control systems relating to the propulsion of the vessel.
2. It is recommended that the above procedure be documented in the company's safety procedure manual and drawn to the attention of all engineering staff.
3. It is further recommended that Interislander give consideration to reducing the period between maintenance layovers to allow senior engineering officers to progress planned maintenance.
