# Accident Report

Grounding

*Ariel II*

16 August 2006

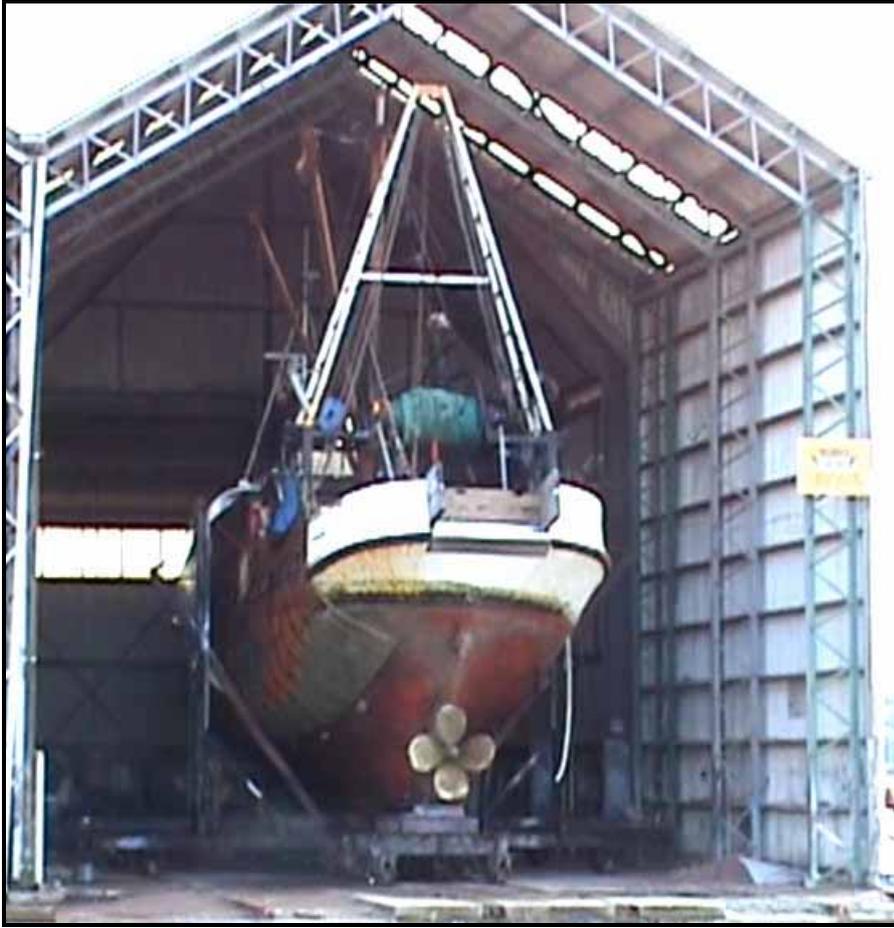
**Photograph 1**  
*Ariel II* on slip in Bluff shortly after the grounding.

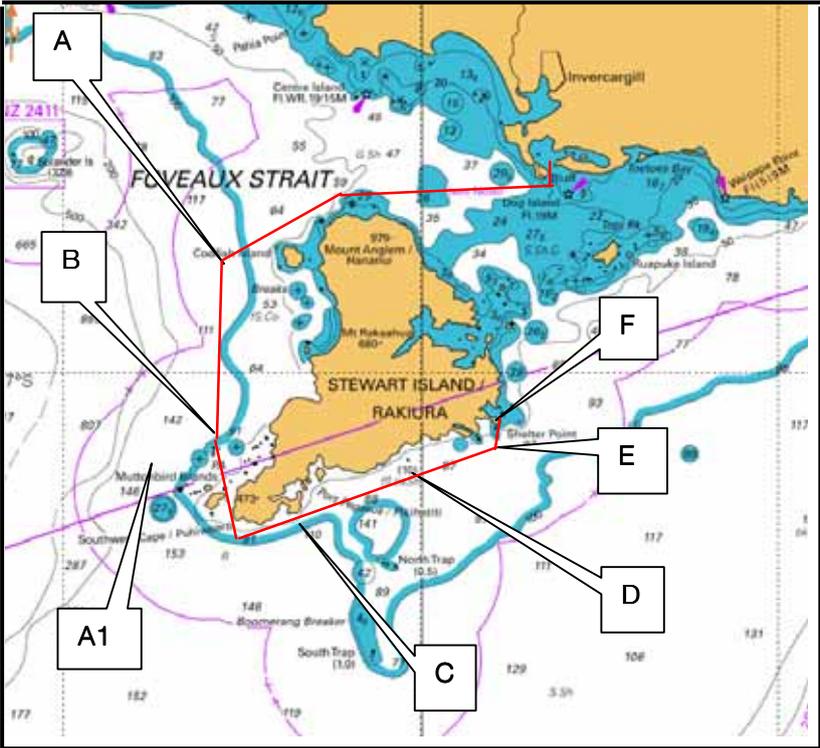
Figure 1

Approximately 10 minutes later they were thrown off their feet as the vessel grounded in *Position F* (See Figure 1). The vessel was thrown bodily over to starboard with the bow pointing in a broadly westerly direction. The main engine stalled and the Skipper made his way to the wheelhouse where he made a Mayday call on the local Bluff Fisherman's Radio VHF channel. He checked the engine room and observed water coming in. He instructed one crewmember to launch the ship's dinghy that was lashed down on the fore deck. After this was completed, the Skipper and one crewmember boarded the dinghy. This capsized shortly afterwards. The dinghy sank leaving both men in the water clinging to the side of the vessel.

The Skipper spent about 10 minutes in the wheelhouse at *Position E* (See *Figure 1*). He states that at this position he made a course adjustment to pass through clear water between Shelter Point and Wreck Reef (See *Figure 4*). He then left the wheelhouse to help on deck for a further 10 minutes. Given a vessel speed of 9 knots and a multiplier of 10 minutes the distance travelled would have been 1.5 nautical miles.

The course selected by the Skipper after *Position E* (See *Figure 1*) should have taken the vessel clear of all obstructions in the area.

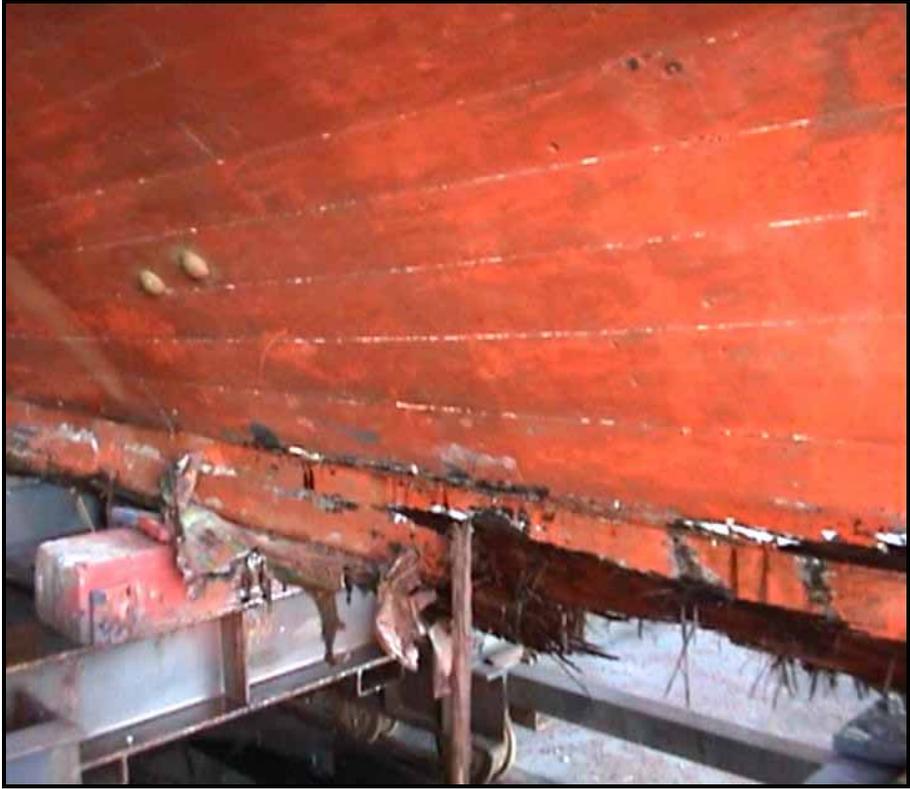
**Photograph 3**  
Keel. The entire length of the keel has impact damage.

The vessel is to be repaired in Bluff.

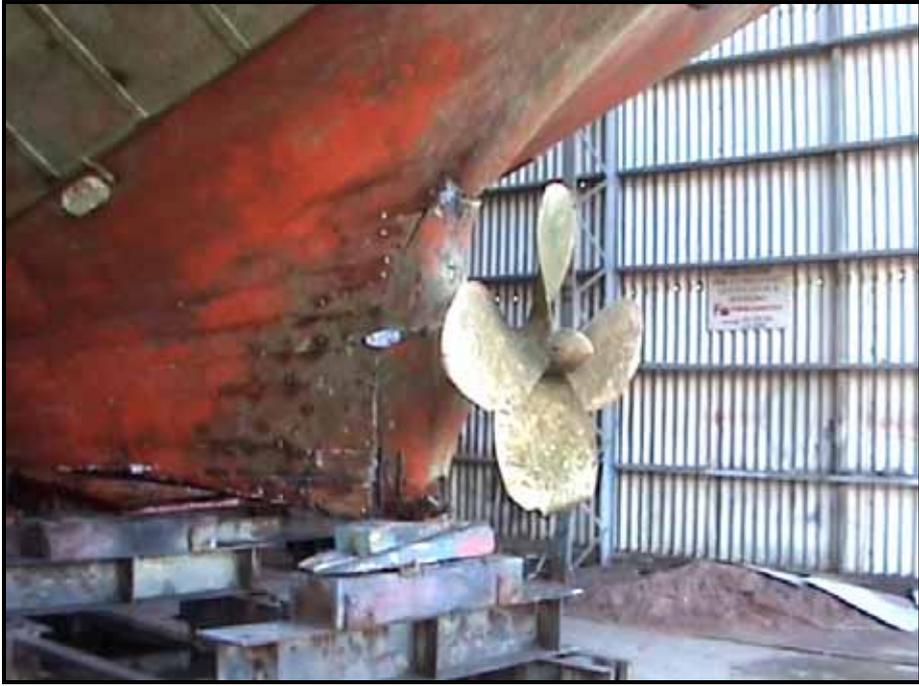
**Photograph 4**  
Skag. The skag is completely missing from where it was scarfed into the keel. The holding bolts have been torn out.

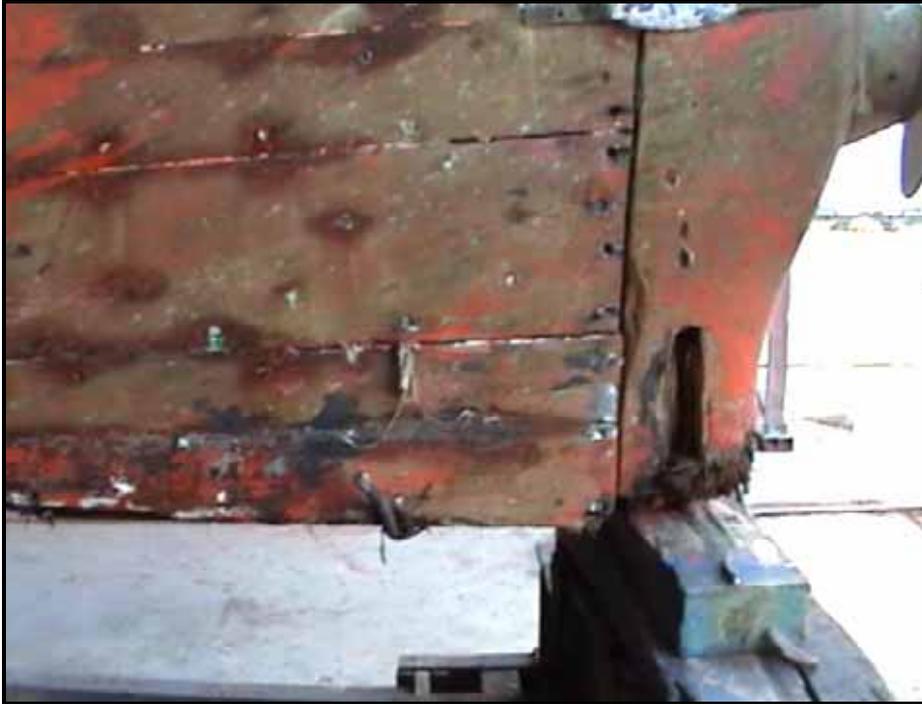
**Photograph 5**  
Sternpost. The sternpost has been critically damaged as a result of the loss of the skeg.

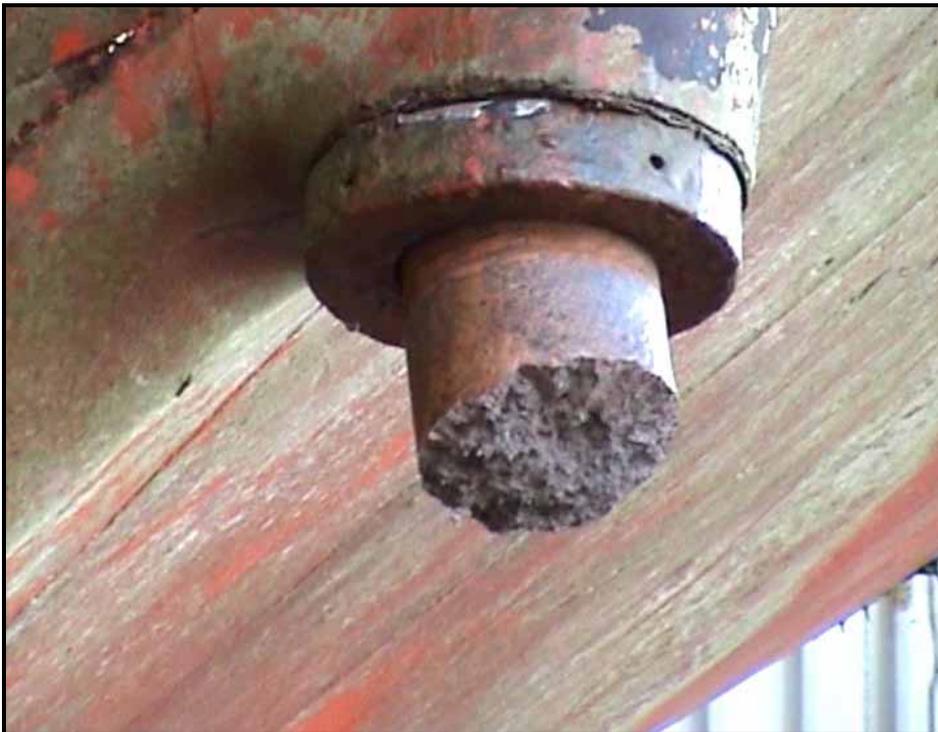
Once clear of the rocks, the Skipper made a second Mayday call to Bluff Fisherman's Radio. This was because the steering was not answering to the helm. It was later determined that the rudder had sheared off during the grounding.

**Photograph 6**  
Rudder. The rudderstock has been sheared off with a cant to port indicating a blow from the starboard side.

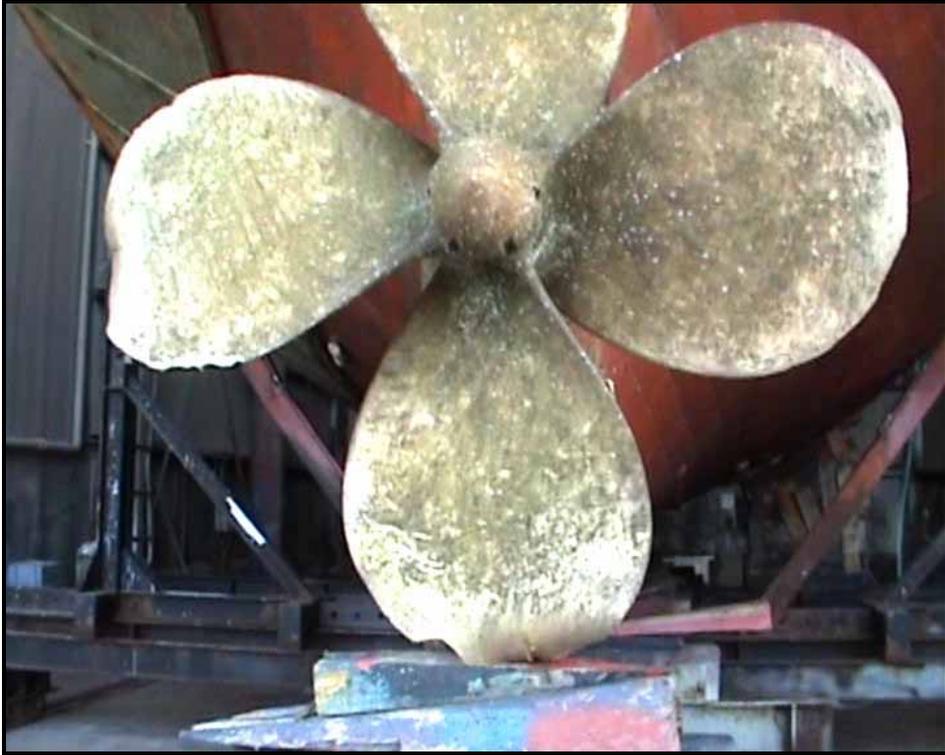
**Photograph 7**

Propeller. The propeller has moderate damage on most blades.

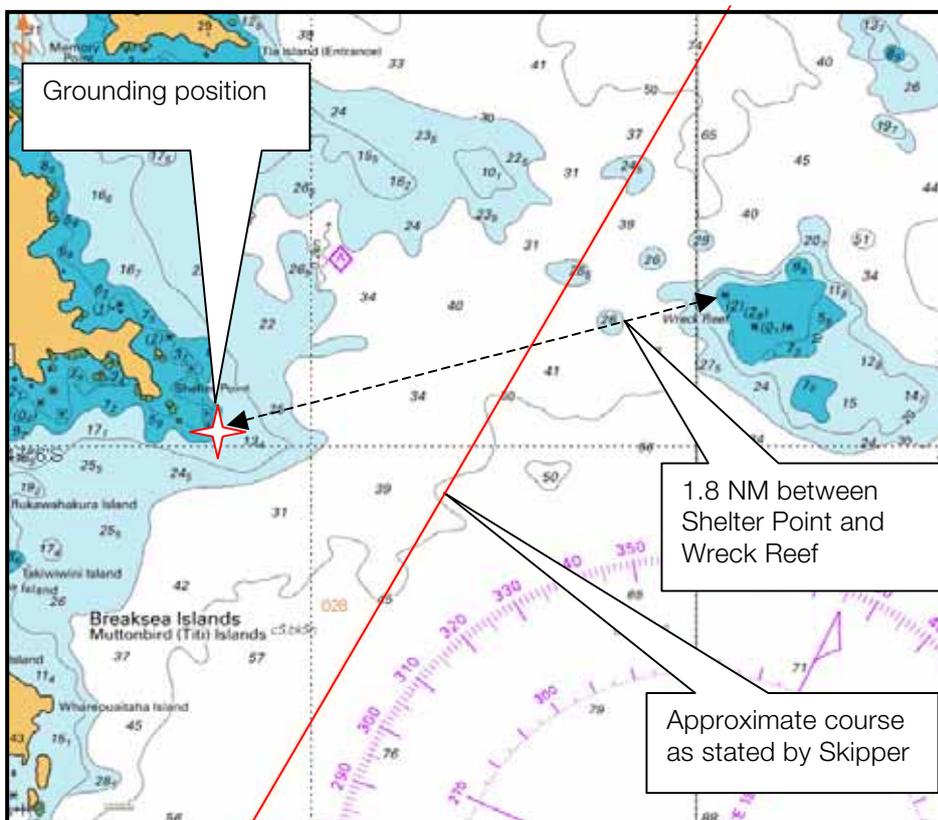
Figure 4

Local fisherman familiar with the area state that with experience, passage can be made between the outlying rocks east of Shelter Point and the land. They also note that there would not have been a noticeable influence (set) on the vessel caused by the tide shortly before the grounding.

The Skipper was on deck for 10 minutes after making his course adjustment. The vessel was travelling at 9 knots; they would have covered a distance of 1.5 NM during this time. During this time the vessel must have tracked along an incorrect course to the grounding position. The Skipper cannot have made any attempt during this time to monitor the vessel's navigation as otherwise he would have been aware of the danger of grounding.

7. That the Skipper uses the waypoint function of the GPS to better assess accuracy of the vessels course during passage.
8. That the Bluff office of Maritime New Zealand monitors this vessel and Skipper closely to assess compliance with the above recommendations.
