Class B Accident Report

**Grounding**

Kenepuru Sound on 8 January 2005

## REPORT NO: 05 1168

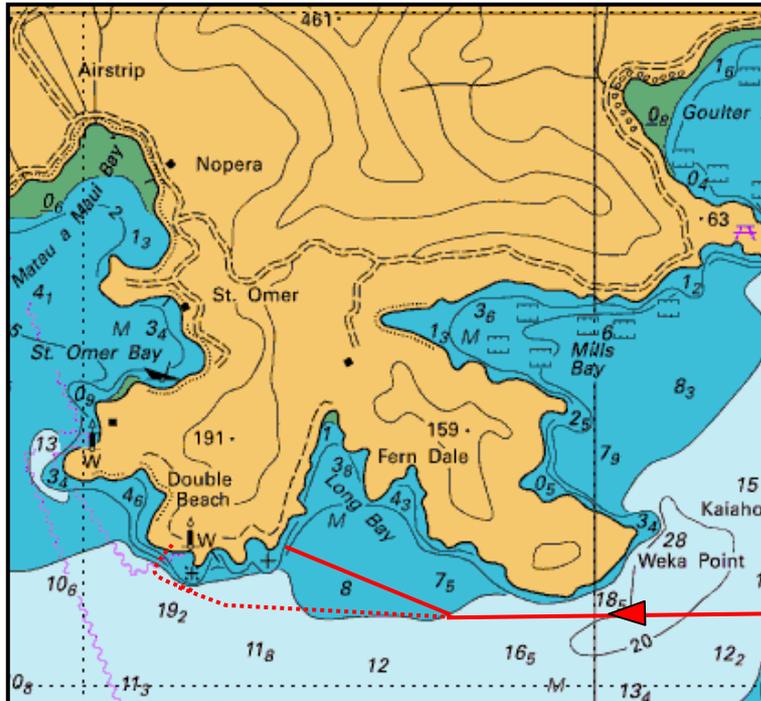
*Audax* hit the rocky shoreline at approximately 15-20 knots, narrowly missing the sheer cliffs to starboard and a potentially disastrous outcome. The vessel ended up almost completely out of the water. The passengers had to be evacuated by another vessel and taken back to their bach. *Audax* was re-floated on the high tide the next day. None of the family sustained any injuries but the vessel was badly damaged.

APPROXIMATE TRACK AND POSITION OF GROUNDING

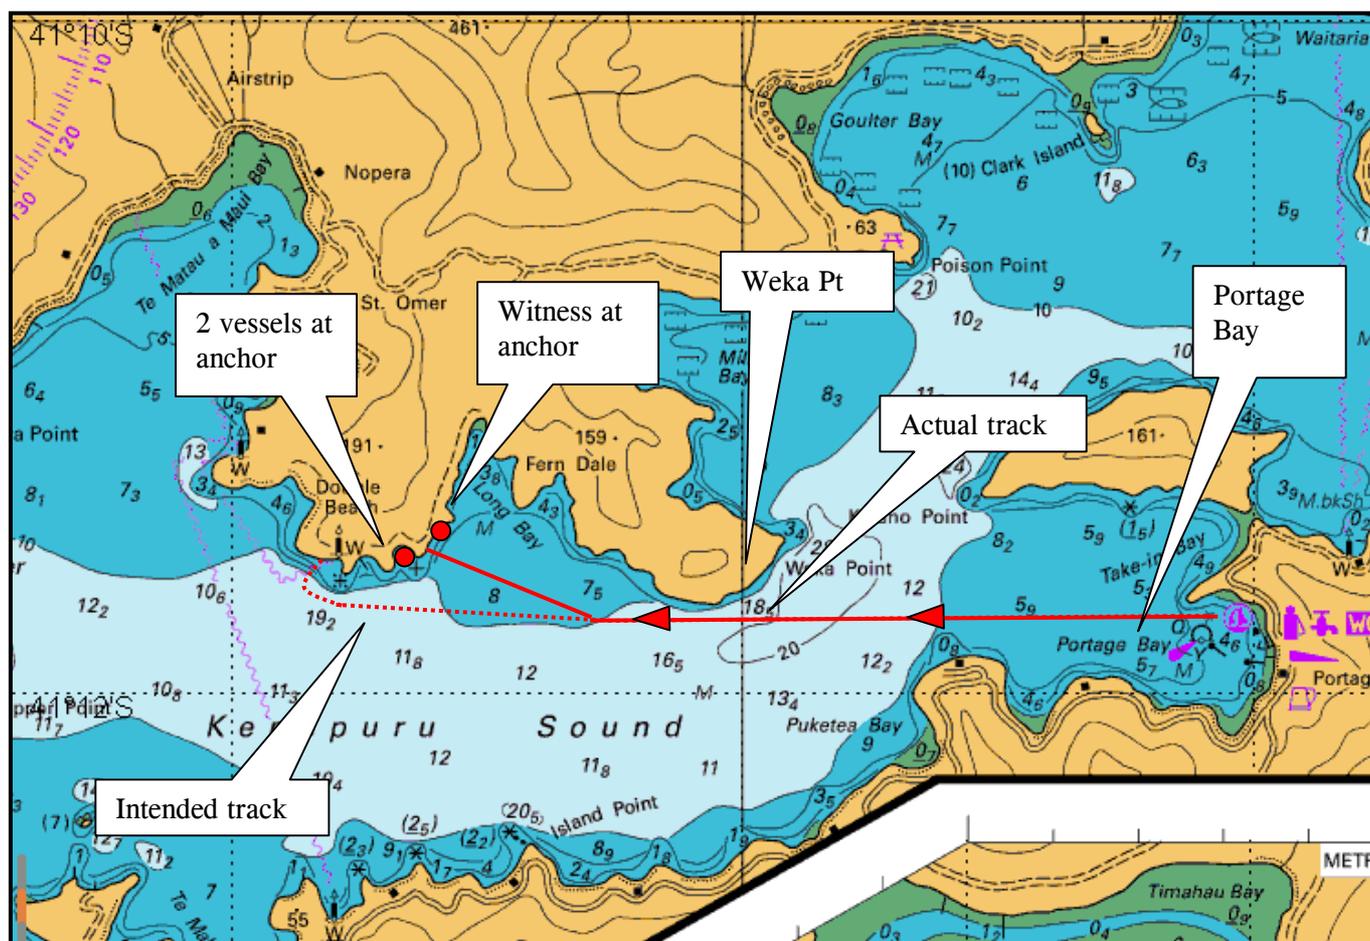
APPROXIMATE COURSES AND POSITIONS OF *AUDAX*

After rounding Weka Point the Skipper observed the port and starboard navigation sidelights of another vessel right ahead. The vessel appeared to be on a reciprocal course to *Audax*. The vessel also appeared to veer slightly to port and then back onto a reciprocal course again. The Skipper of *Audax* presumed that the vessel was heading to an anchorage position in Fern Dale Bay.

As the Skipper tried to identify the intentions of the oncoming vessel he took the vessel out of autopilot and steered the vessel manually. He then altered course to starboard to avoid passing too close to the vessel.

While the Skipper was concentrating on the oncoming vessel he lost his orientation in relation to his planned track. Too late he realised that he was standing into danger before reducing speed. As he reduced speed the shoreline appeared in the vessel's lights ahead and they grounded.
